TEST SETUP PHOTOS

EUT was tested on a small PCB and as close to a stand-alone configuration as possible with the additional antenna. Emissions were investigated both with and without the case to ensure it did not affect results.

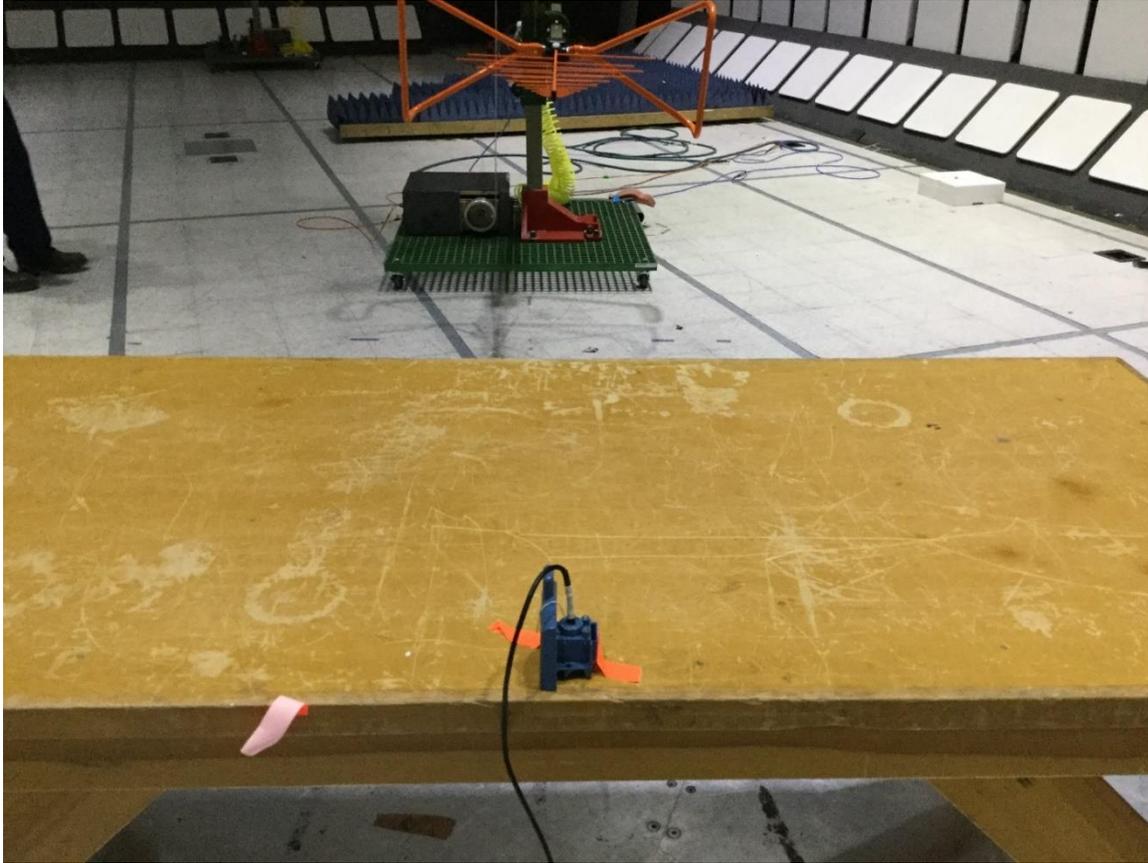
Shown with case

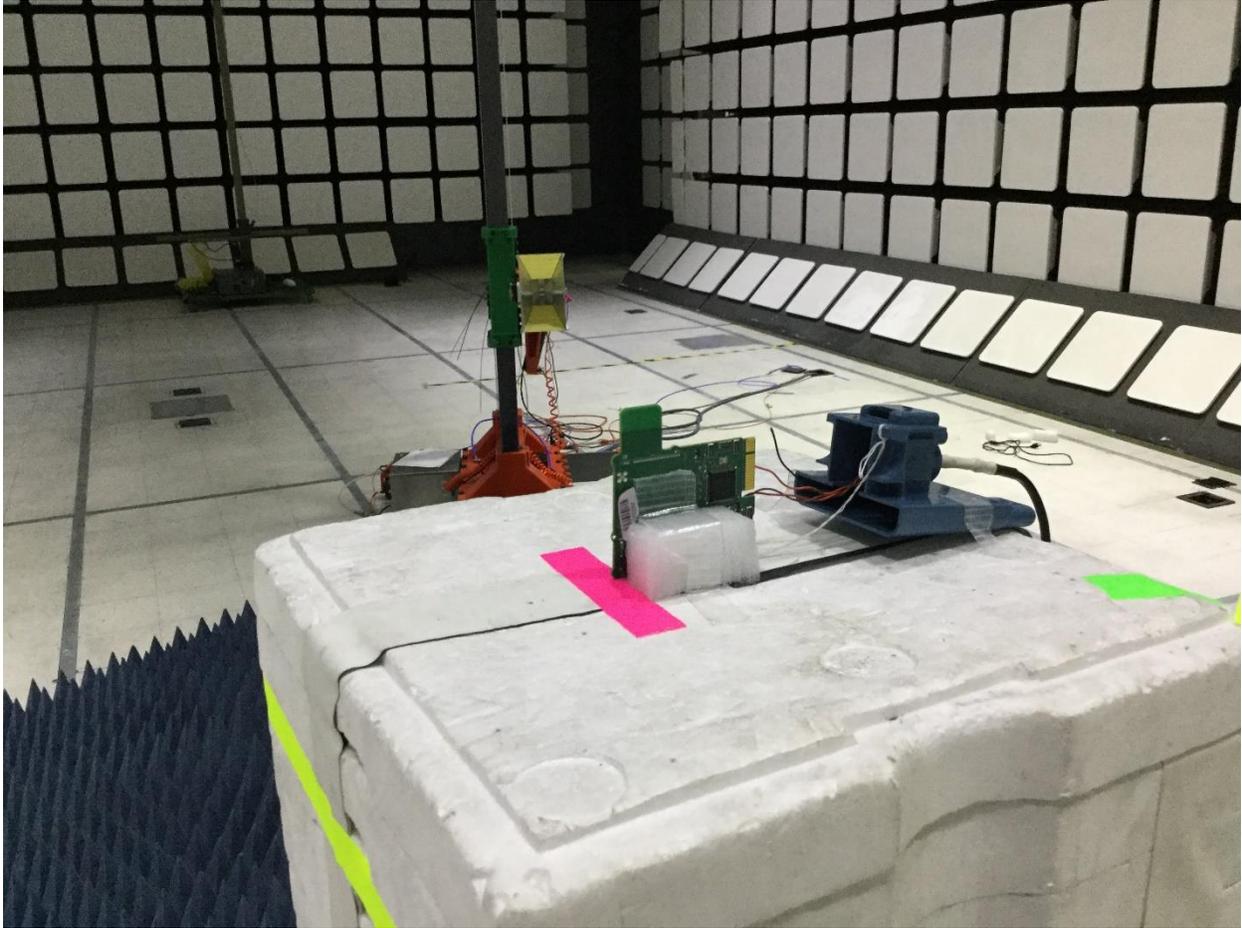
Shown without case

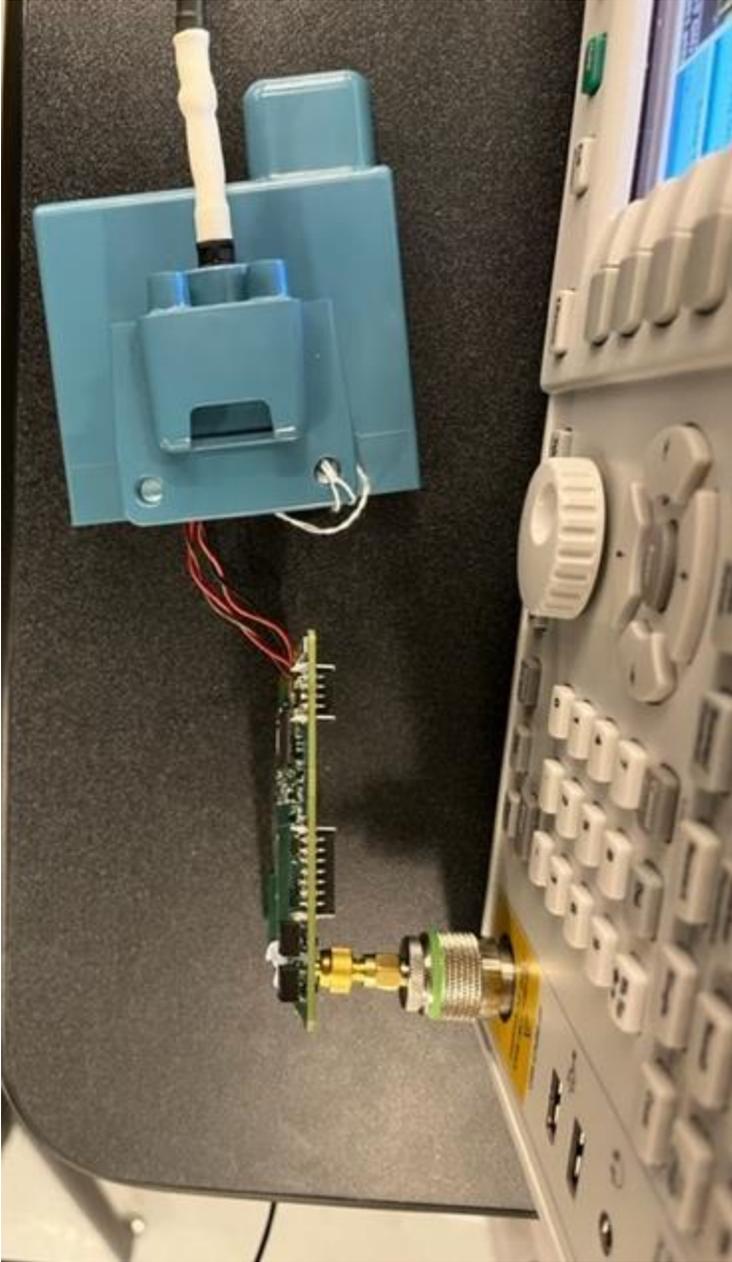
Conducted RF power
