Photographs of the EUTs as viewed from in front of the antenna, site B:

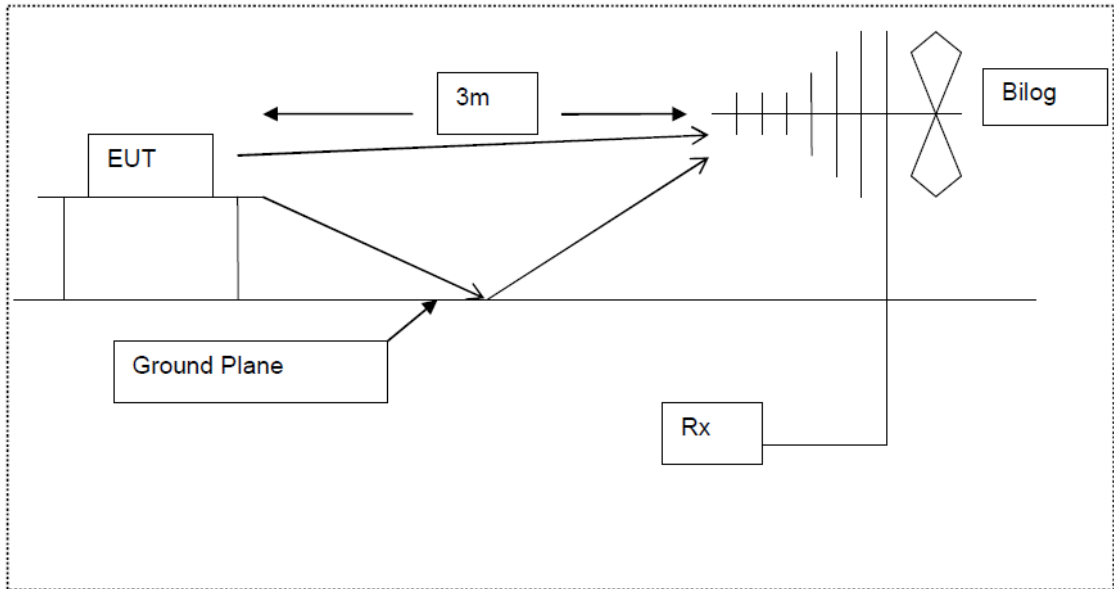
Diagram of the 30MHz – 1GHz radiated emissions test setup, site M.

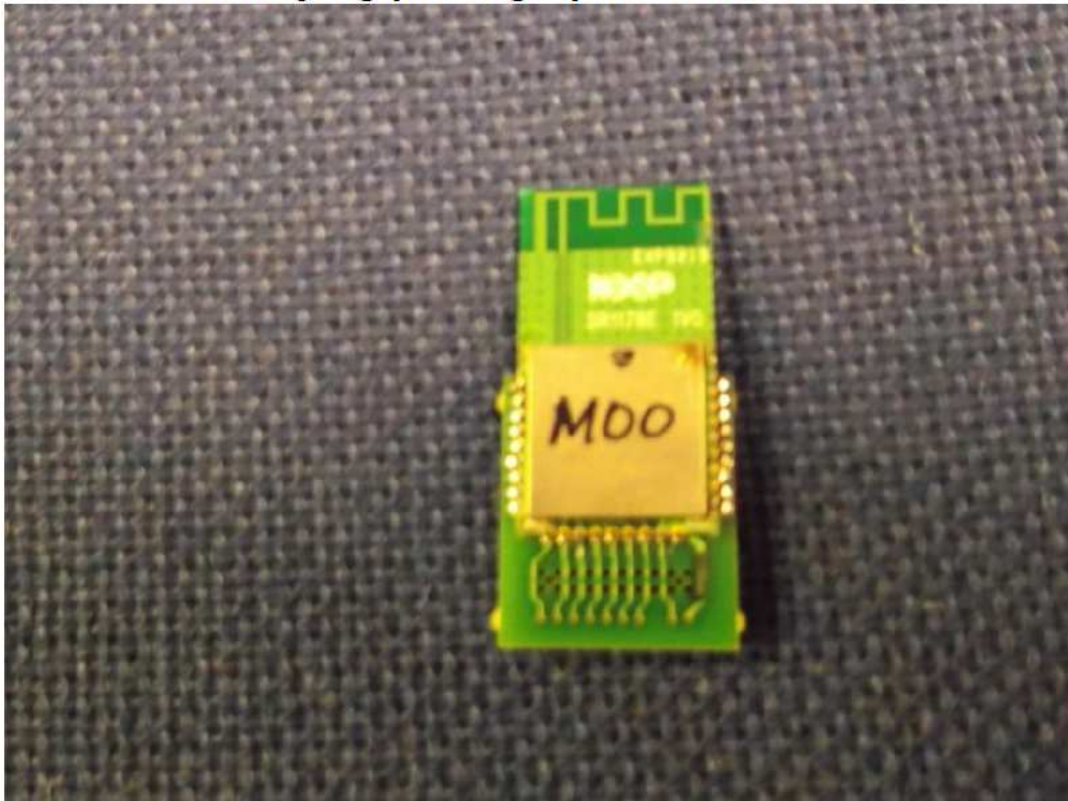
**Identifying photographs of the EUTs:**
