# **FCC MPE REPORT**

**Product Name:** Microwave Oven

Model Tested: EMB34G5MA-S

FCC ID: VG8EMA34GYY-S

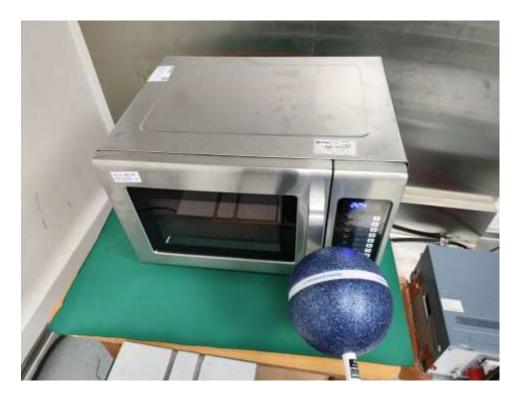
# 1.2.5 Test setup photo

The EUT was set-up according to the FCC MP-5 and FCC Part 18 for radiation Hazard measurement. The measurement was using a microwave leakage meter to measure the radiation leakage in the asreceived condition with the oven door closed A 770mL water load in a breaker was located in the center of the oven and the microwave oven was set to maximum power. While the oven operating, the microwave meter will check the leakage and then record the maximum leakage.
