## TEST REPORT

Report No. : AT0035786(7) Date : 29 May 2015

Sample Description	Model No.
Large Laser League	TK-0526 / TK-0527

Test Method : 47 CFR Part 15 (10-1-12 Edition), ANSI C63.4 – 2009

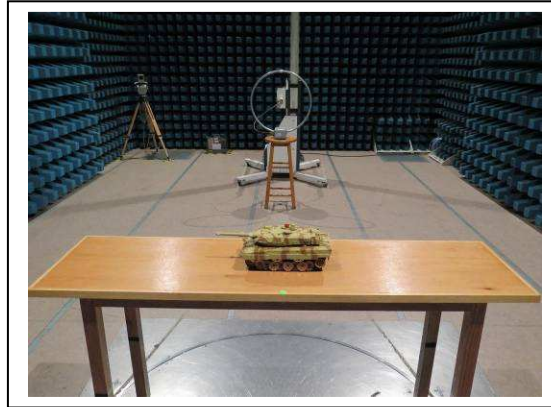
(Front view, 9kHz – 30MHz)

(Back view, 9kHz – 30MHz)

For below 30MHz, a loop antenna with its vertical plane is placed 3m from the EUT and rotated about its vertical axis for maximum response at each azimuth about the EUT. And the centre of the loop shall be 1 m above the ground.

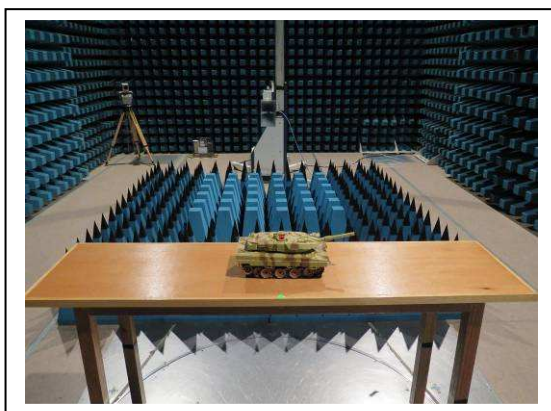
(Front view, 1GHz – 25GHz)

(Back view, above 1GHz – 25GHz)

For above 1GHz, horn antenna with its vertical and horizontal plane is placed 3m from the EUT and rotated about its vertical and horizontal axis for maximum response at each azimuth about the EUT. Preamplifier and High Pass filter was used for measurements. The reference point of antenna shall be 1 m above the ground.

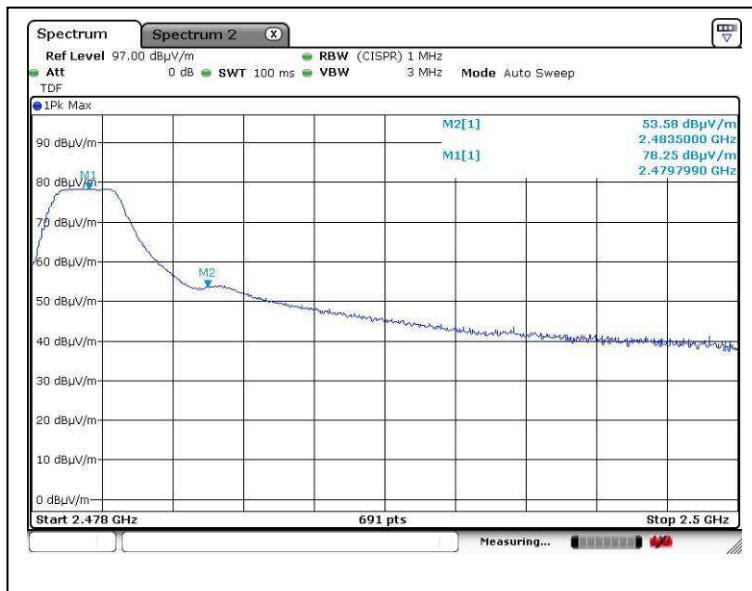
Higher edge (Peak measurement)

Higher edge (Average measurement)

The plot saved in TestRpt3.pdf shows the band edge is fulfil 15.209 requirement.
