**APPENDIX 3: Photographs of test setup**

**UL Japan, Inc.**

**Ise EMC Lab.**

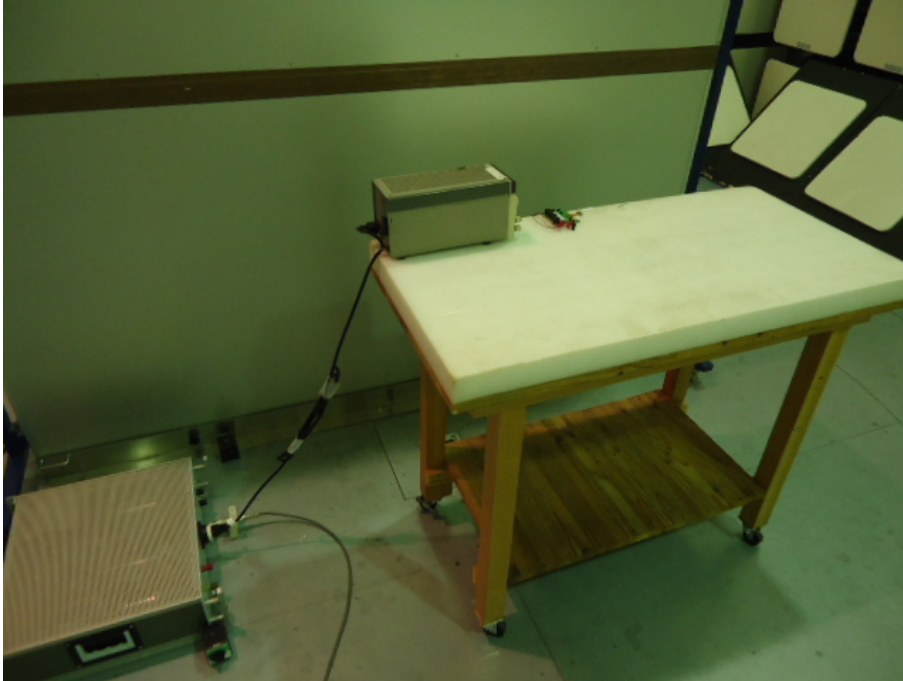
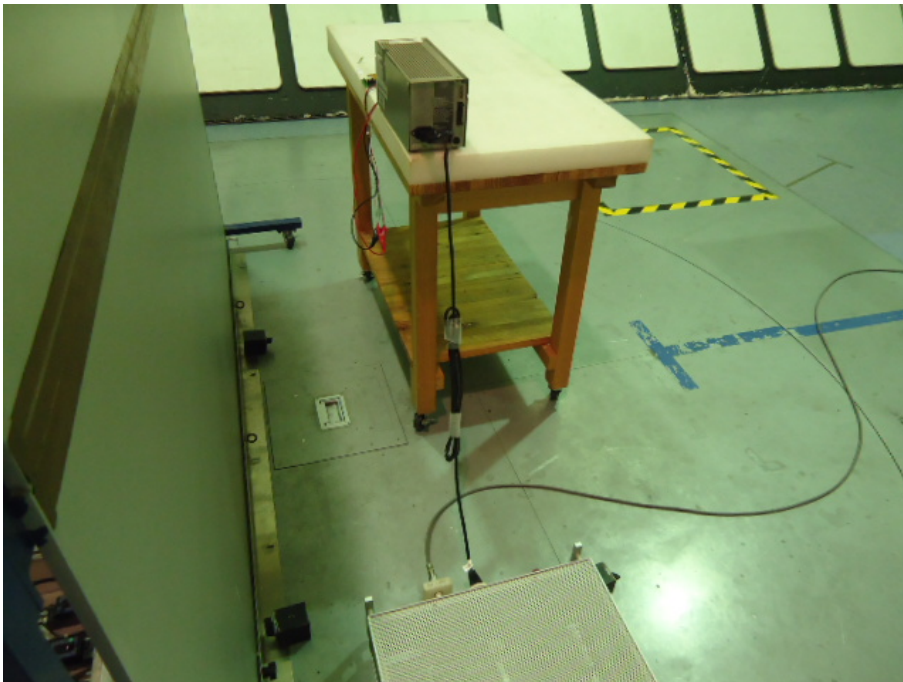
**Conducted Emission**

External antenna

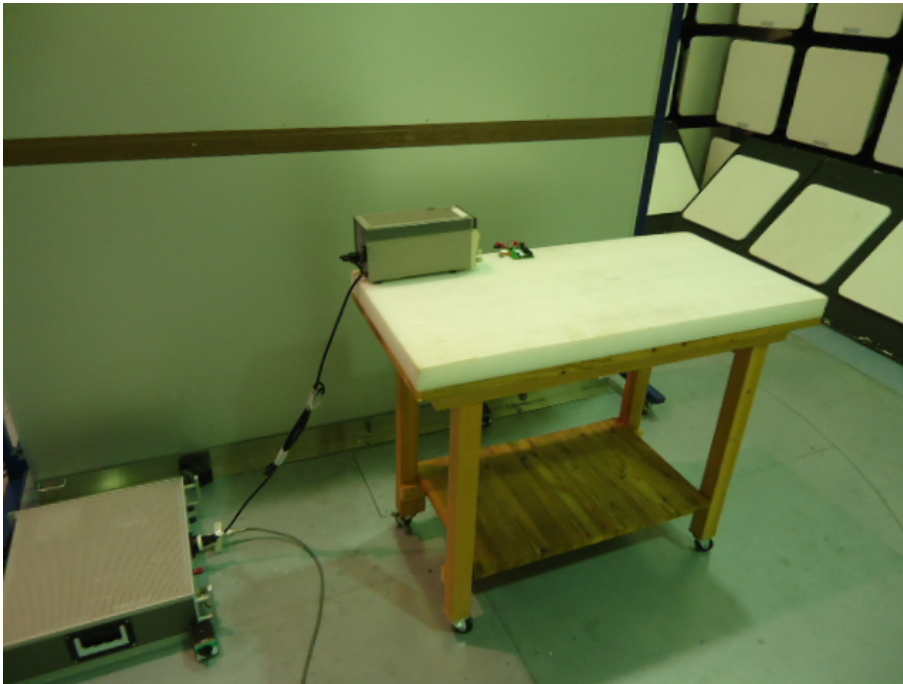
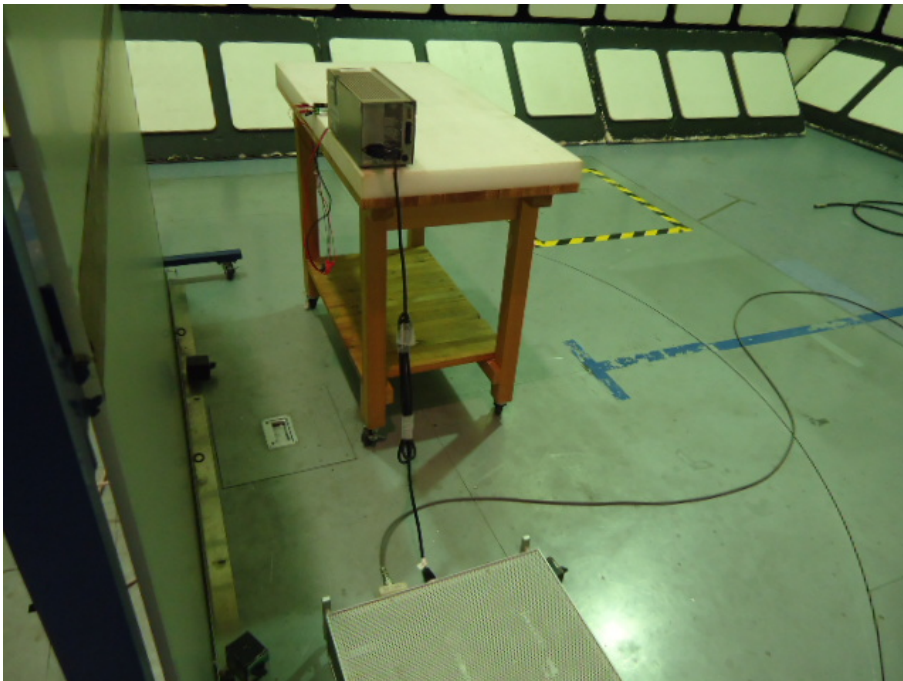
**Conducted Emission**  
Internal antenna

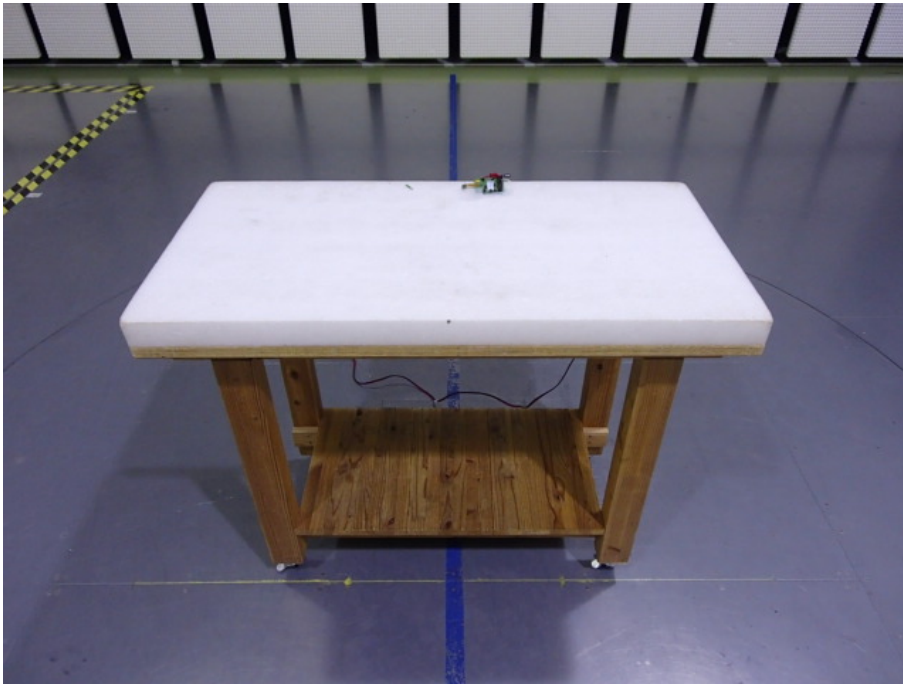
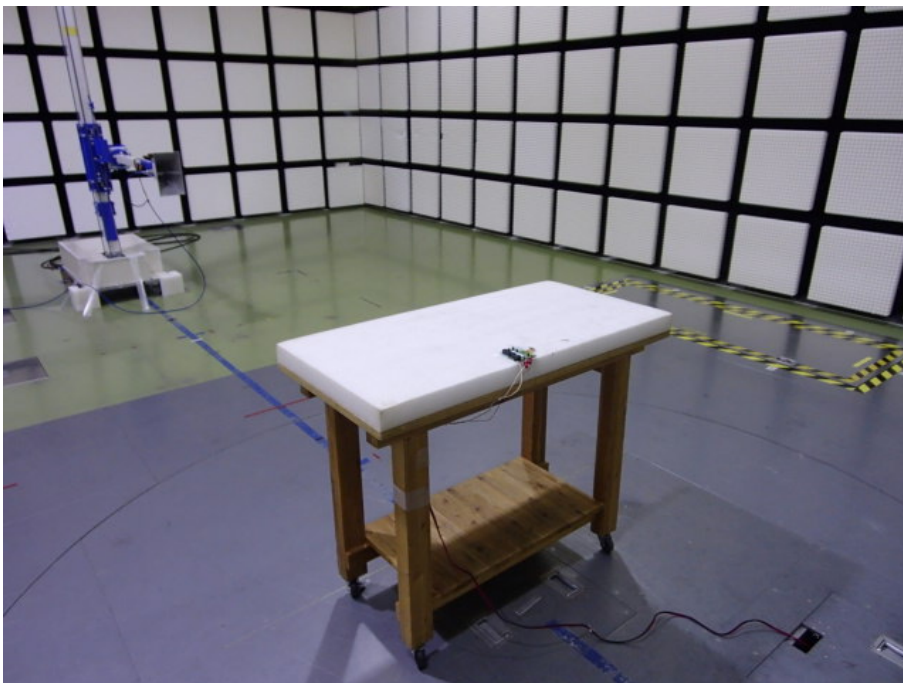
**Radiated Spurious Emission**  
External antenna

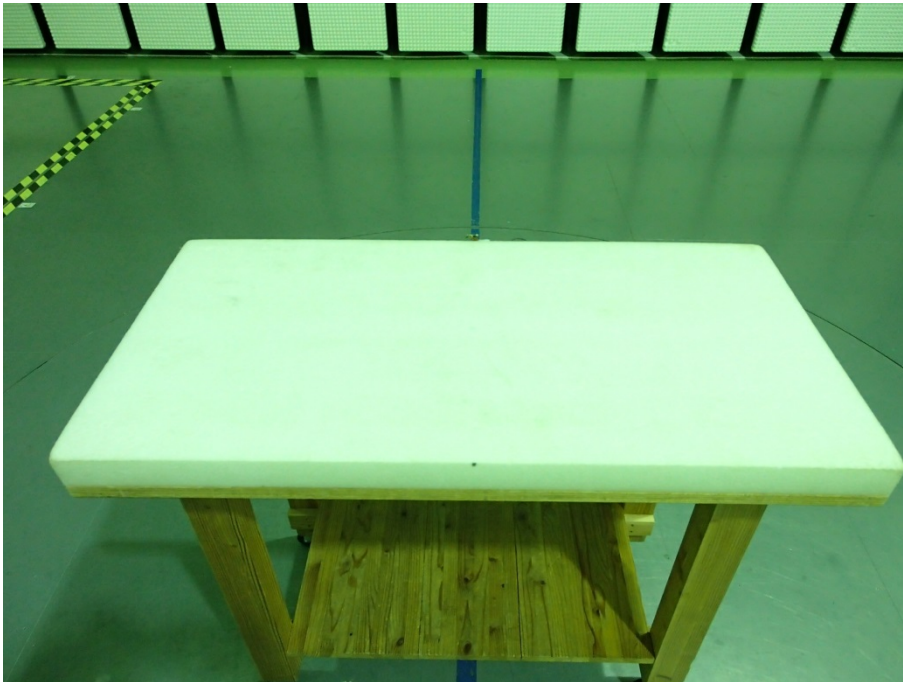
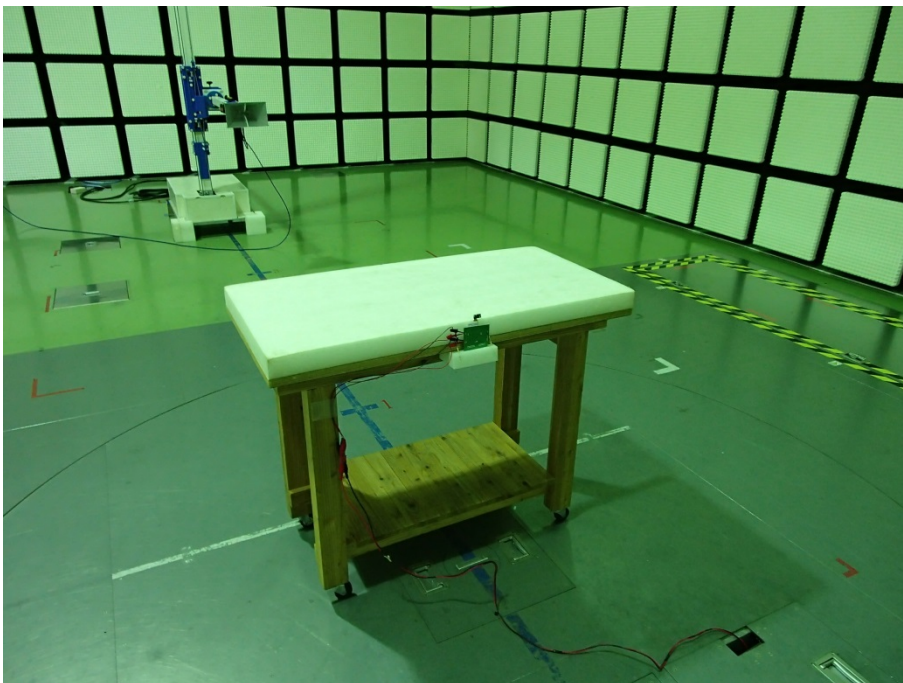
**Radiated Spurious Emission**  
Internal antenna

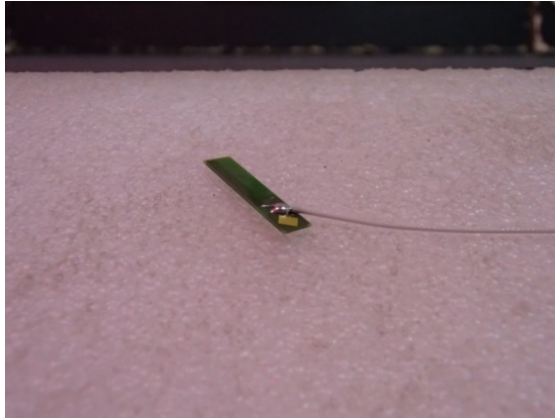
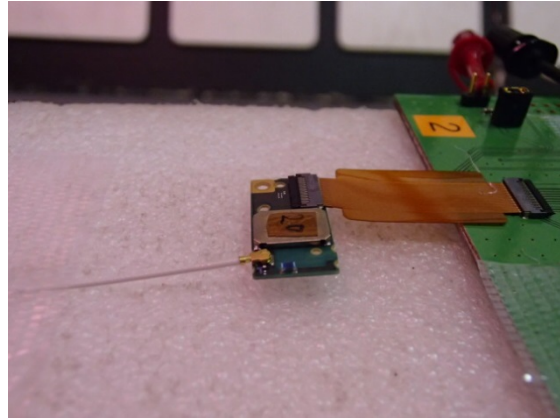
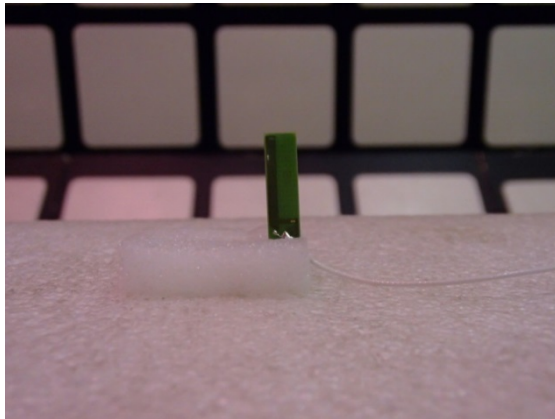
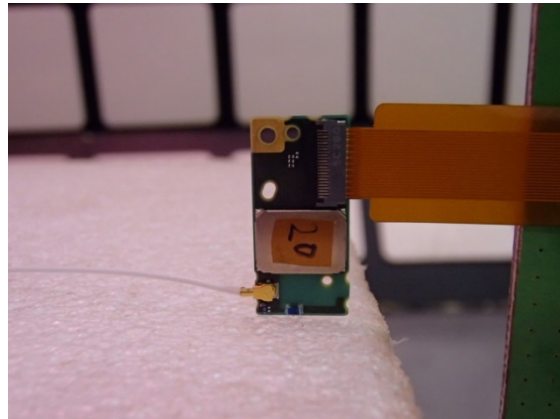
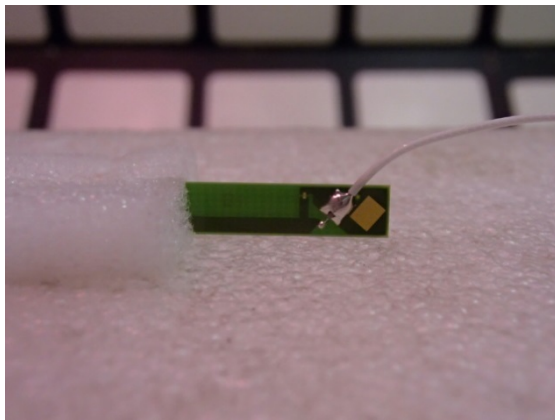
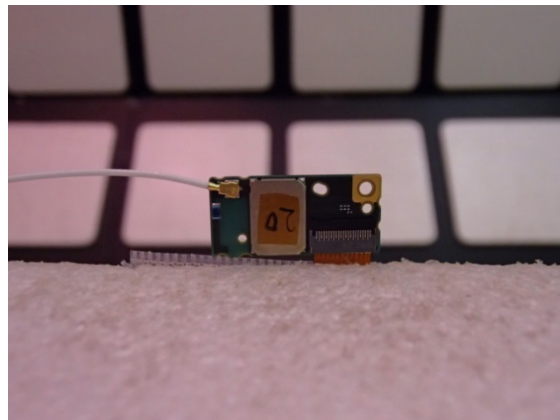
**Worst Case Position**  
External antenna

Above 1GHz (Horizontal: Antenna X Module X / Vertical: Antenna Y Module X)  
Below 1GHz (Horizontal: Antenna X Module X / Vertical: Antenna X Module X)

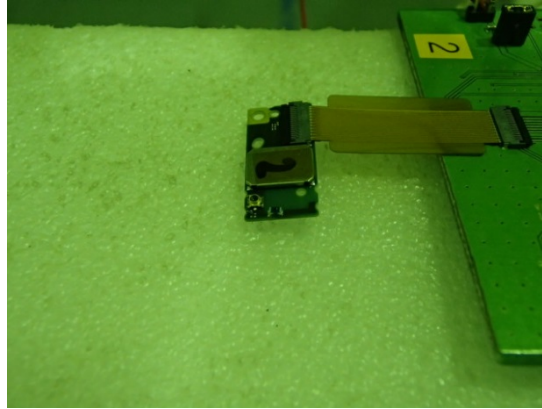
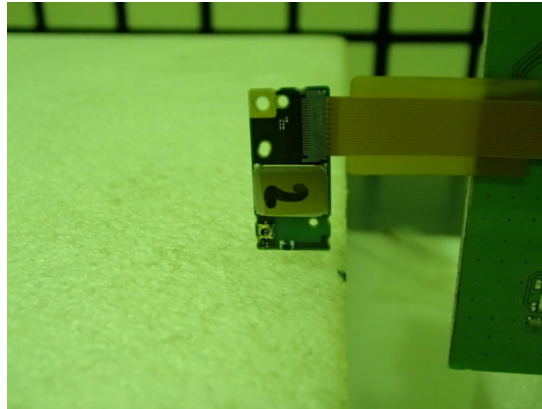
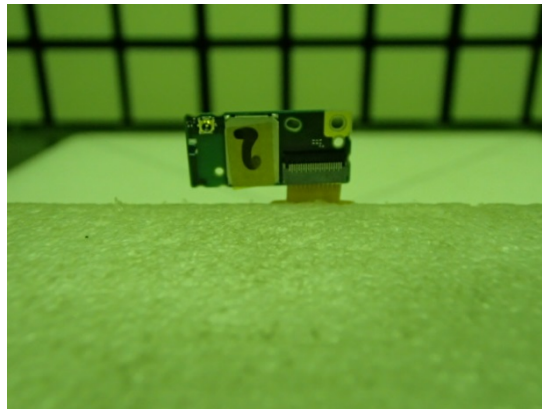
**Worst Case Position**  
Internal antenna

Above 1GHz (Horizontal: Y-axis/ Vertical:Z-axis)  
Below 1GHz (Horizontal: Z-axis/ Vertical:Z-axis)
