APPENDIX 1: Photographs of test setup

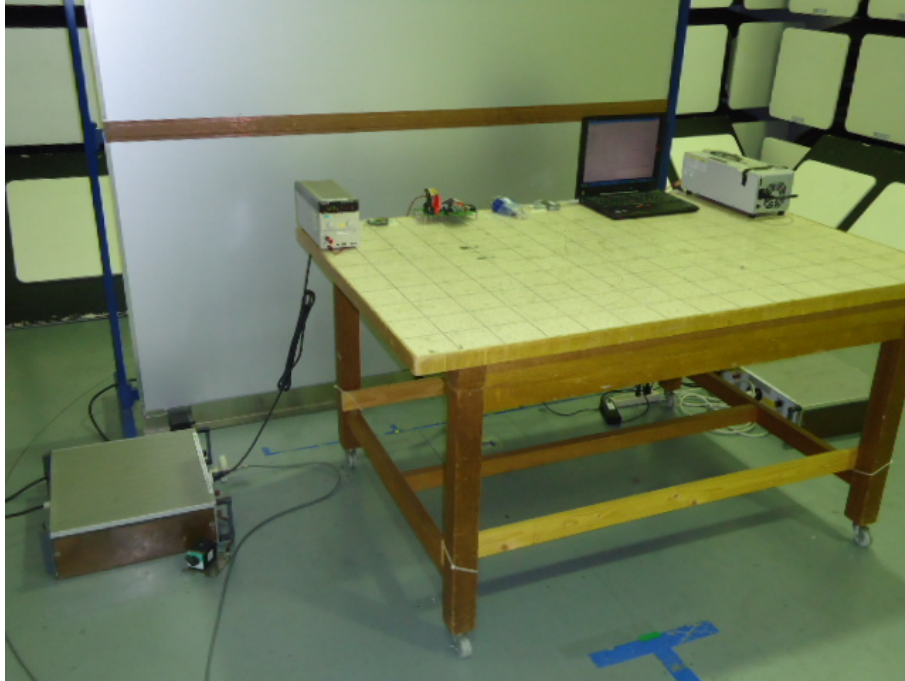
Photo 1

Conducted Emission

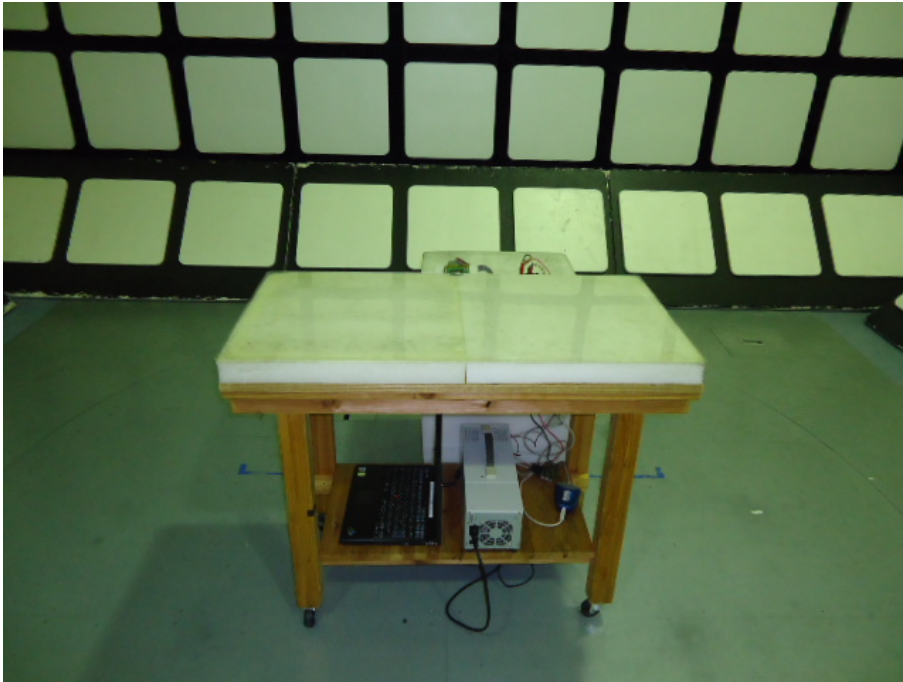
Photo 1

Radiated Spurious Emission

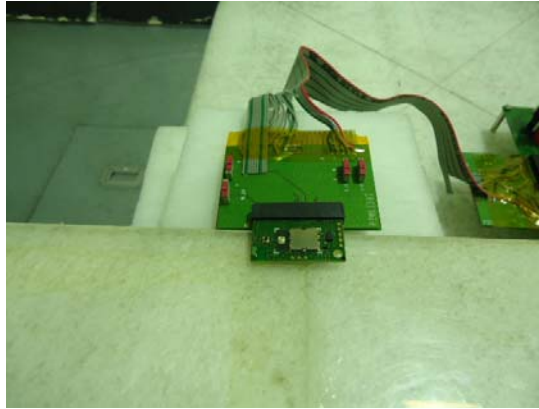
X-axis

Worst Case Position

Below 1GHz: Horizontal: X-axis/ Vertical:X-axis
Above 1GHz: Horizontal: X-axis/ Vertical:Z-axis
