Registration number: W6R22002-19655-C-54

FCC ID: W23-WMXWAVE2AS

3.13 Channel Move Time, Channel Closing Transmission Time

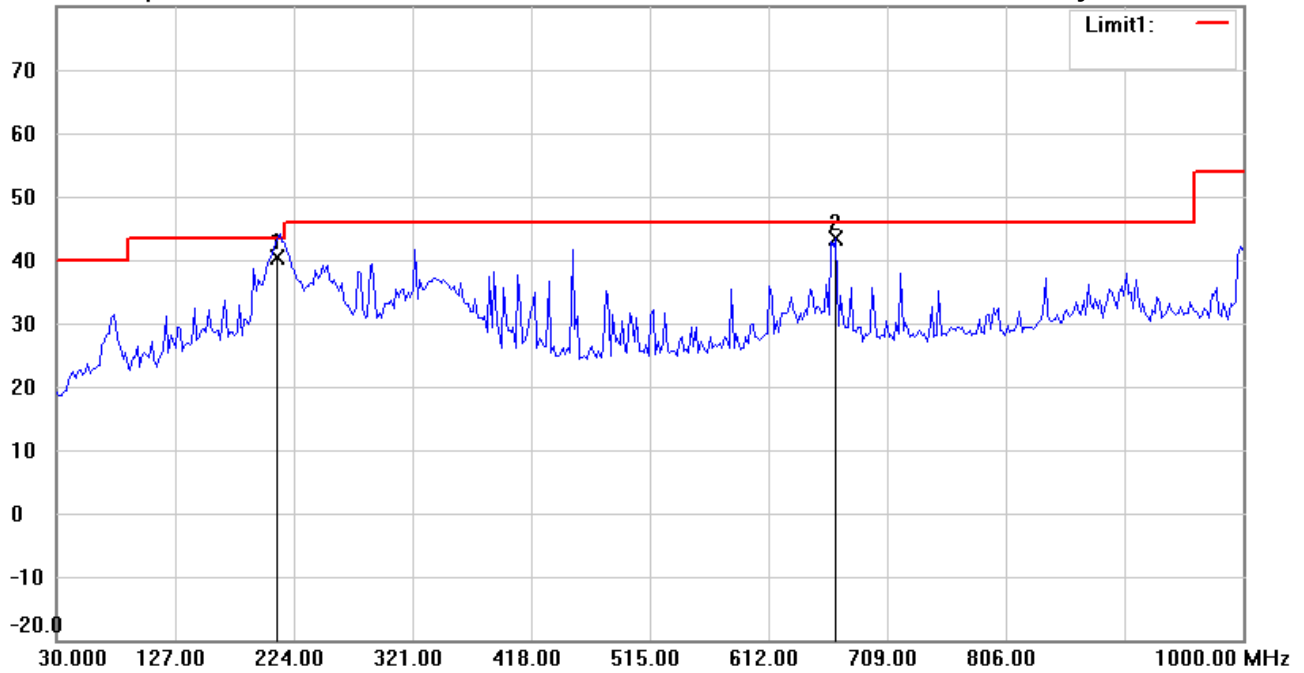
Condition : FCC_part 15 RE-Class E_30-1000MHz

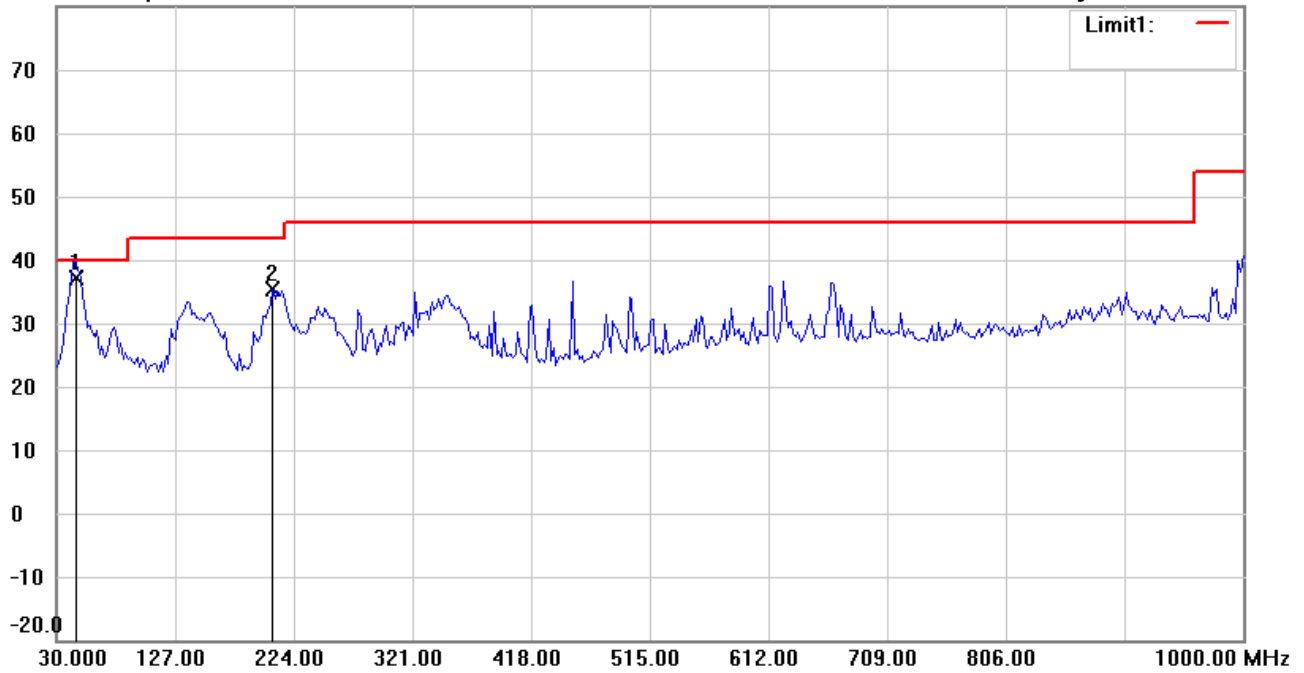
Condition : FCC_part 15 RE-Class E_30-1000MHz

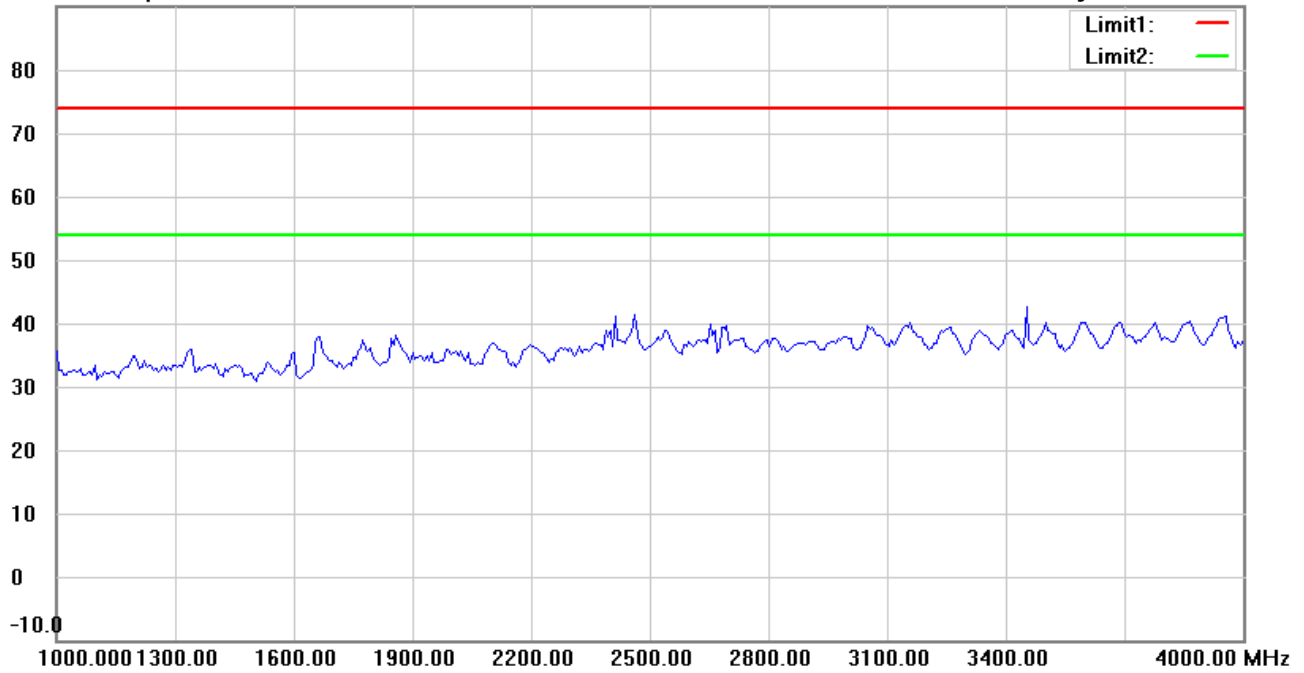
Condition : FCC_part 15E RE_Above 1GHz_PK
