Radiated Emission Measurement

Condition : FCC_part 15E RE_Above 1GHz_PK

EUT : W6R22002-19655

Test Mode : TX 802.11a CH100

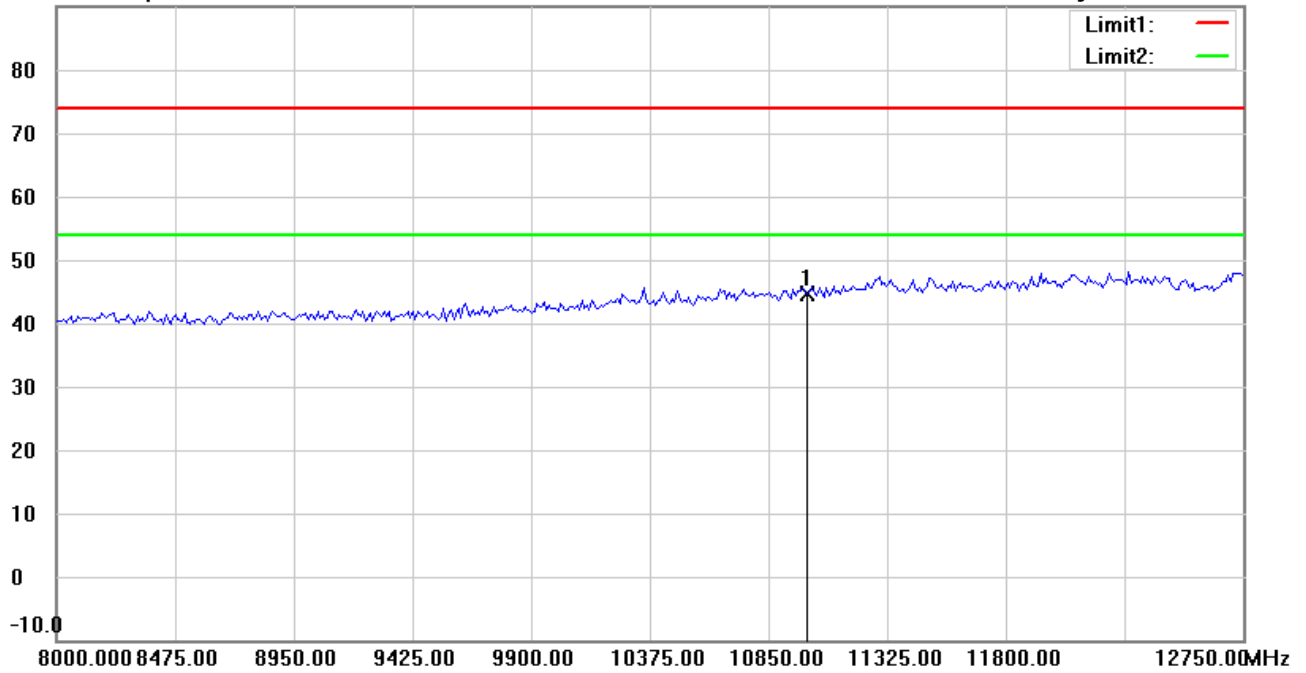
Polarization: *Horizontal*

Mk.	Frequency (MHz)	Reading (dBuV)	Detector	Corr. factor (dB/m)	Result (dBuV/m)	Limit (dBuV/m)	Ant.Pos (cm)	Tab.Pos (deg.)	Margin (dB)	Comment
*	11000.000	35.07	peak	9.51	44.58	74.00	150	95	-29.42

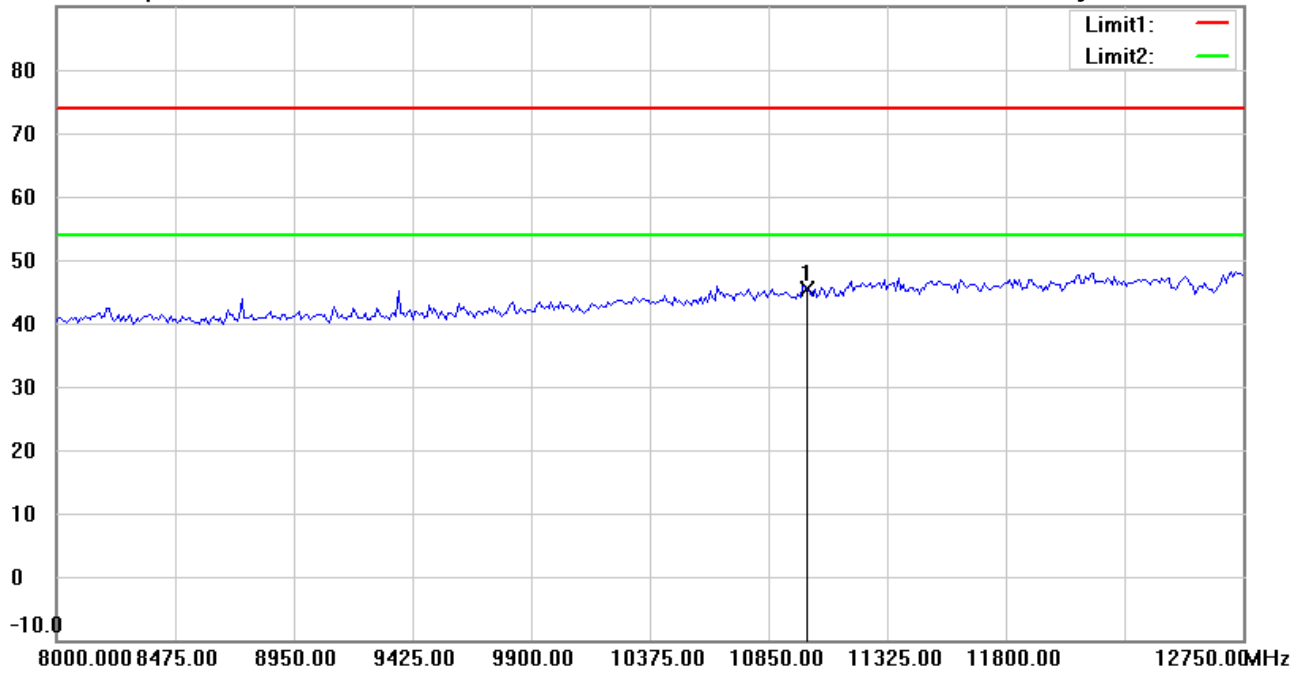
Condition : FCC_part 15E RE_Above 1GHz_PK

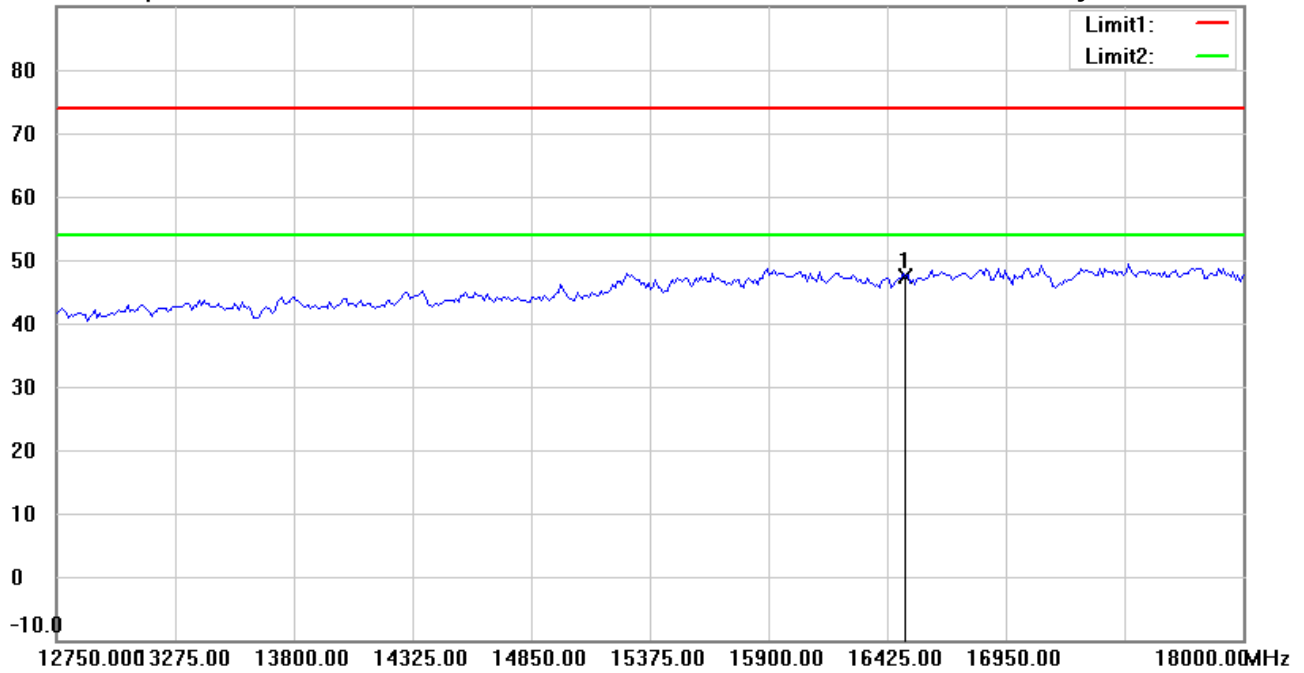
Condition : FCC_part 15E RE_Above 1GHz_PK

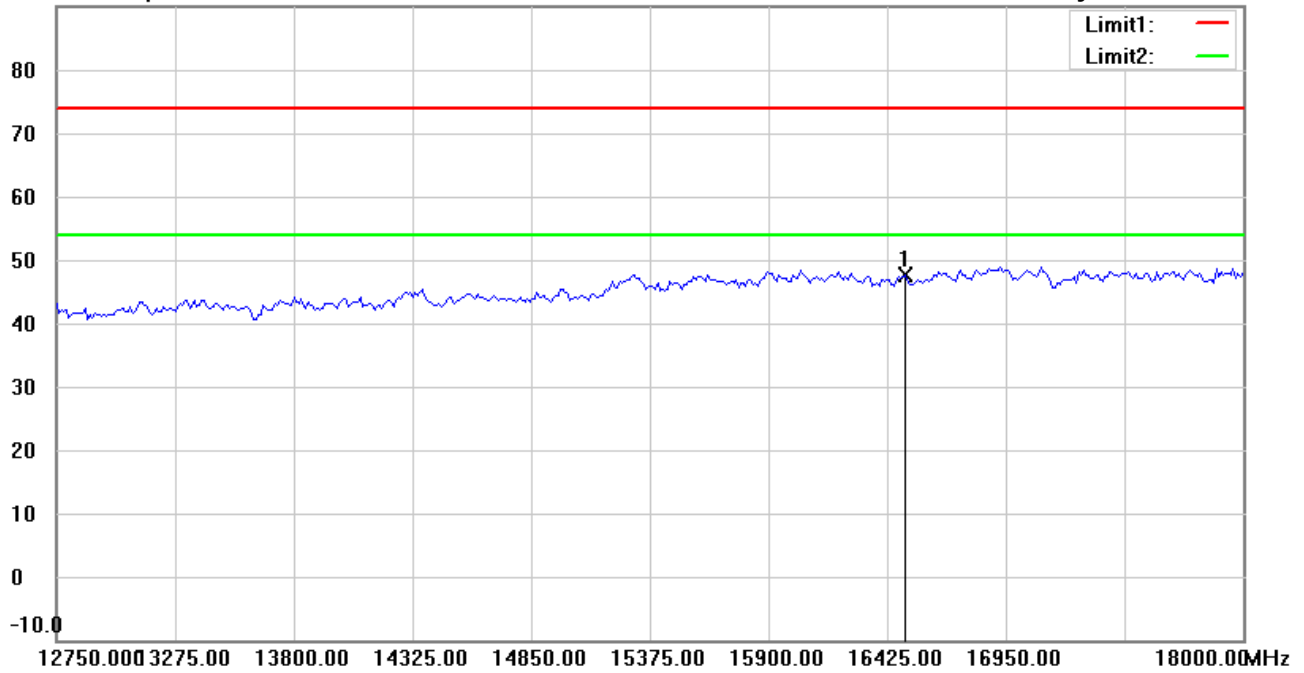
Condition : FCC_part 15E RE_Above 1GHz_PK
