Radiated Emission Measurement

Condition : FCC_part 15E RE_Above 1GHz_PK

EUT : W6R22002-19655

Test Mode : TX 802.11a CH52

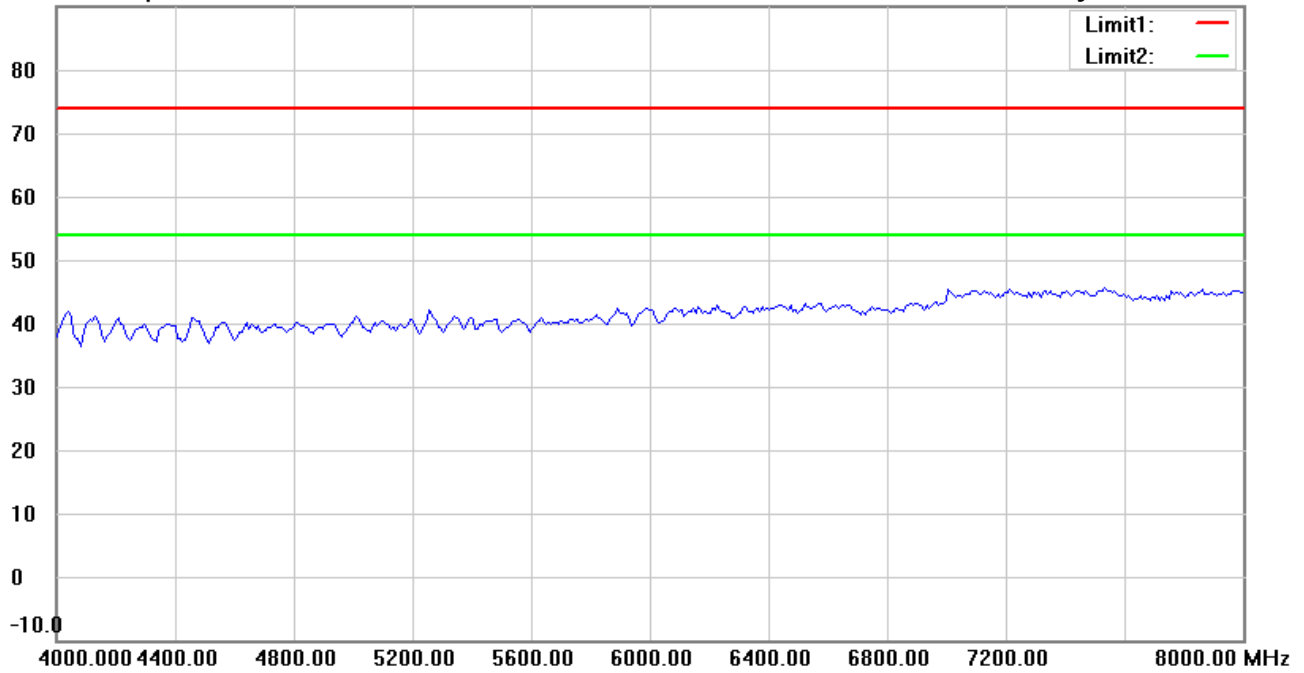
Polarization: *Horizontal*

Distance: 3m
