### APPENDIX 3: Photographs of test setup

#### Radiated Spurious Emission

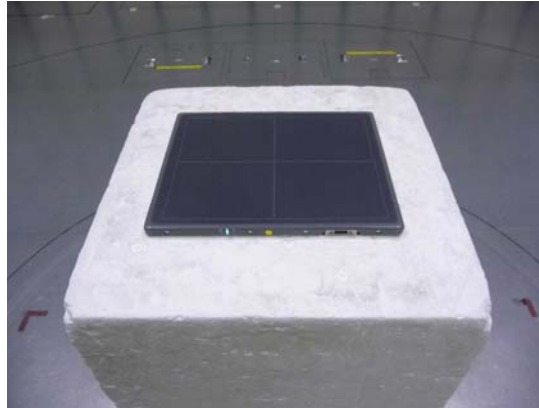
**X-axis**

**Worst Case Position**  
(Below 1GHz Horizontal: Z-axis / Vertical: X-axis  
Above 1GHz Horizontal: Y-axis / Vertical: X-axis)
