**APPENDIX 3: Photographs of test setup**

**Radiated emission**

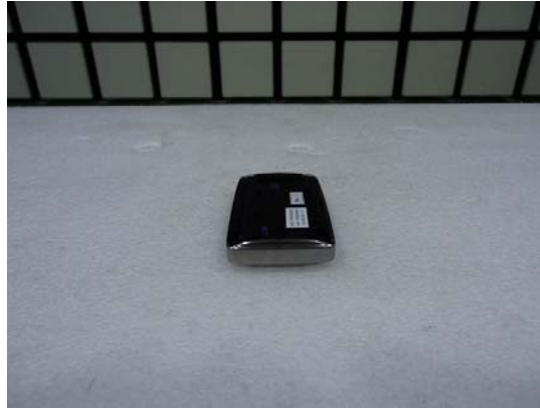
**X-axis**

**Worst case position**

**(Below 1GHz Horizontal: X-axis / Vertical: Y-axis)  
(Above 1GHz Horizontal: X-axis / Vertical: Y-axis)**

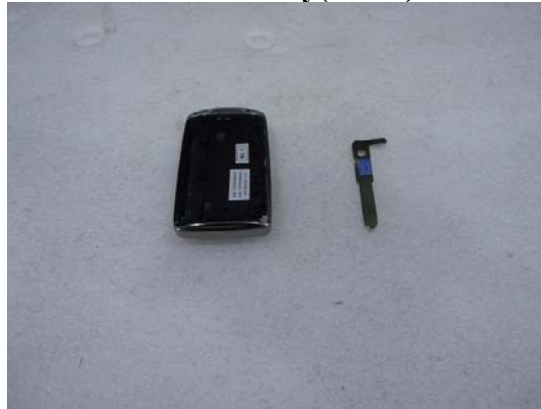
**Worst case position**

**Without Key(worst)**

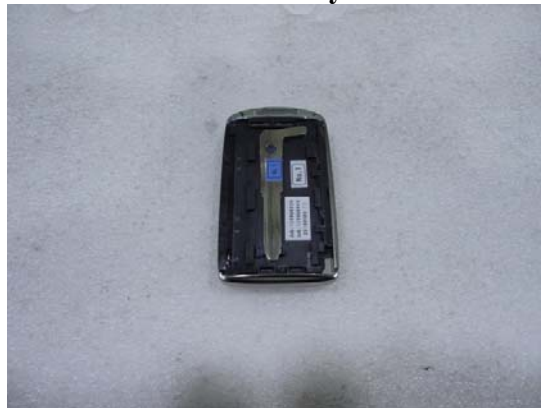
**With Key**
