APPENDIX 3: Photographs of test setup

Radiated Emission

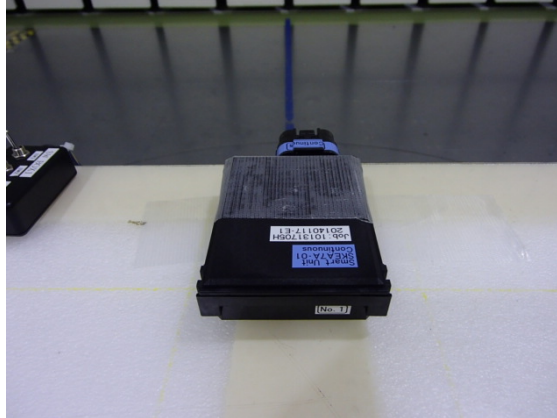
Worst Case Position (EUT: X-axis / Antenna: Y-axis)
