APPENDIX 3: Photographs of test setup

Radiated emission

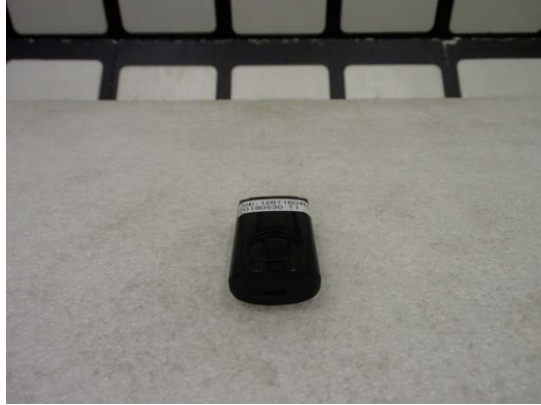
Below 1 GHz : (Horizontal: X-axis / Vertical: Y-axis)

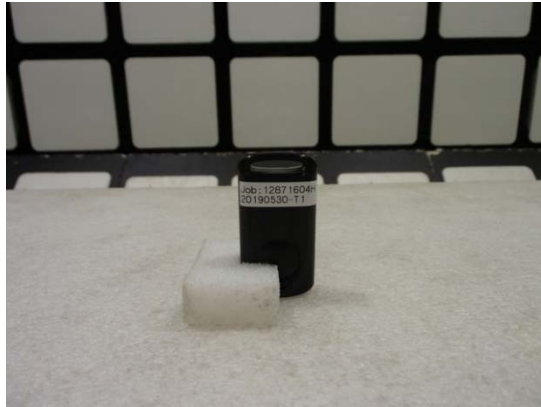
Y-axis

Above 1 GHz : (Horizontal: Z-axis / Vertical: Y-axis)
