Band Edge

Conducted RF Spurious Emission

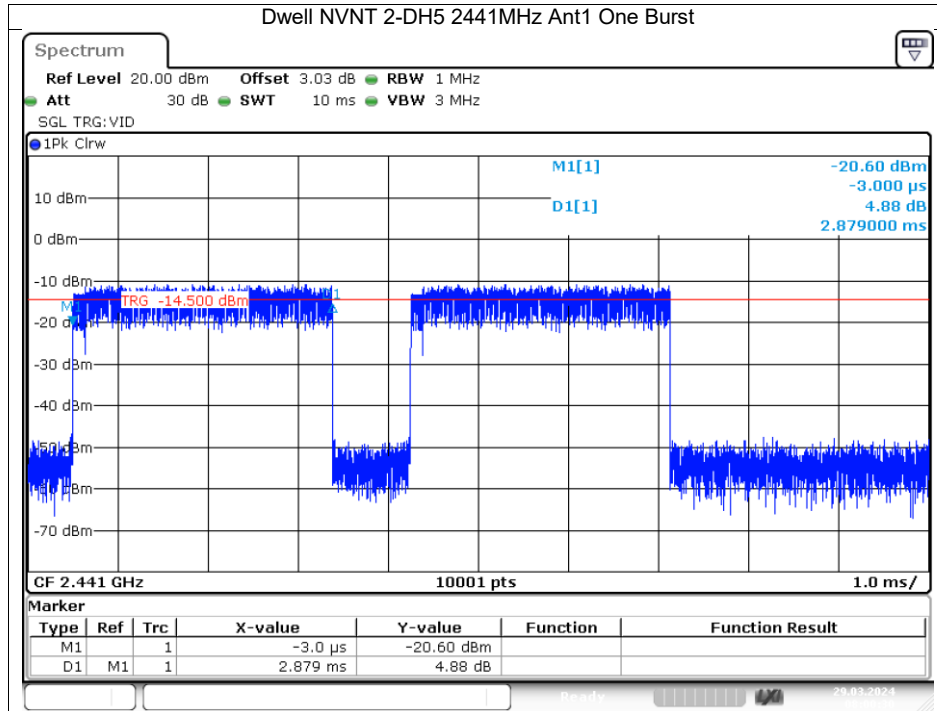
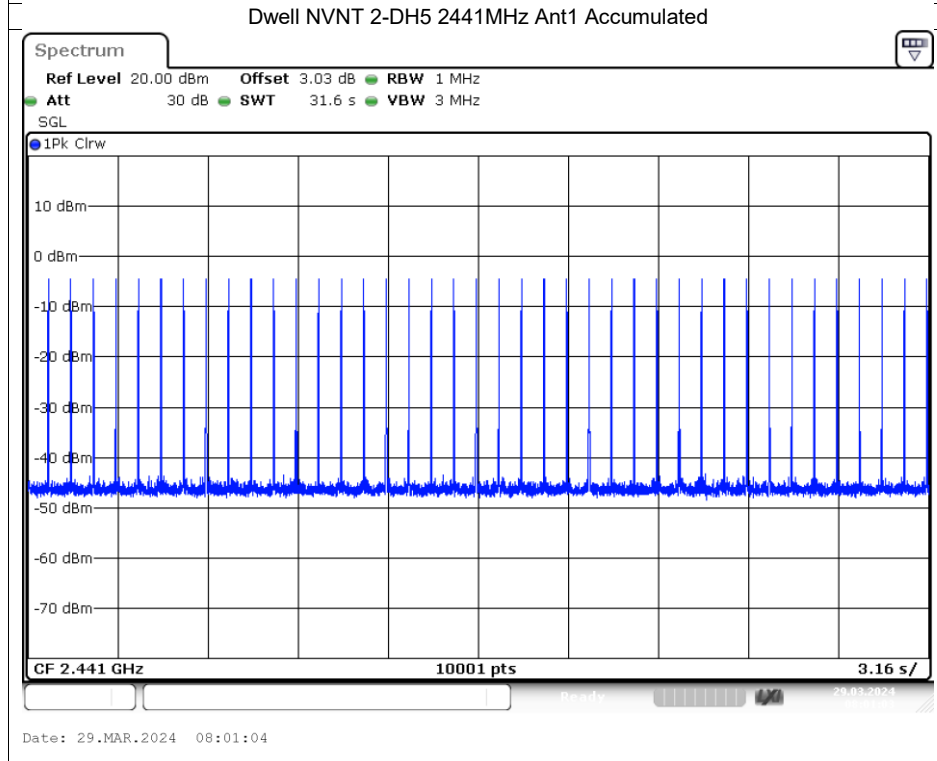
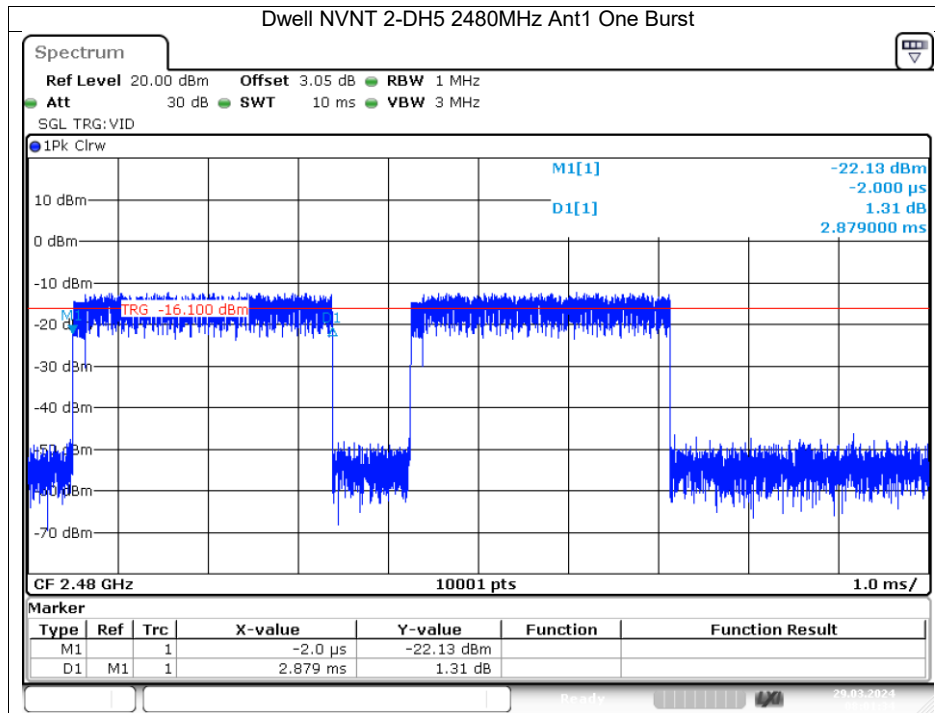
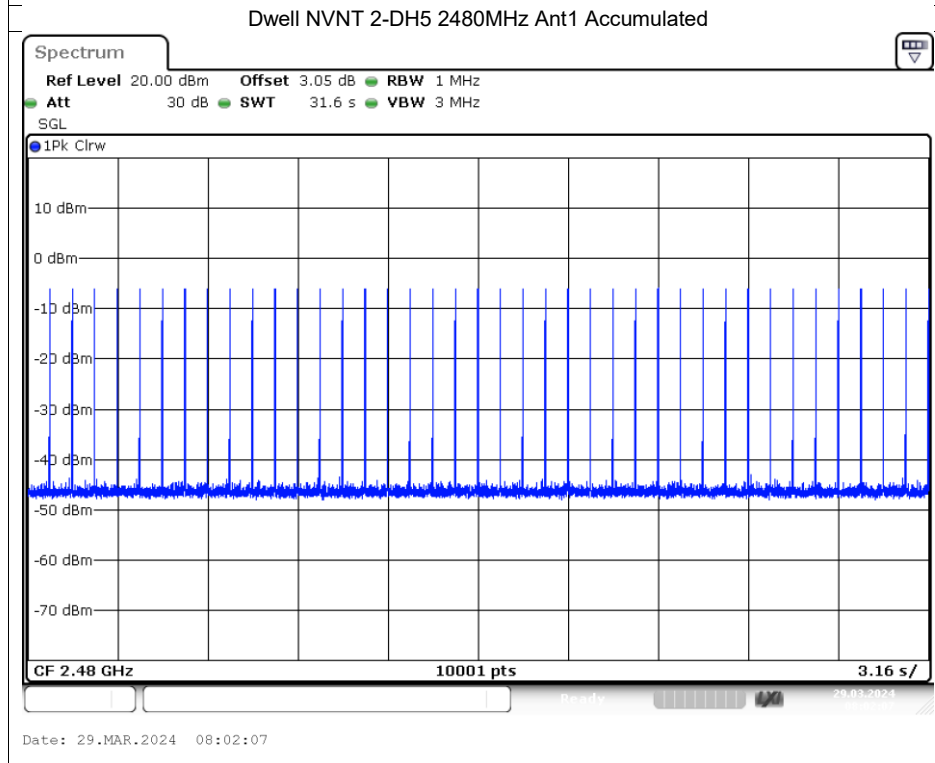
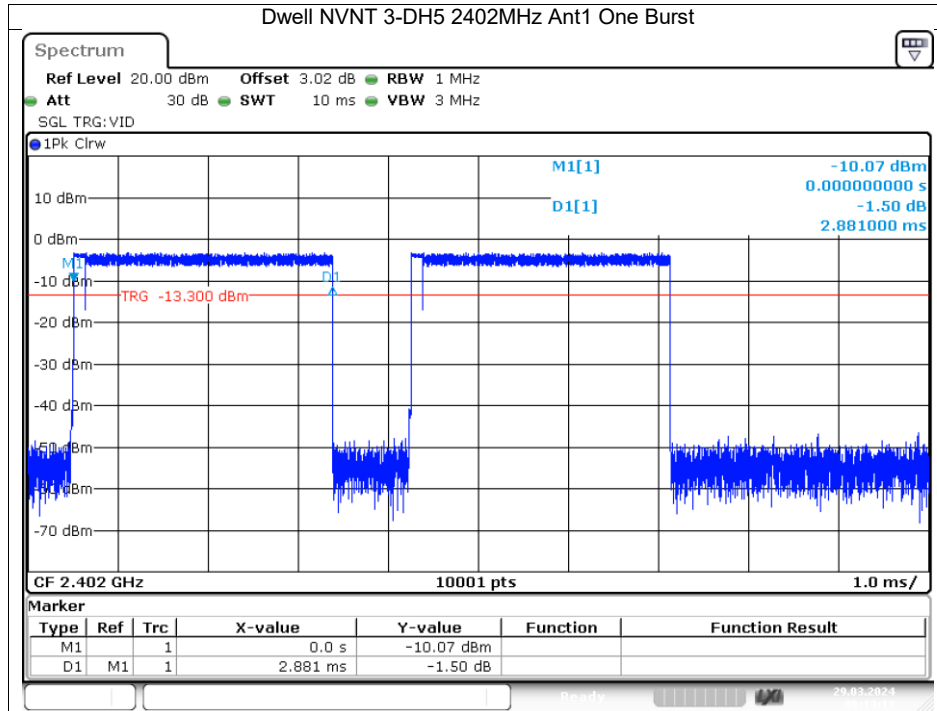
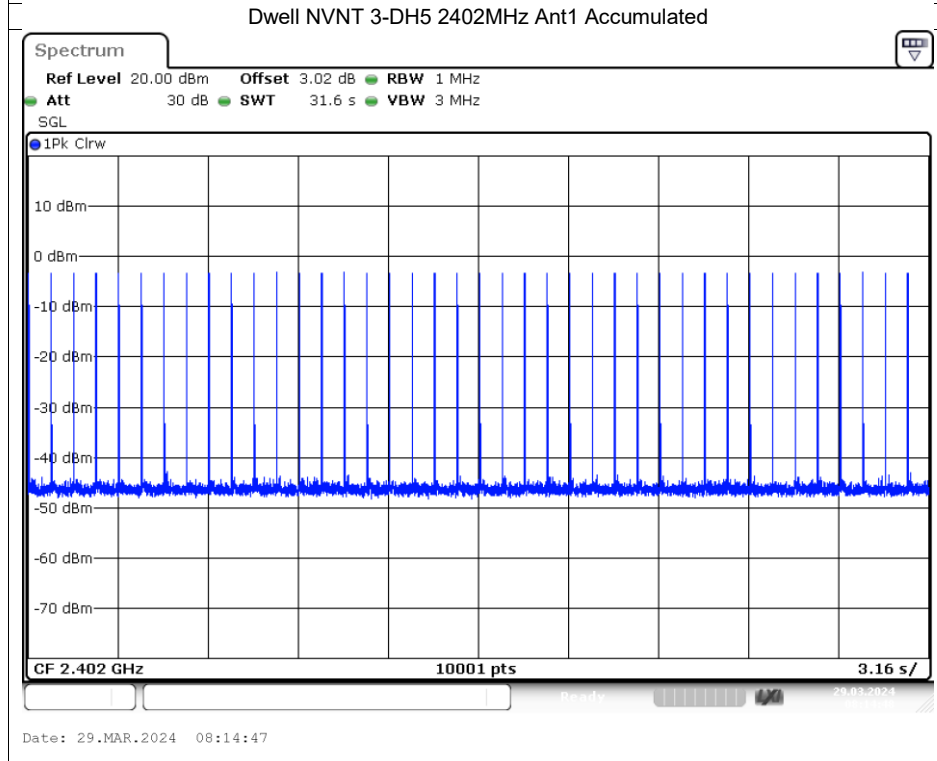
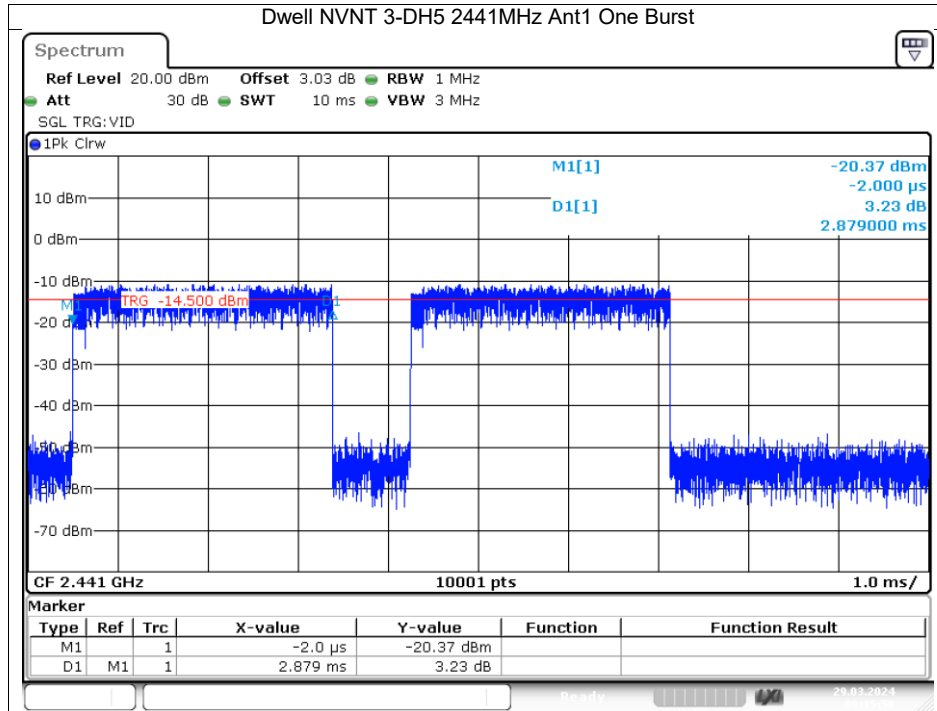
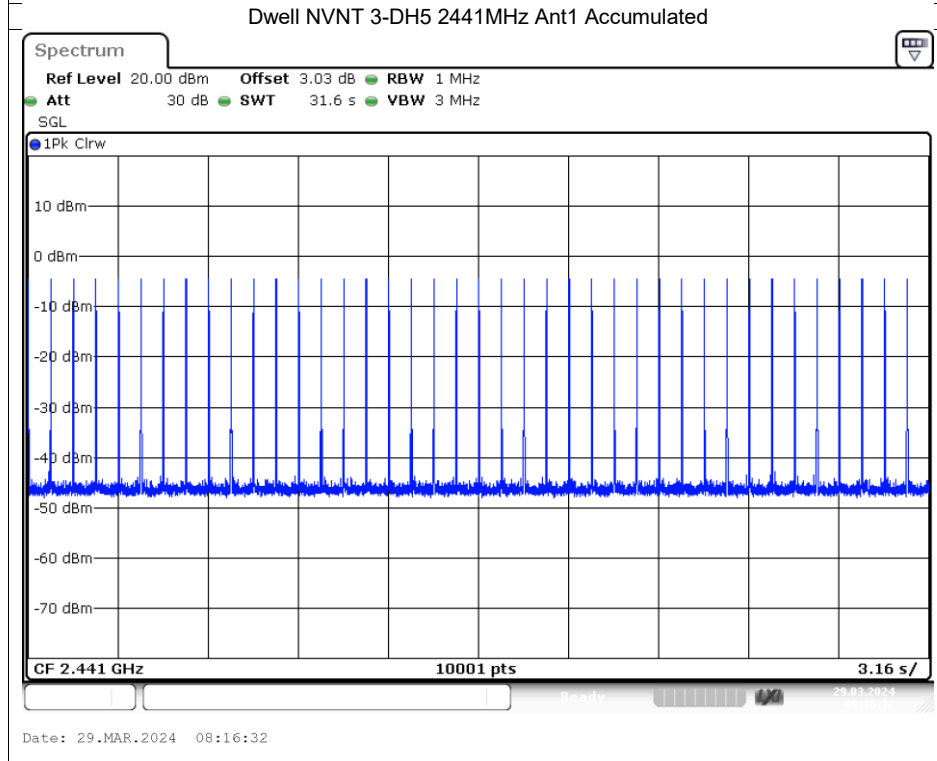
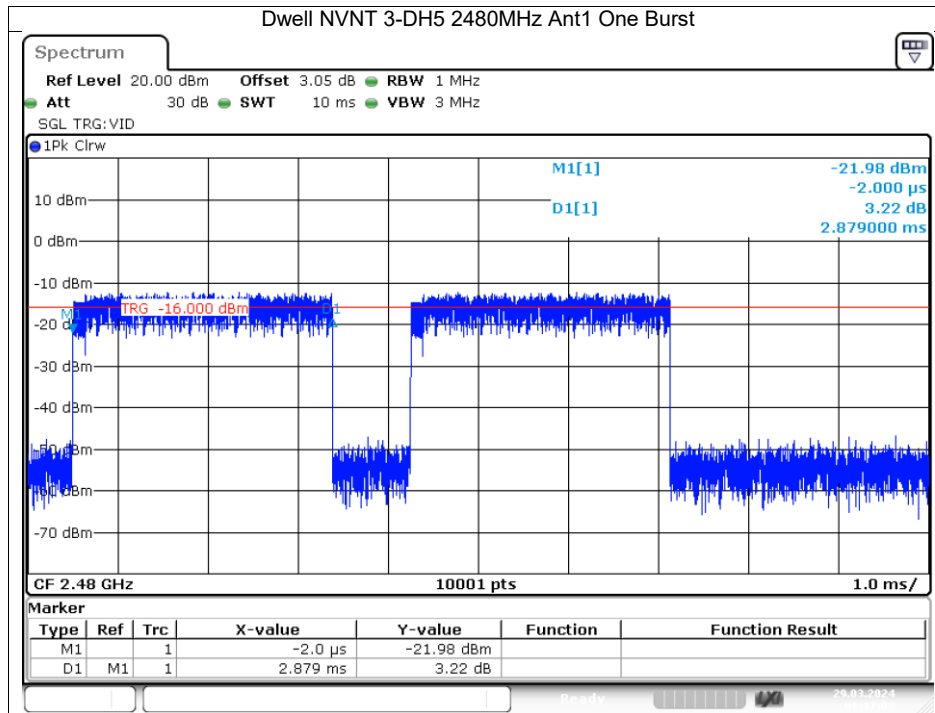
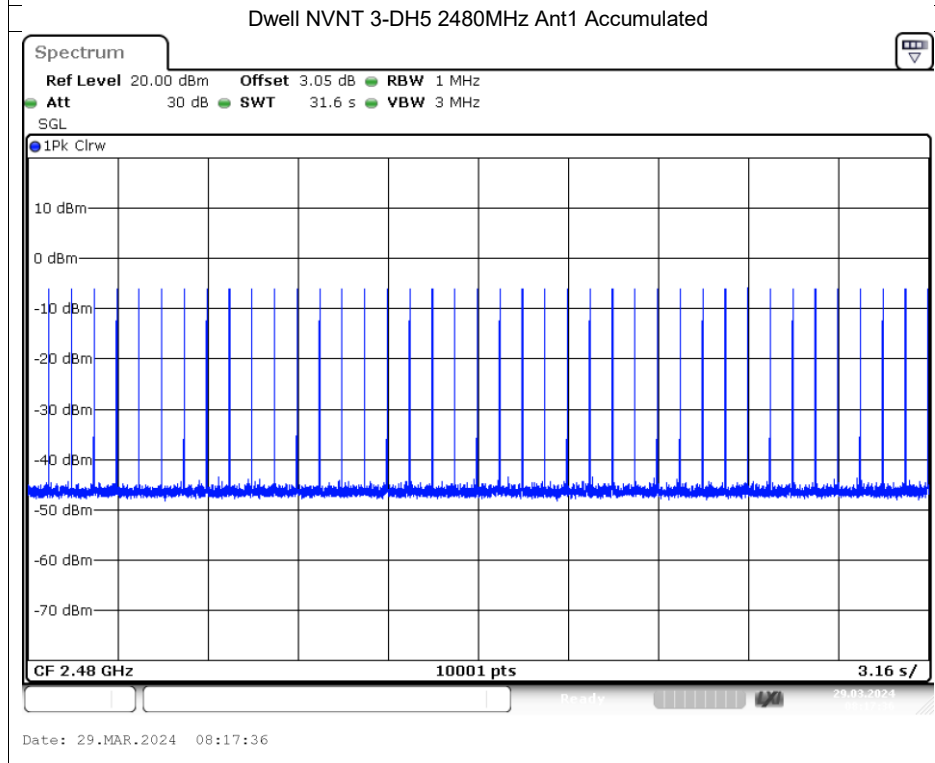
Condition	Mode	Frequency (MHz)	Antenna	Hopping Mode	Max Value (dBc)	Limit (dBc)	Verdict
NVNT	1-DH5	2402	Ant1	No-Hopping	-48.02	-20	Pass
NVNT	1-DH5	2480	Ant1	No-Hopping	-46.06	-20	Pass
NVNT	2-DH5	2402	Ant1	No-Hopping	-47.33	-20	Pass
NVNT	2-DH5	2480	Ant1	No-Hopping	-46.56	-20	Pass
NVNT	3-DH5	2402	Ant1	No-Hopping	-49.93	-20	Pass
NVNT	3-DH5	2480	Ant1	No-Hopping	-48.24	-20	Pass

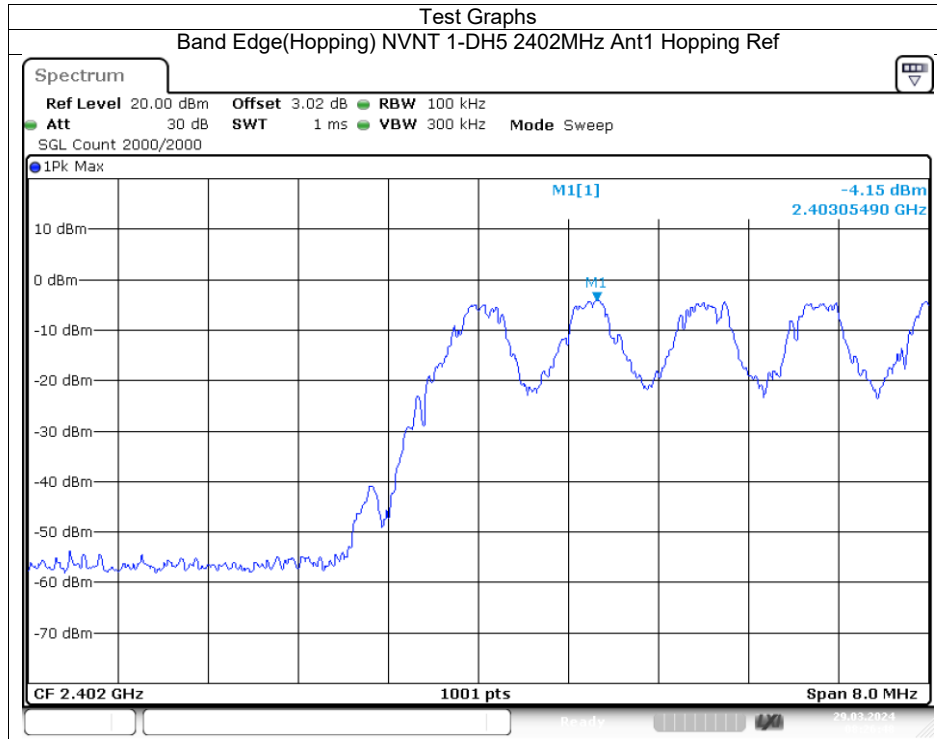
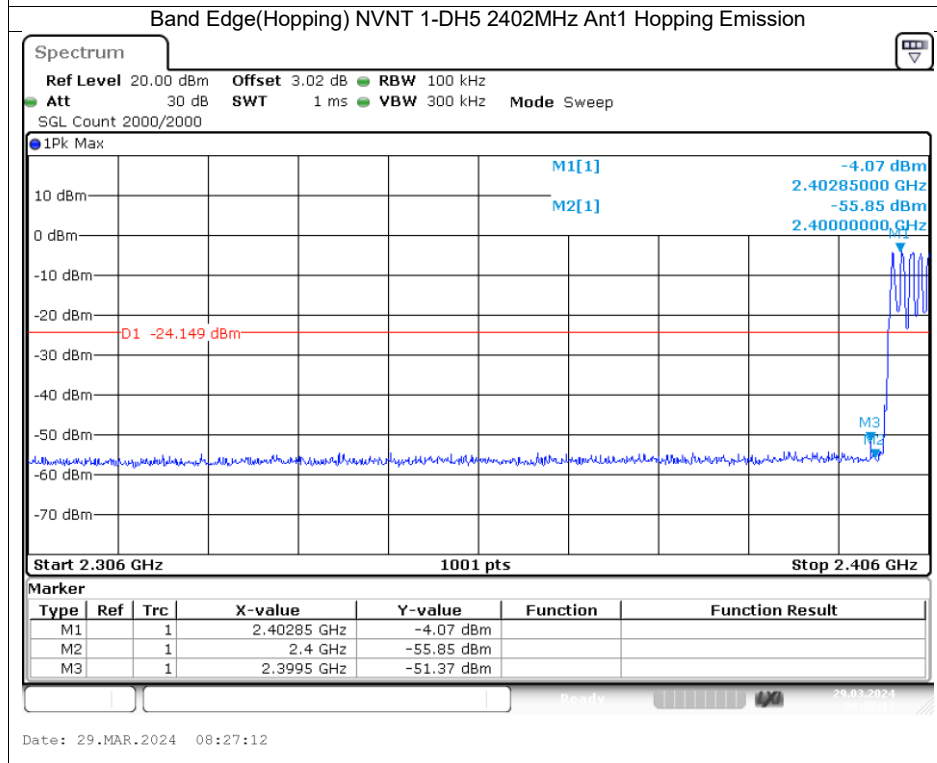
Band Edge(Hopping)

Condition	Mode	Frequency (MHz)	Antenna	Hopping Mode	Max Value (dBc)	Limit (dBc)	Verdict
NVNT	1-DH5	2402	Ant1	Hopping	-47.22	-20	Pass
NVNT	1-DH5	2480	Ant1	Hopping	-46.96	-20	Pass
NVNT	2-DH5	2402	Ant1	Hopping	-47.71	-20	Pass
NVNT	2-DH5	2480	Ant1	Hopping	-48.25	-20	Pass
NVNT	3-DH5	2402	Ant1	Hopping	-47.83	-20	Pass
NVNT	3-DH5	2480	Ant1	Hopping	-47.37	-20	Pass

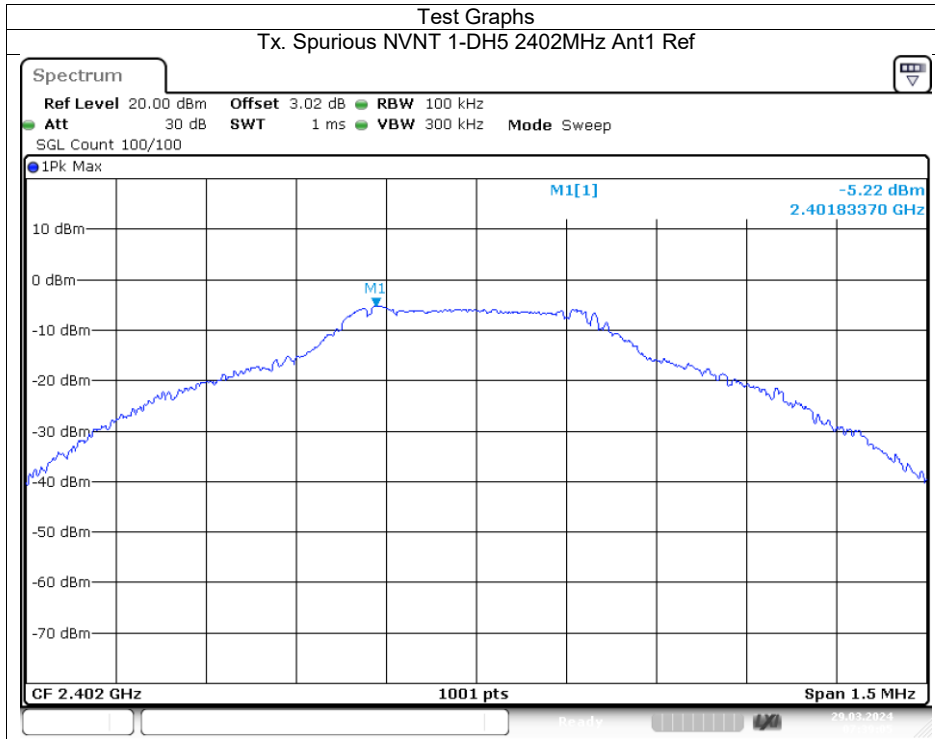
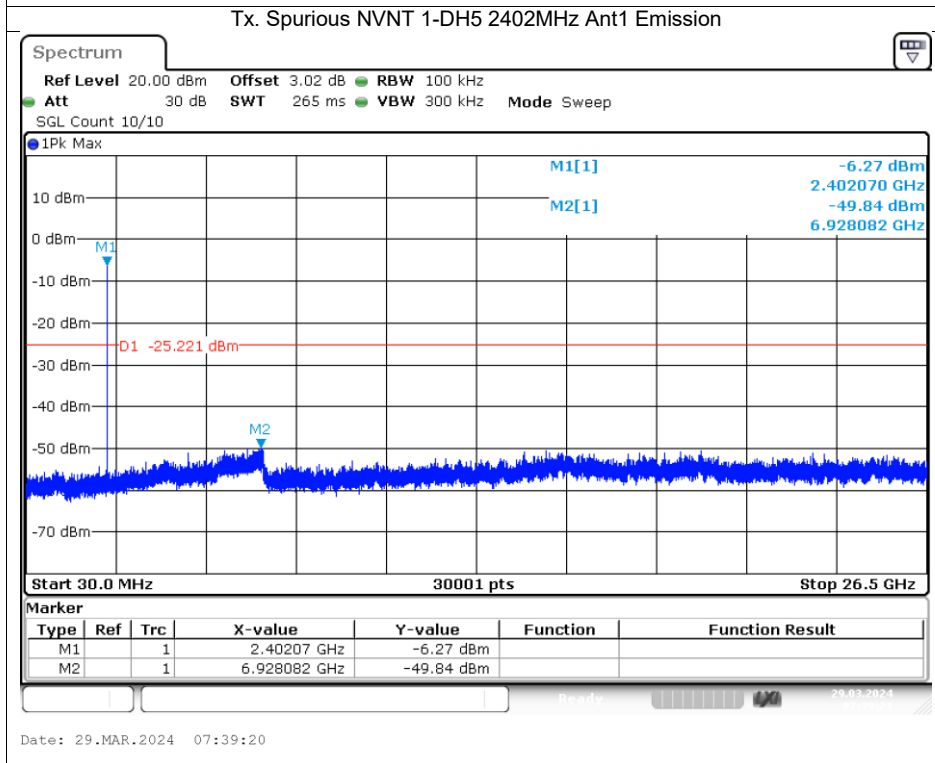
Condition	Mode	Frequency (MHz)	Antenna	Max Value (dBc)	Limit (dBc)	Verdict
NVNT	1-DH5	2402	Ant1	-44.62	-20	Pass
NVNT	1-DH5	2441	Ant1	-41.99	-20	Pass
NVNT	1-DH5	2480	Ant1	-41.28	-20	Pass
NVNT	2-DH5	2402	Ant1	-44.91	-20	Pass
NVNT	2-DH5	2441	Ant1	-43.25	-20	Pass
NVNT	2-DH5	2480	Ant1	-42.95	-20	Pass
NVNT	3-DH5	2402	Ant1	-45.06	-20	Pass
NVNT	3-DH5	2441	Ant1	-44.65	-20	Pass
NVNT	3-DH5	2480	Ant1	-42.54	-20	Pass

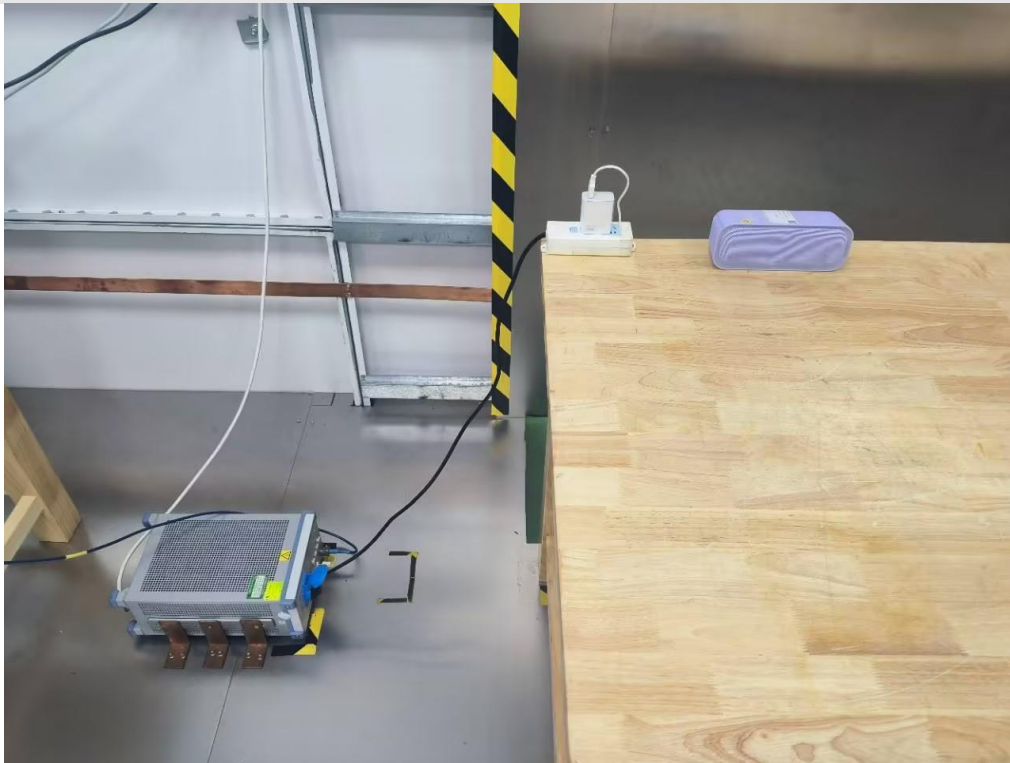
AC Power Line Conducted Emission

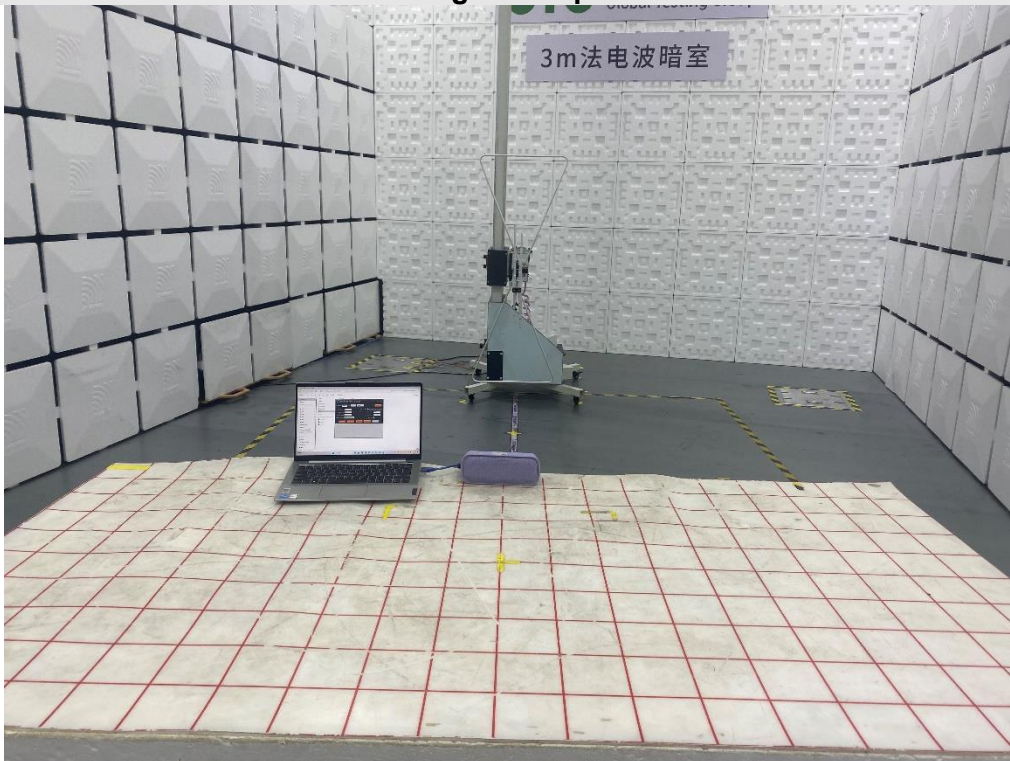
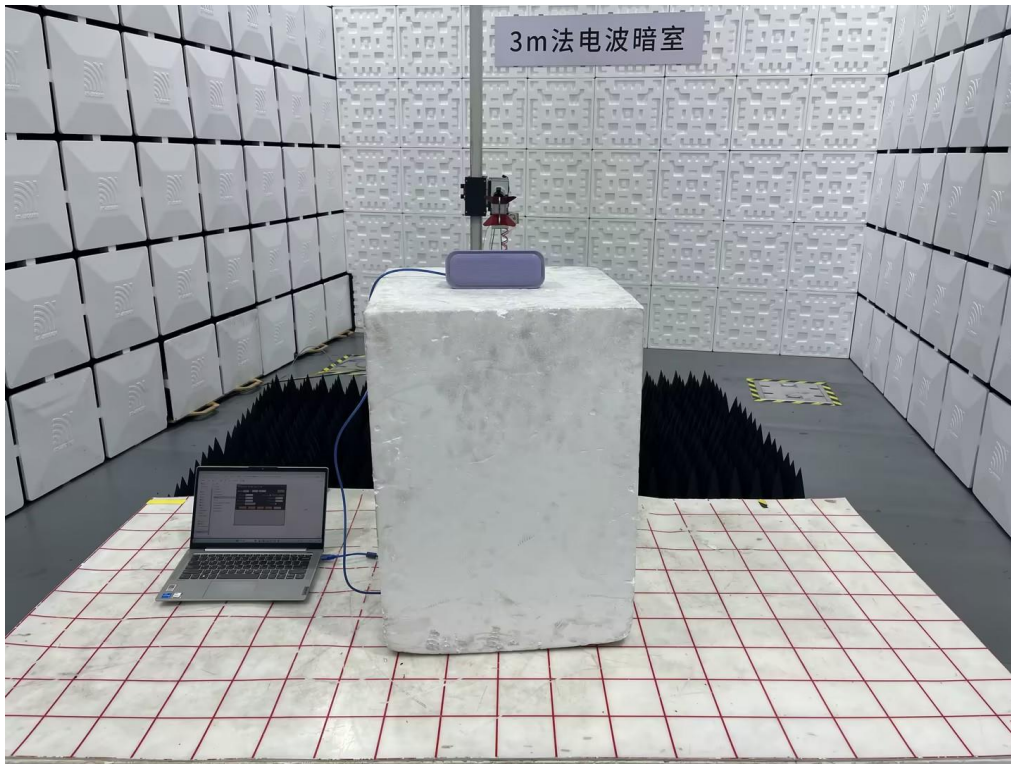
Radiated Band edge and Spurious Emission
