APPENDIX 3: Photographs of test setup

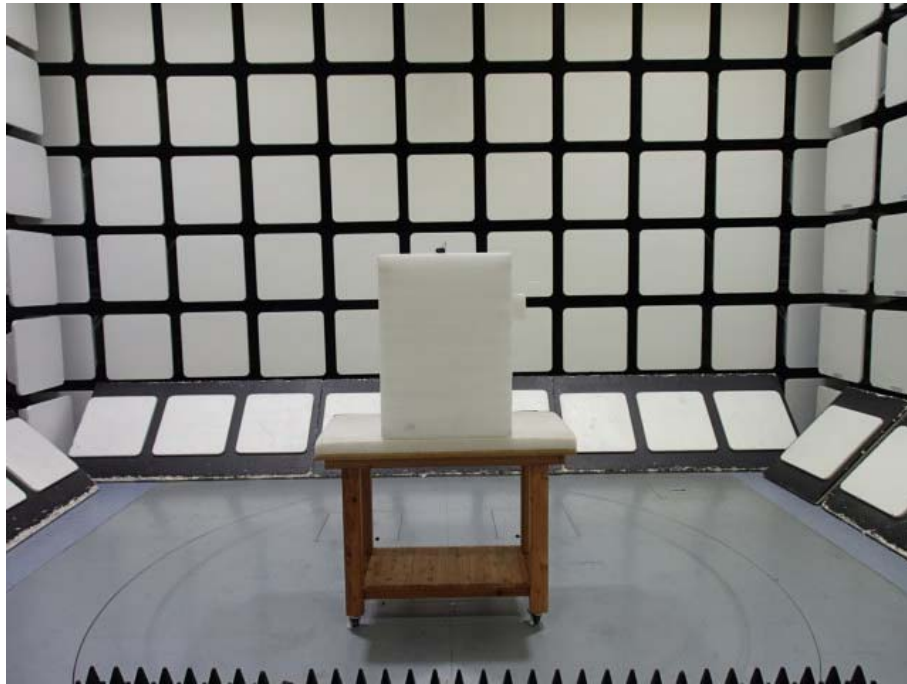
Photo 1

Radiated Spurious Emission

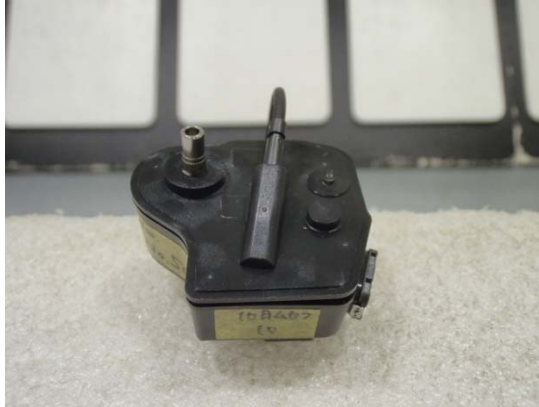
X-axis

Worst Case Position

Below 1 GHz (Horizontal: X-axis/ Vertical: X-axis)
Above 1 GHz (Horizontal: Y-axis/ Vertical: Z-axis)

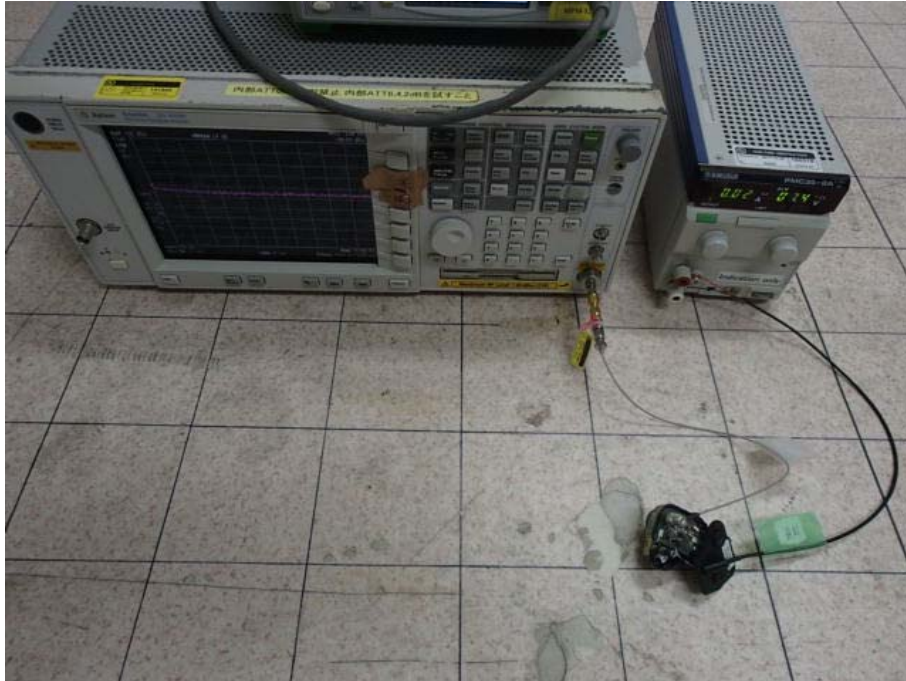
Photo 1

Antenna Terminal Conducted Tests
