APPENDIX

10. Photographs of Test Setup

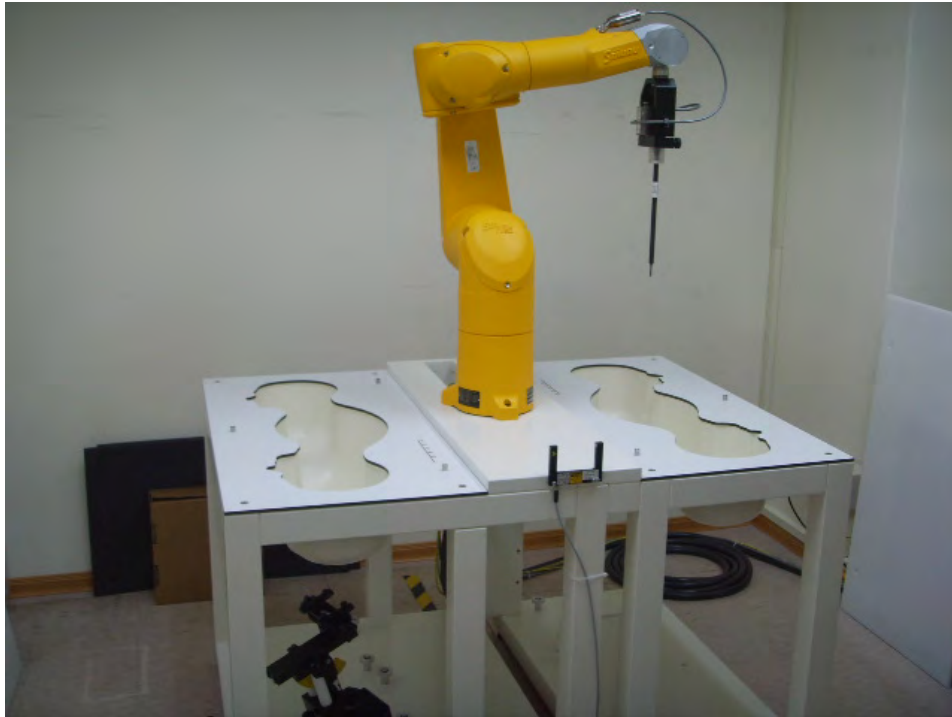
Fig.1 Photograph of the SAR measurement System

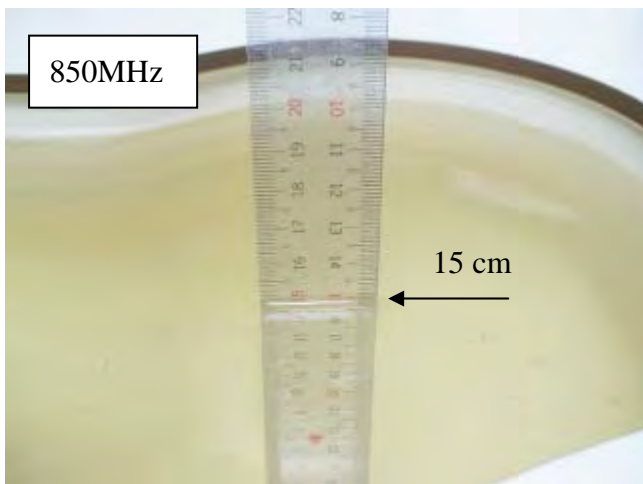
Fig.2.1 Photograph of the Tissue Simulant Fluid liquid depth 15cm for Left-head Side

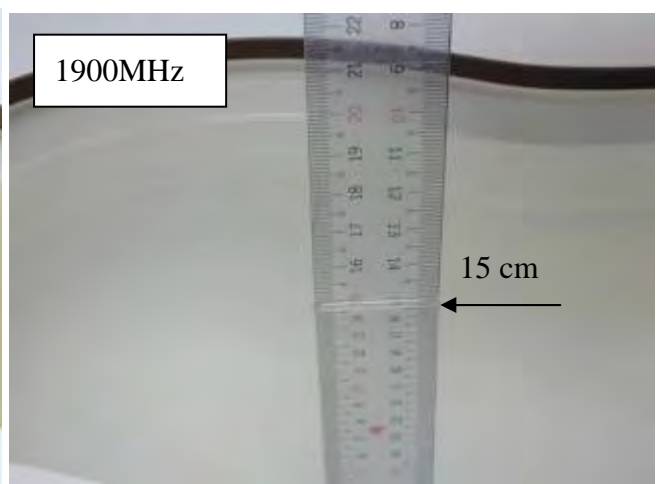
Fig.2.2 Photograph of the Tissue Simulant Fluid liquid depth 15cm for Right-head Side

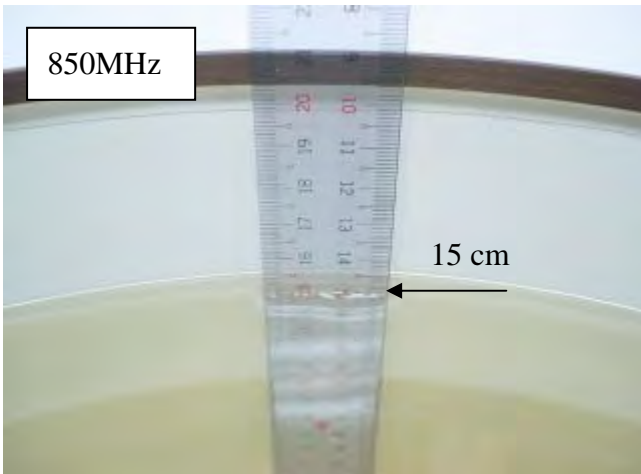
850MHz

15 cm

Fig.2.3 Photograph of the Tissue Simulant Fluid liquid depth 15cm for Flat (Body)

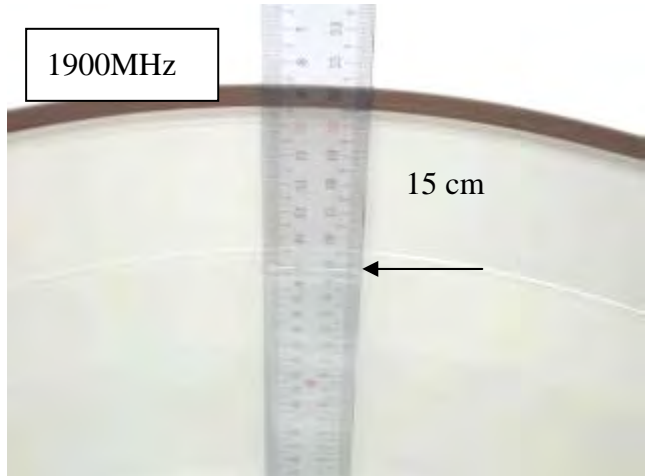
1900MHz

15 cm

Fig.2.4 Photograph of the Tissue Simulant Fluid liquid depth 15cm for Flat (Body)

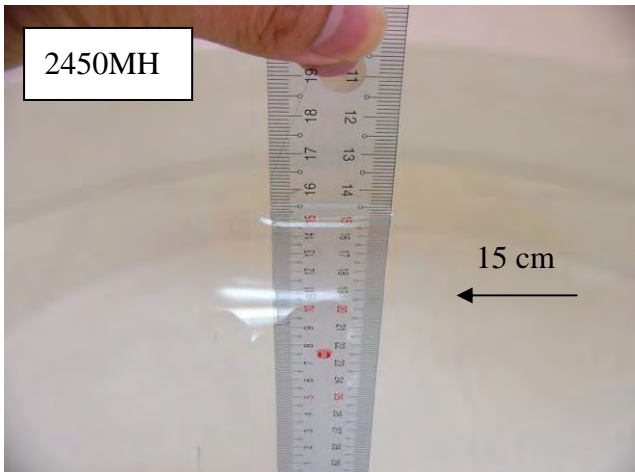
2450MH

15 cm

Fig.2.5 Photograph of the Tissue Simulant Fluid liquid depth 15cm for Flat (Body)

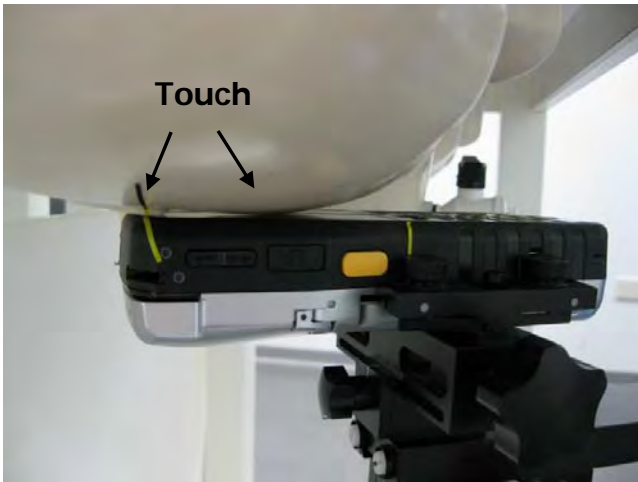
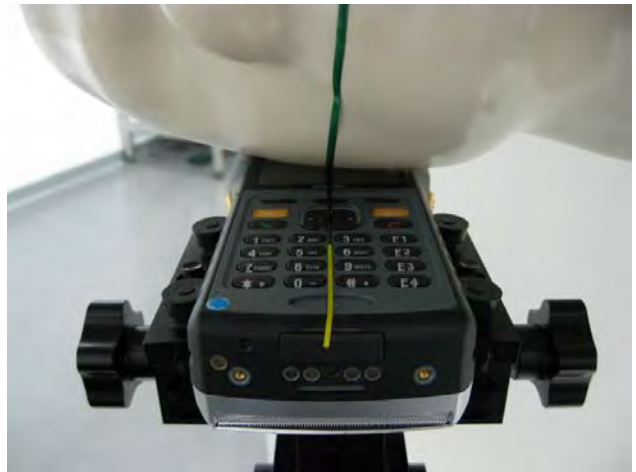
Fig.3 Right Head Section / Cheek-Touch Position

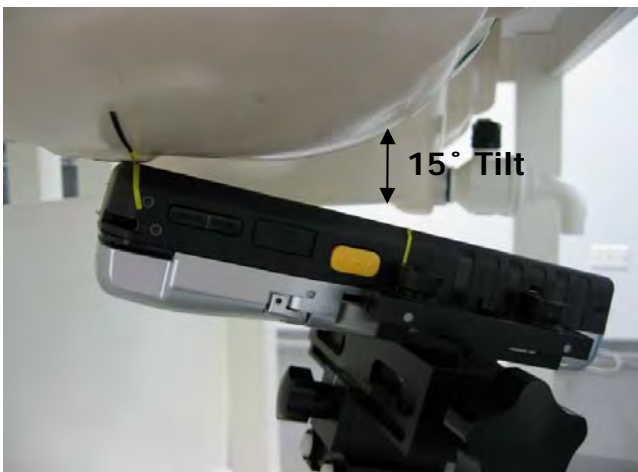
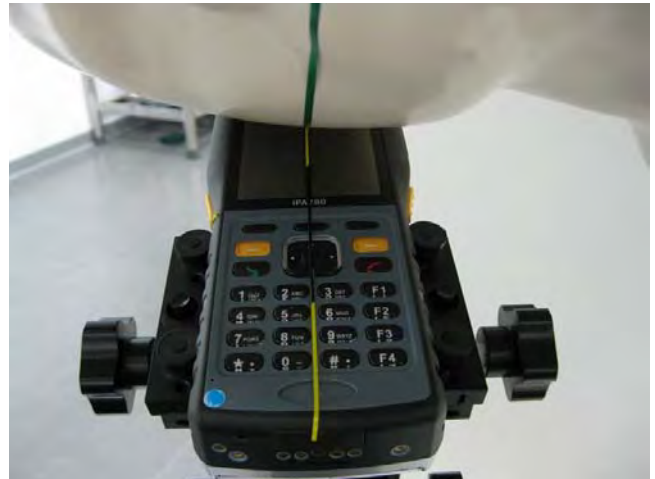
Fig.4 Right Head Section / Ear-Tilt Position(15°)

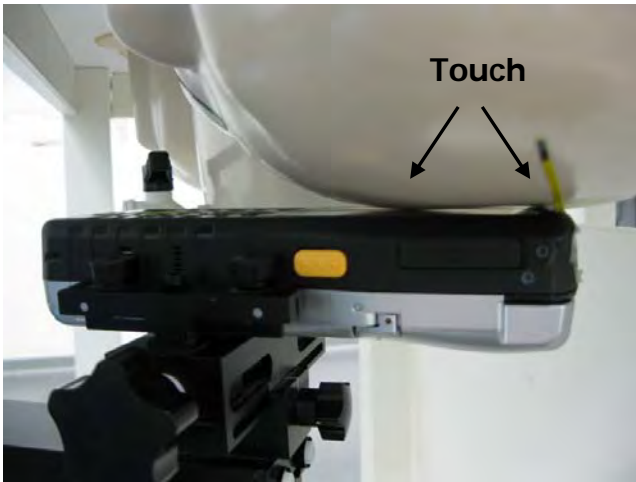
Fig.5 Left Head Section / Cheek-Touch Position

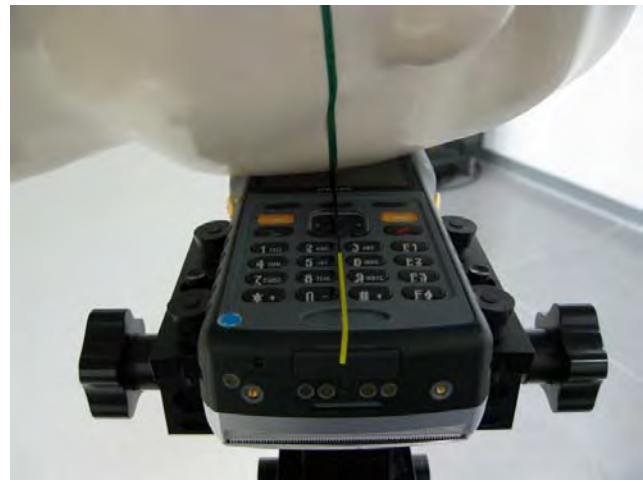
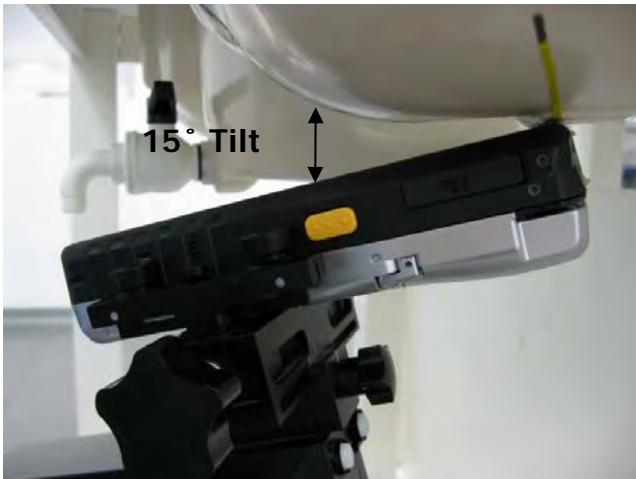
Fig.6 Left Head Section / Ear-Tilt Position(15°)

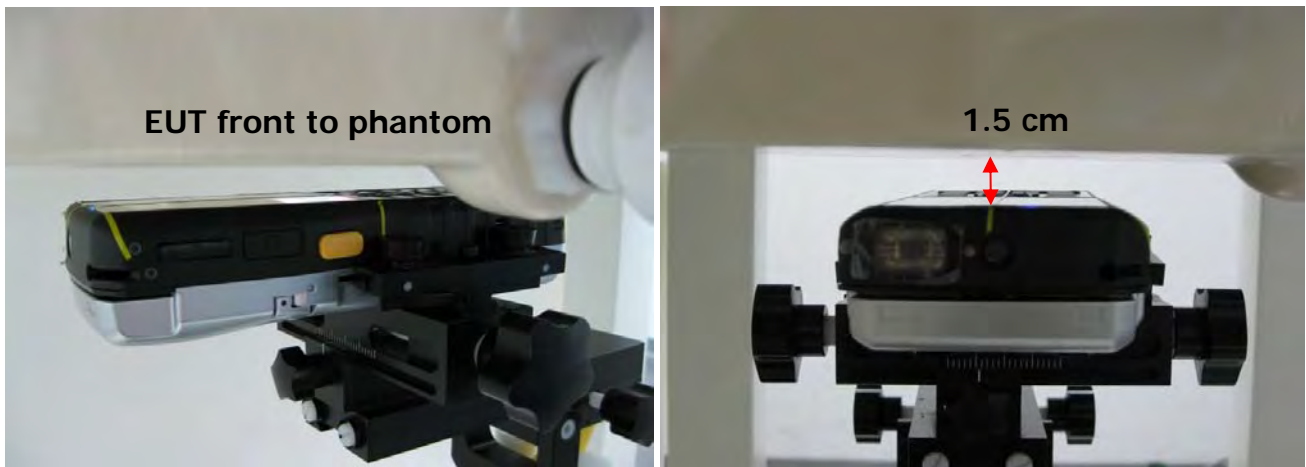
Fig.7 Body worn- EUT front to flat phantom and distance between flat phantom and mobile phone is 1.5 cm

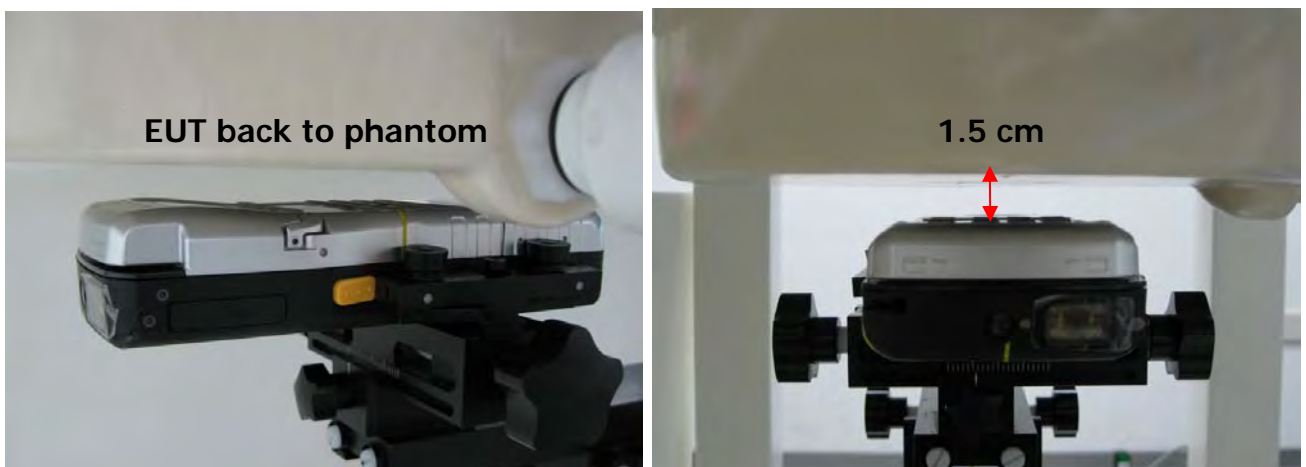
Fig.8 Body worn- EUT back to flat phantom and distance between flat phantom and mobile phone is 1.5 cm

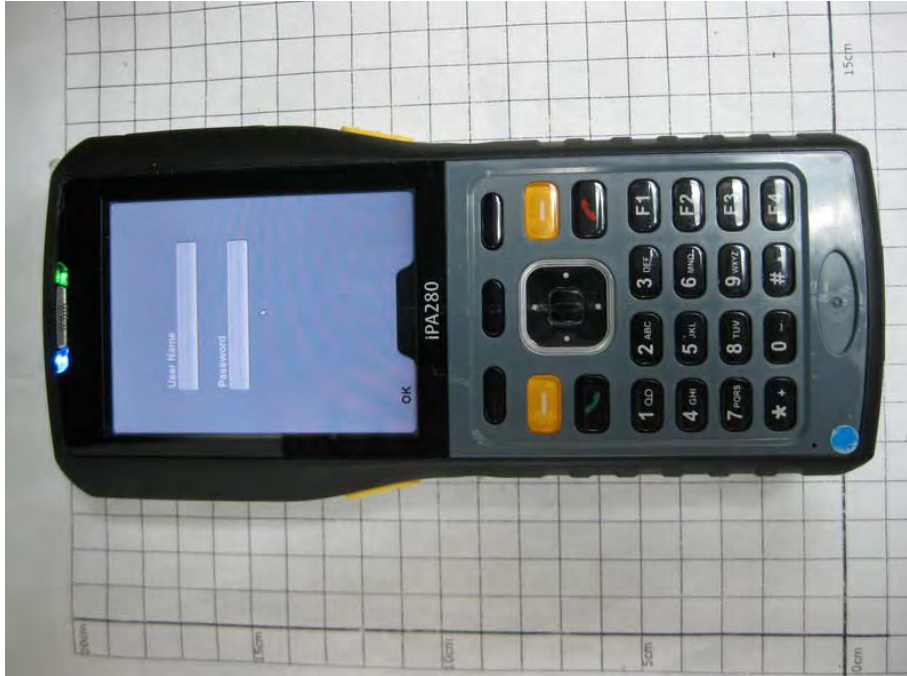
Fig.9 Front view of device

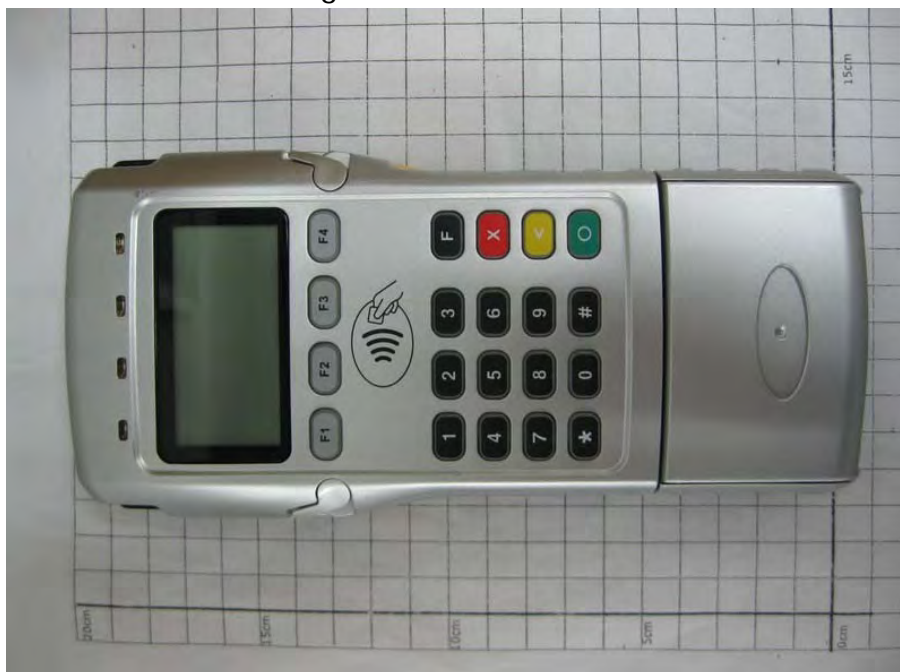
Fig.10 Back view of device

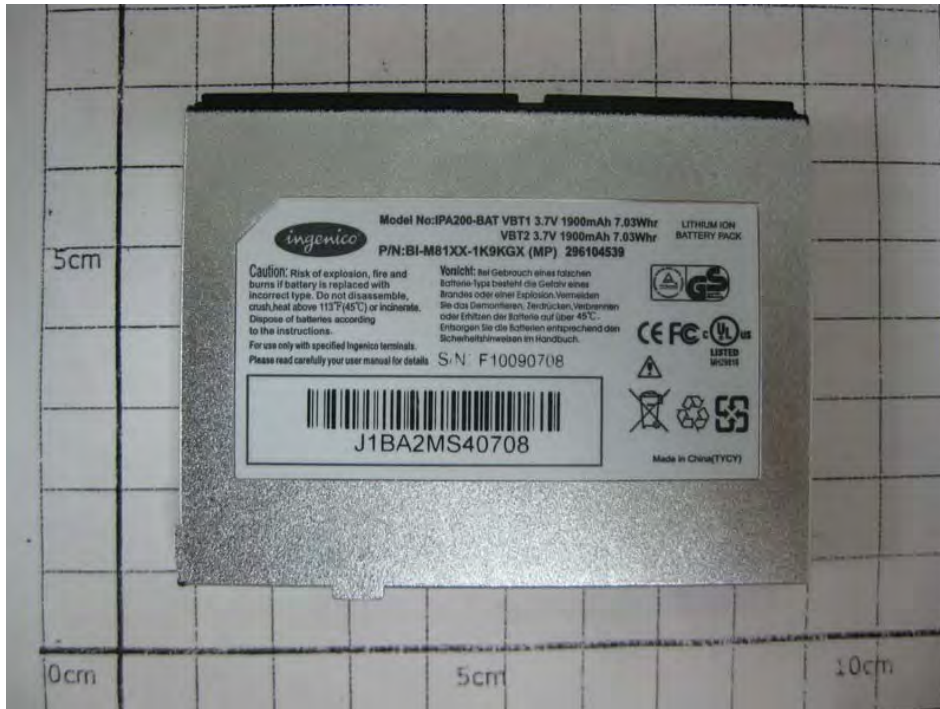
Fig.11 Front view of Battery

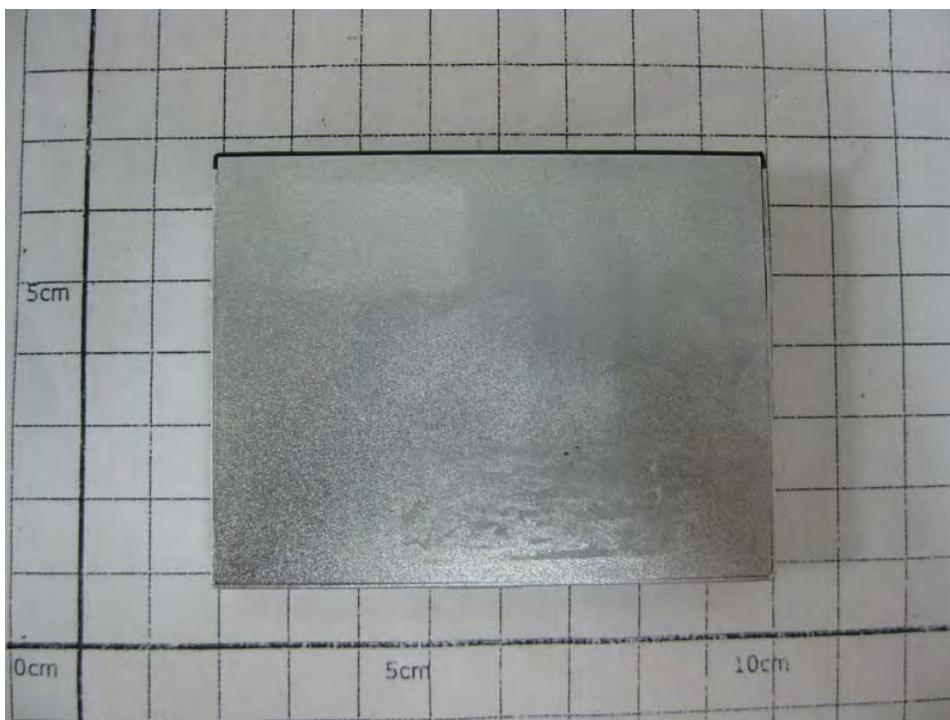
Fig.12 Back view of Battery

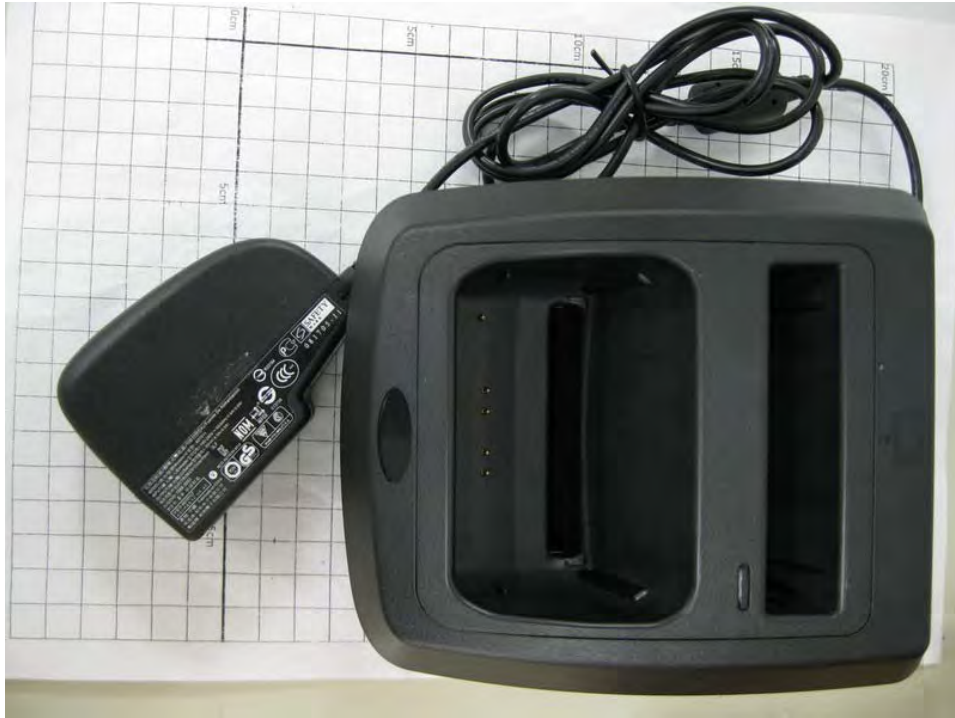
Fig.13 AC charge
