DSCF v2

FRN: 0019054196
FCC ID: XO9-DSCF003
Model ID: DSCF

Product Internal Images

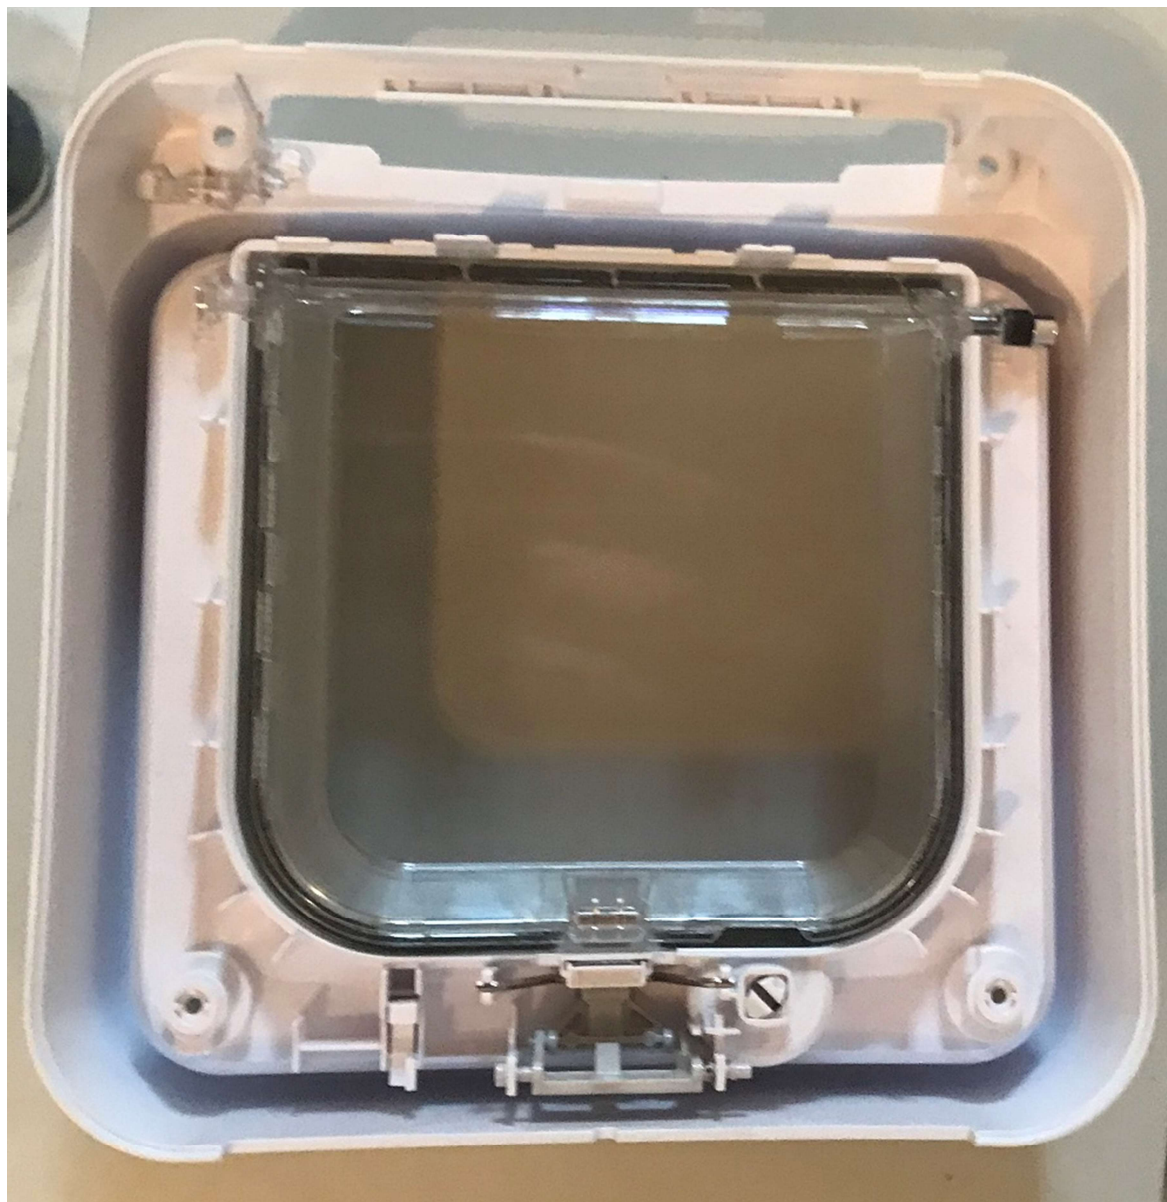
Inside of the front cover showing latch system
