Test report No.	FCC_RF_SL15083101-SPC-045_0402
Page	10 of 74

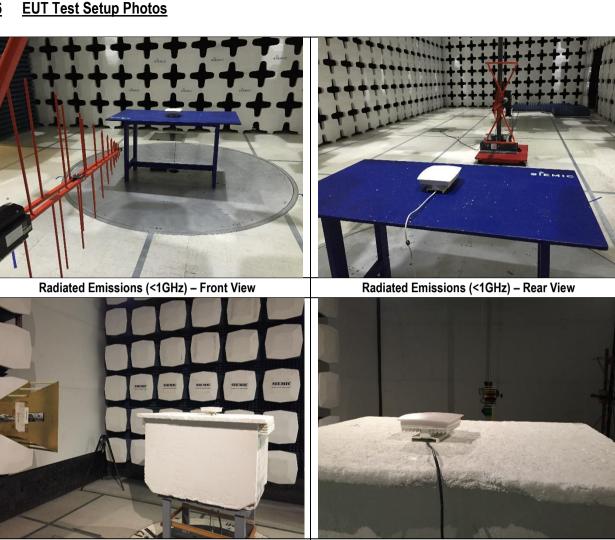
Radiated Emissions (>1GHz) - Front View

Radiated Emissions (>1GHz) - Rear View

Note: The spurious emission in different EUT orientation was investigated, including the EUT standing up position and the laying down position. The EUT orientation shown in above setup photo is the worst case position.
