APPENDIX 3: Photographs of test setup

Radiated Emission

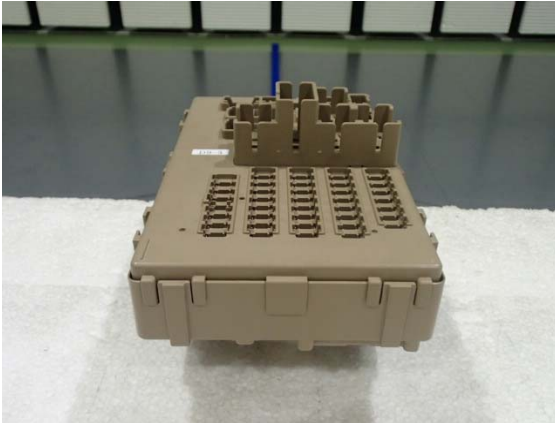
ECU
Below 30 MHz
X-axis
Above 30 MHz
Horizontal: X-axis / Vertical: X-axis
X-axis

Worst Case Position

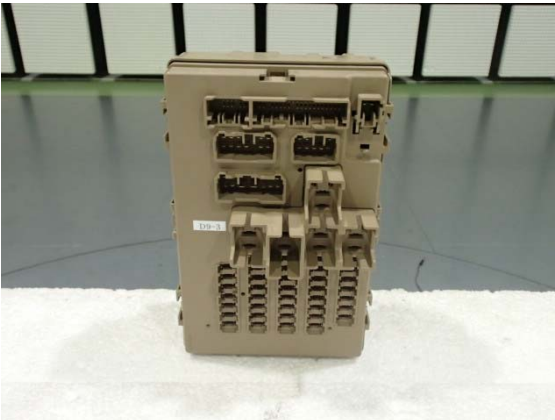
Y-axis

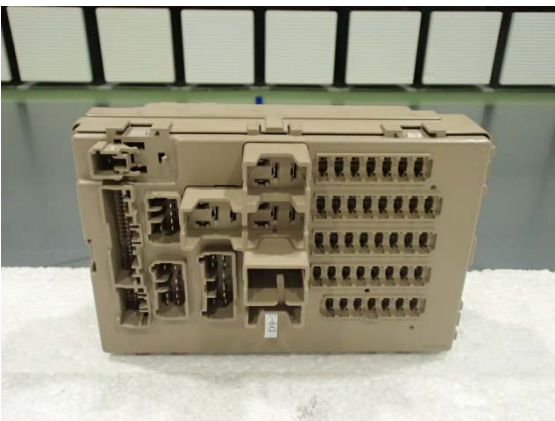
Z-axis

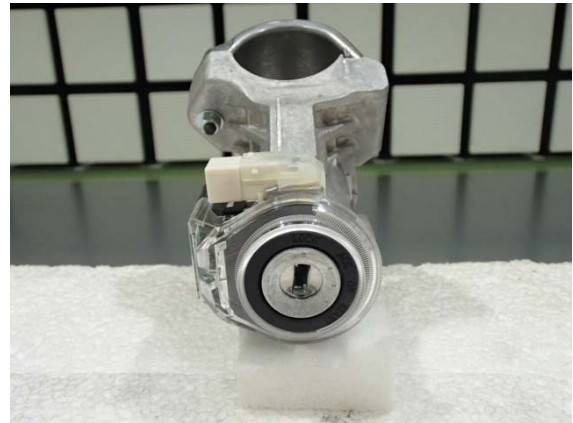
ANT
Below 30 MHz
X-axis
Above 30 MHz
Horizontal: X-axis / Vertical: X-axis
X-axis

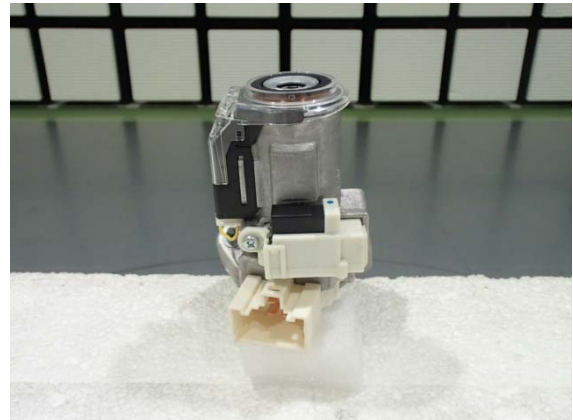
Y-axis

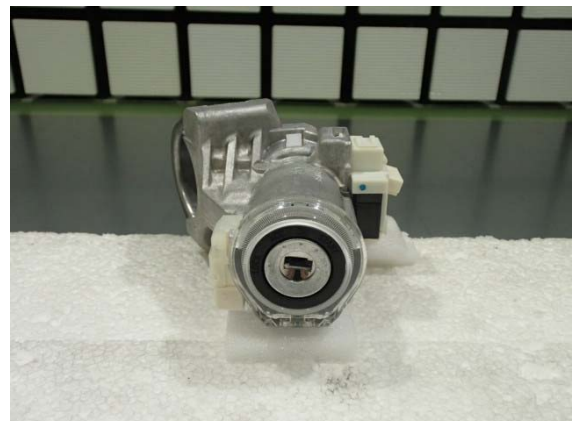
Z-axis

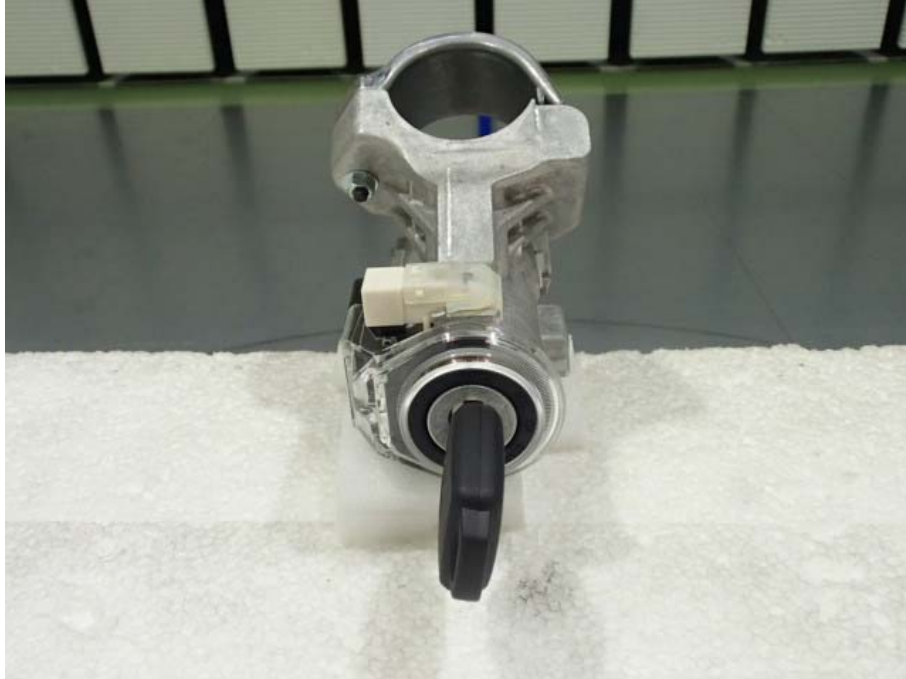
With transponder key inserted

Worst case position

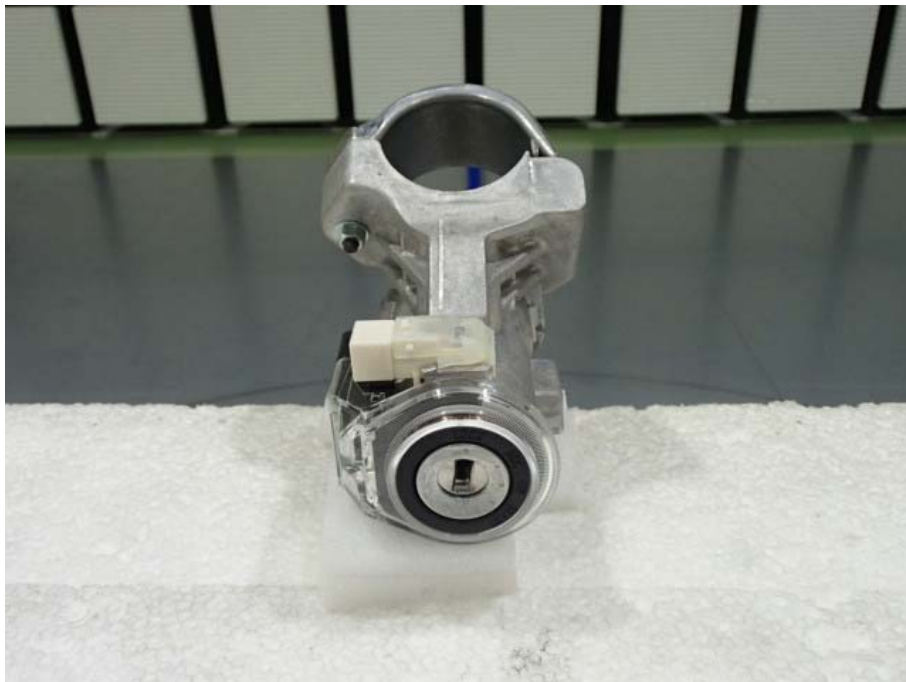
Without transponder key inserted (Worst)
