Photo Report on Test Setups

Report Reference: MDE_3M_1601_FCC_Photo_Setups

7layers GmbH
Borsigstrasse 11
40880 Ratingen
Germany

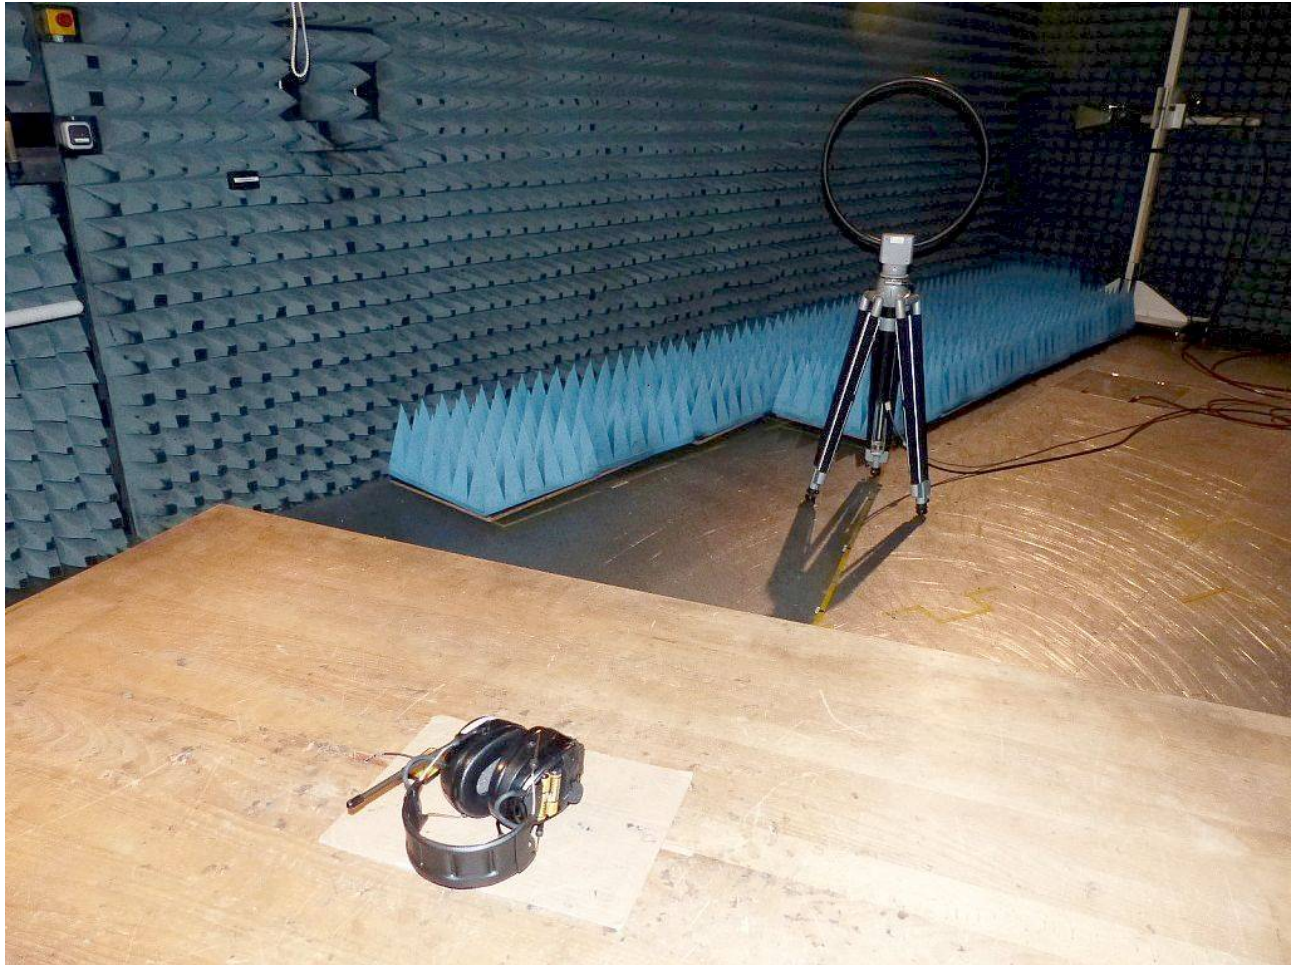
Photo 1: Test setup for radiated measurements (Enclosure, below 30 MHz, intentional radiator §15.209, ANSI C63.10)

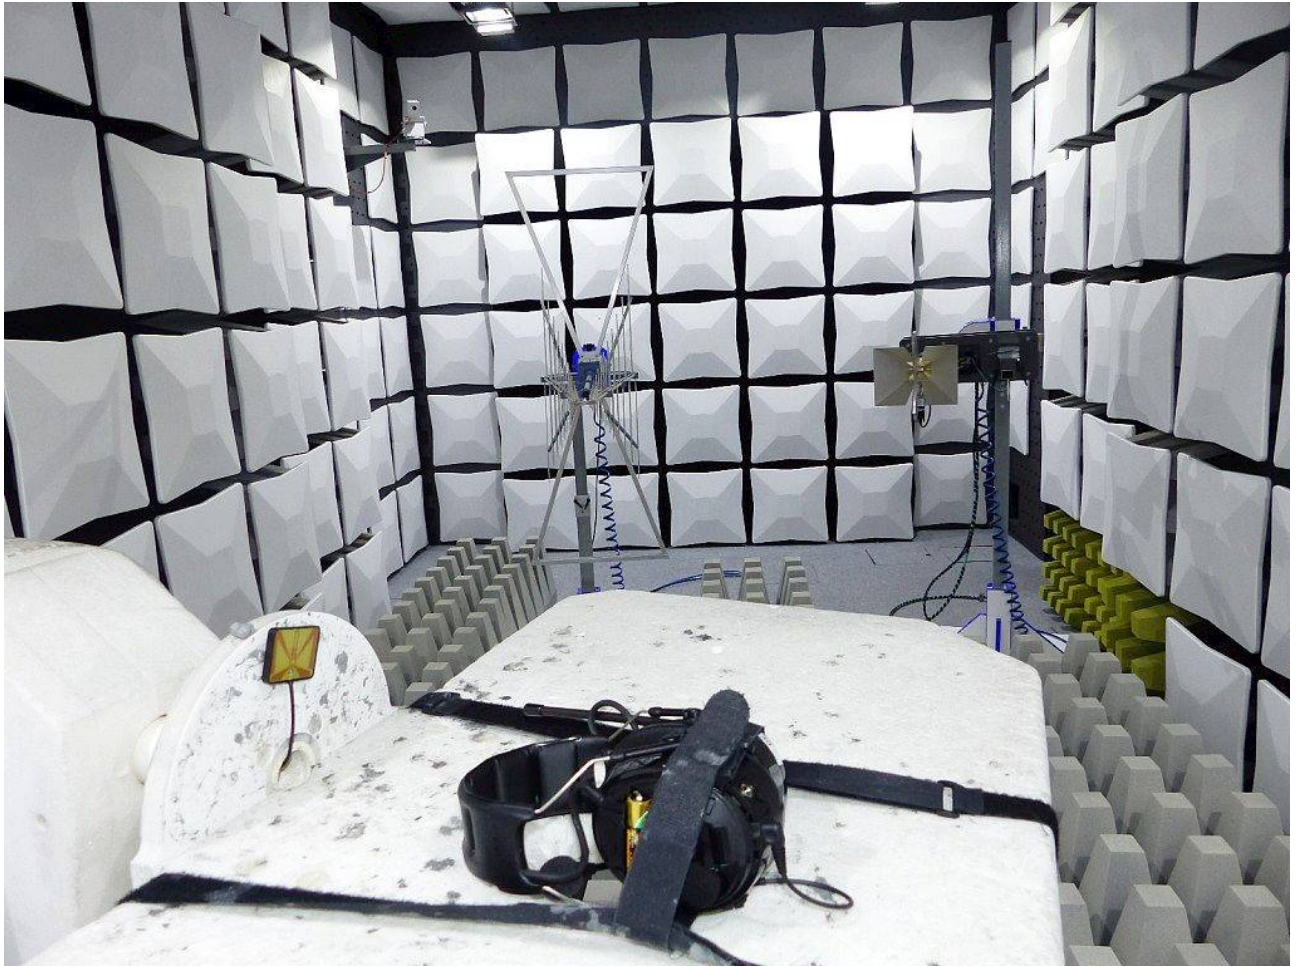
Photo 3: Test setup for radiated measurements (Enclosure, fully-anechoic chamber, 1-25 GHz intentional radiator §15, ANSI C63.10)

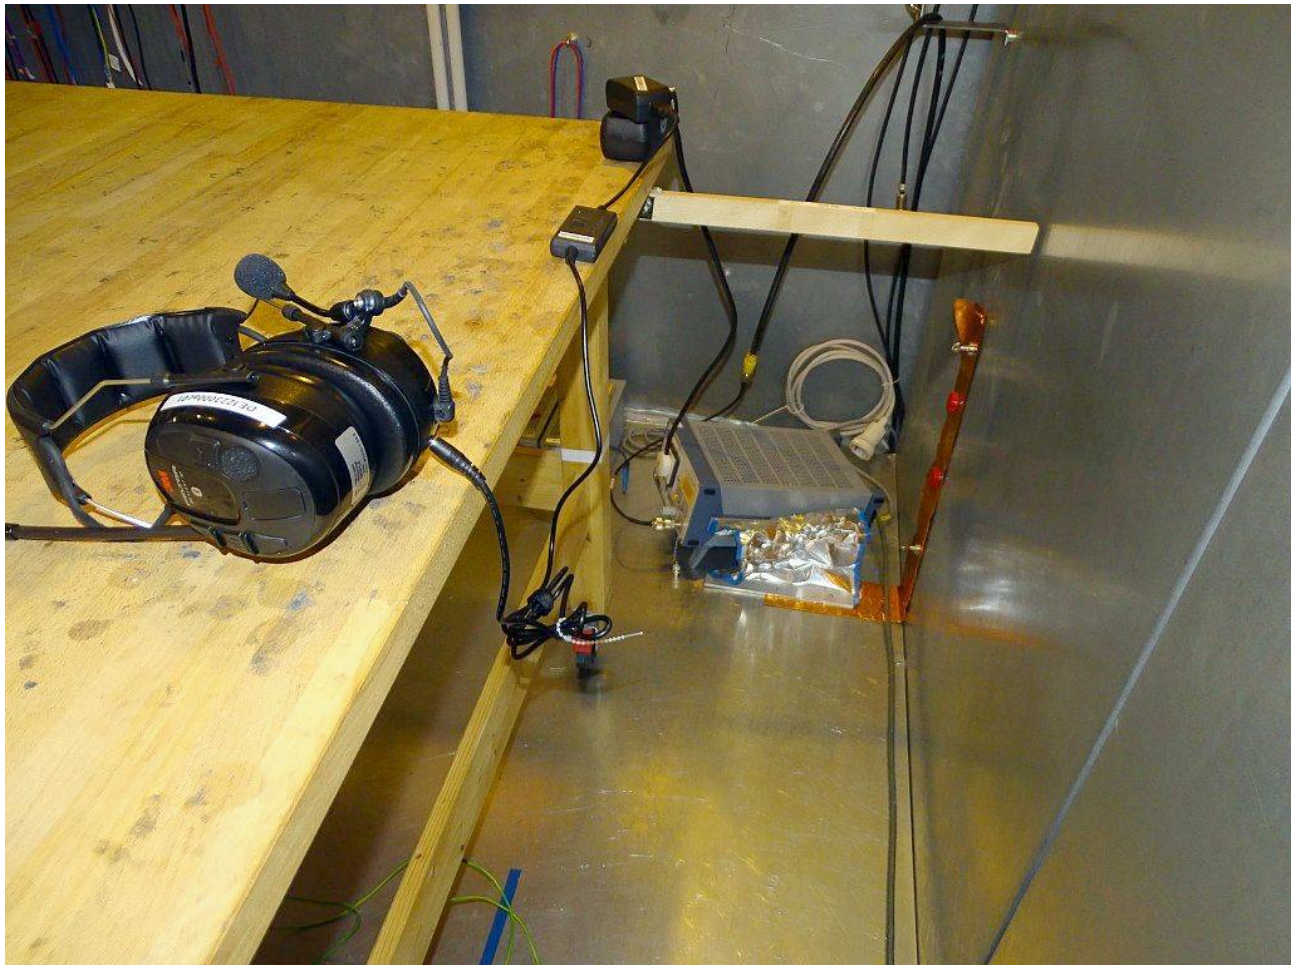
Photo 4: Test setup for conducted measurements (AC Port (power line), EUT supplied by AC/DC adapter, intentional / unintentional radiator §15, ANSI C63.10/4)

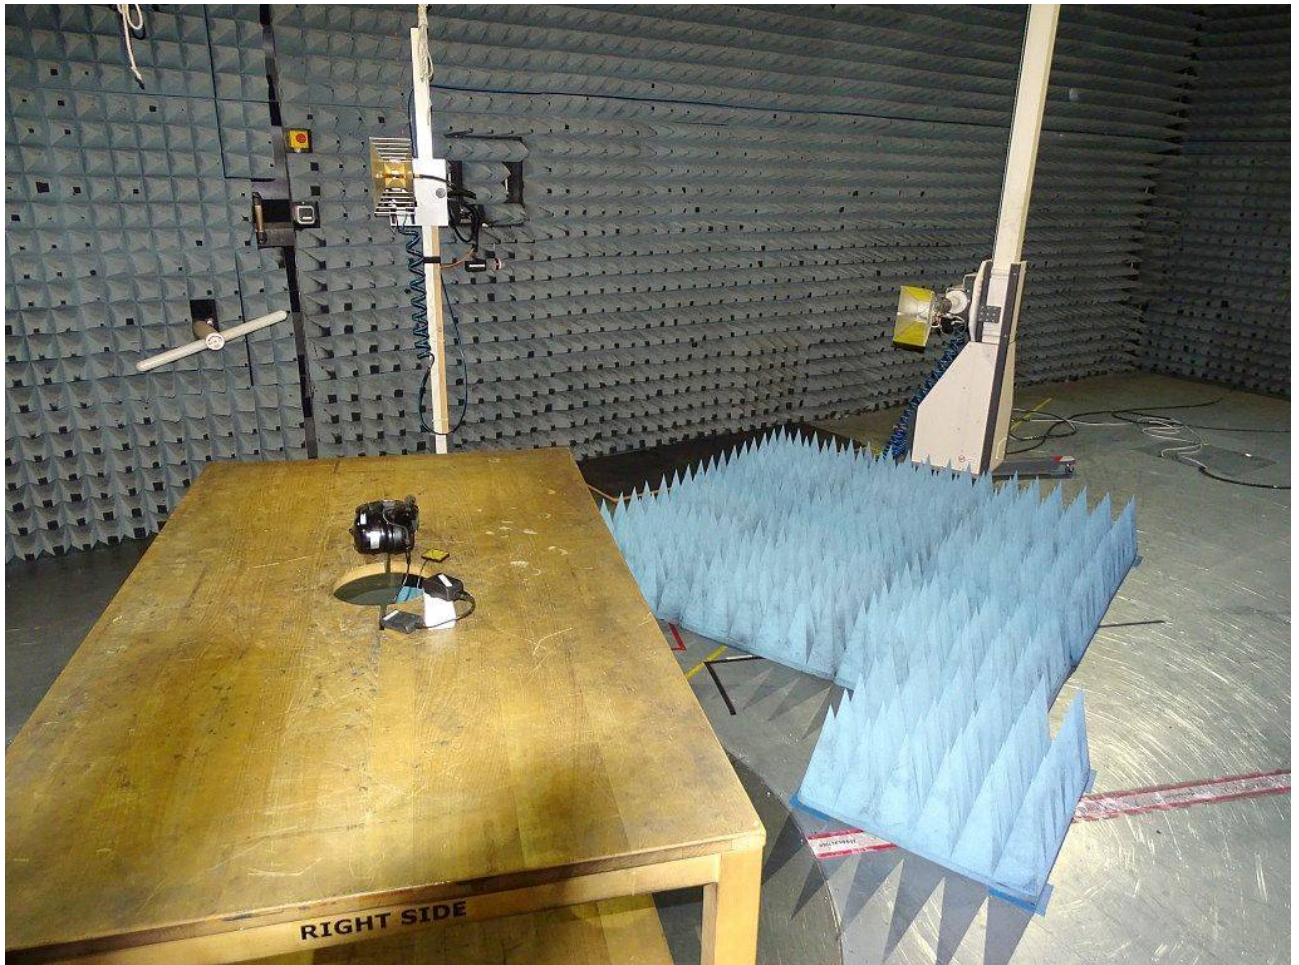
Photo 6: Test setup for radiated measurements above 1 GHz (AC Port (power line), EUT supplied by AC/DC adapter, unintentional radiator §15.109, ANSI C63.4); the test antenna is on the right side mounted at the boresight-mast.
