Report No. N-14/0018Au01S01-01

Test Report Reference: MDE_HUF_1302_EMCb Page 27 of 31

PHOTO REPORT

PHOTO REPORT:

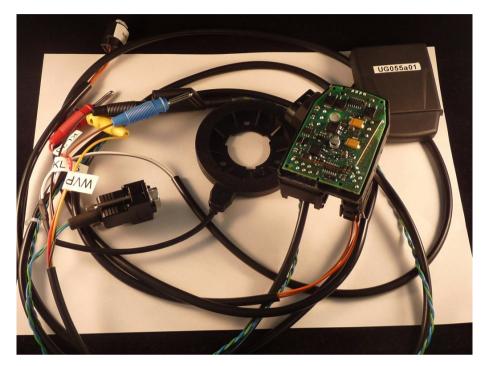
Picture 1 : EUT A and EUT B

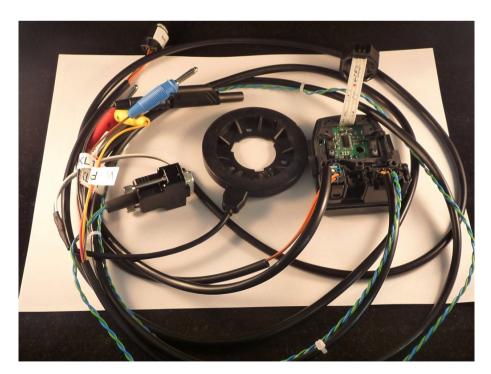
Picture 2 : EUT A turned around and EUT B

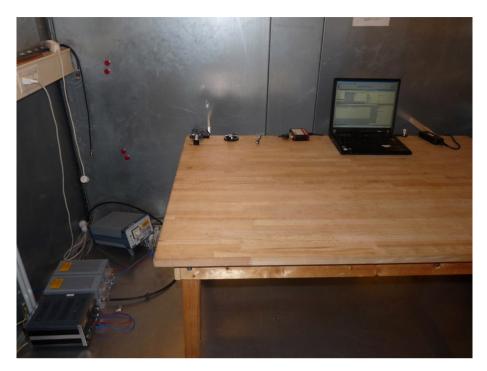
Picture 3 : setup for the test "Conducted interference voltage"

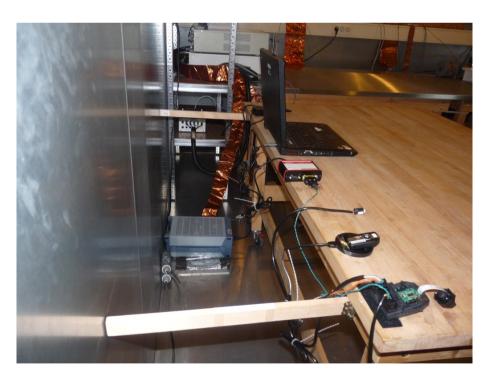
Picture 4 : setup for the test "Conducted interference voltage", detailed view

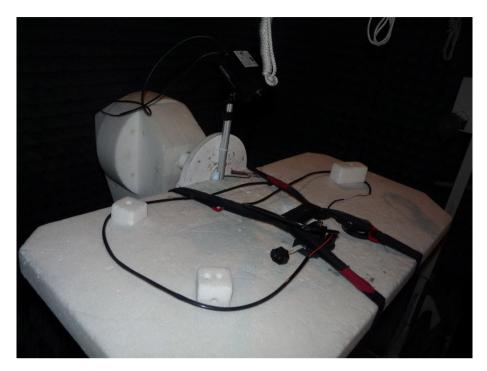
Picture 5 : setup for the test "RF-electromagnetic field", detailed view

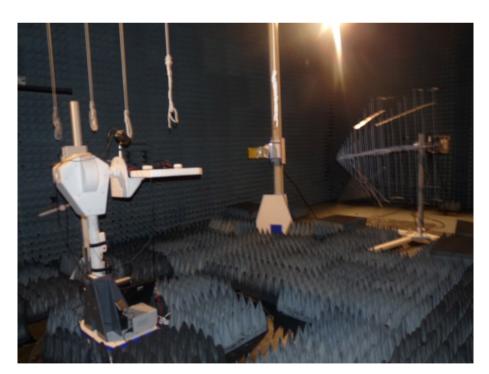
Picture 6 : setup for the test "RF-electromagnetic field"

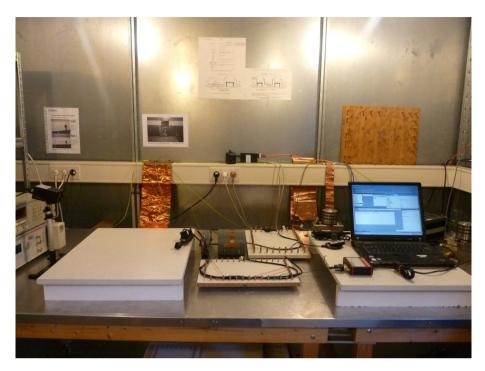
Picture 7 : setup for the test "RF-common mode"

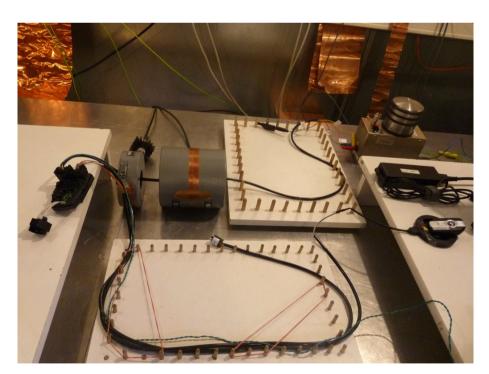
Picture 8 : setup for the test "RF-common mode", detailed view left side

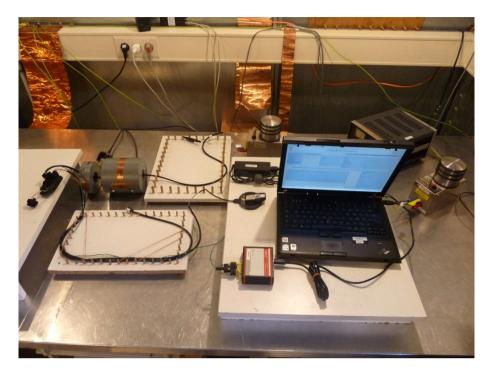
Picture 9 : setup for the test "RF-common mode", detailed view right side

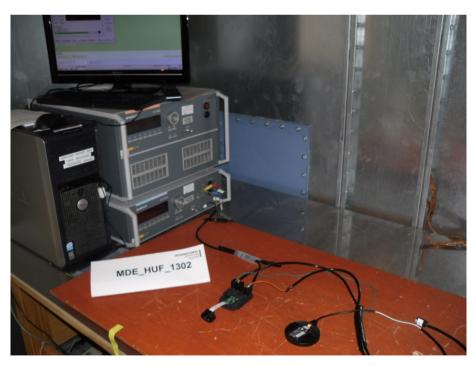
Picture 10 : setup for the test "Vehicular Pulses / Transients and Surges"

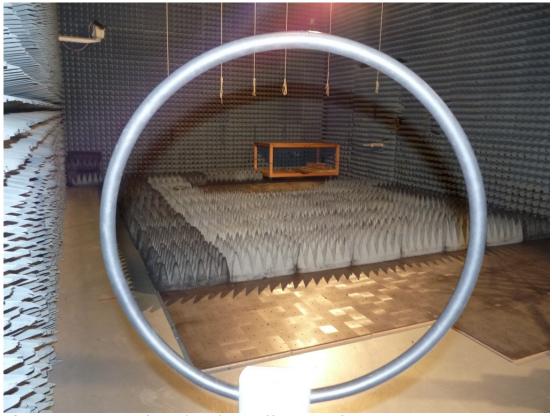
Photo No. 1: Setup for radiated tests (f < 30 MHz)

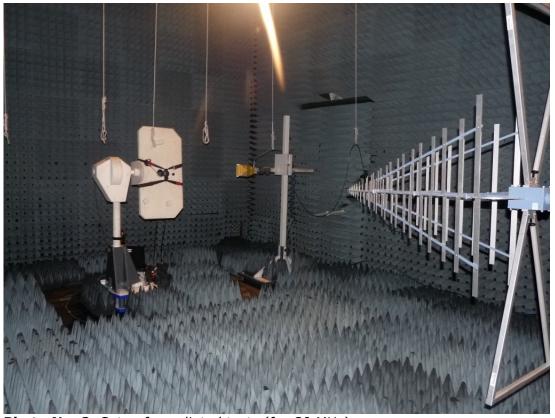
Photo No. 2: Setup for radiated tests ($f \ge 30 \text{ MHz}$)

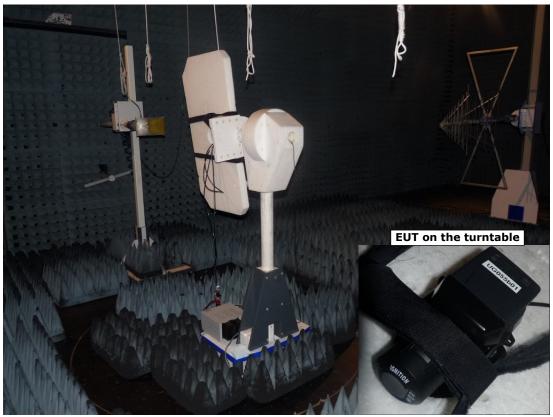
Photo 1: EUT test setup for radiated measurements.

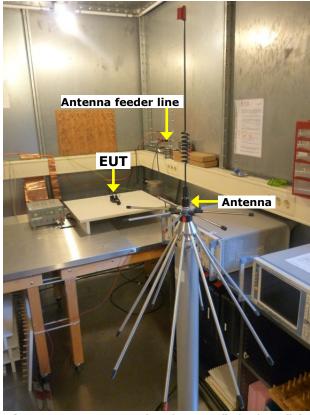
Photo 2: Setup for the test "Blocking" (inside the shielded cabin)

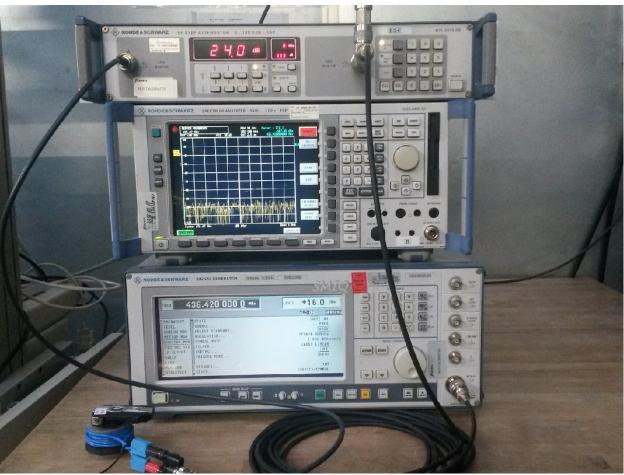
Photo 3: Setup for the test "Blocking" (outside the shielded cabin)
