Environmental Testing of the Vesper Marine Ltd  
VHF DSC Radio Transceiver, Model: Cortex M1 and Handset, Model: Cortex H1  
In accordance with IEC 60945

**Document 75943855 Report 10 Issue 2**

**June 2020**

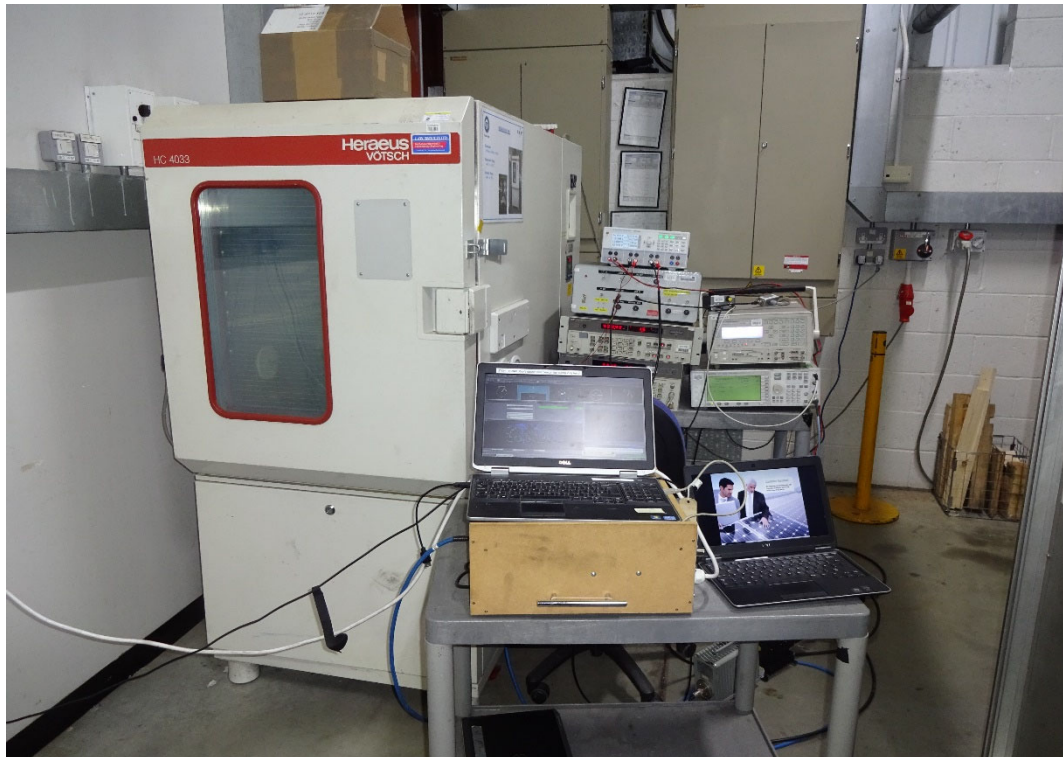
2.1.6.1 - Test Equipment Setup outside the chamber

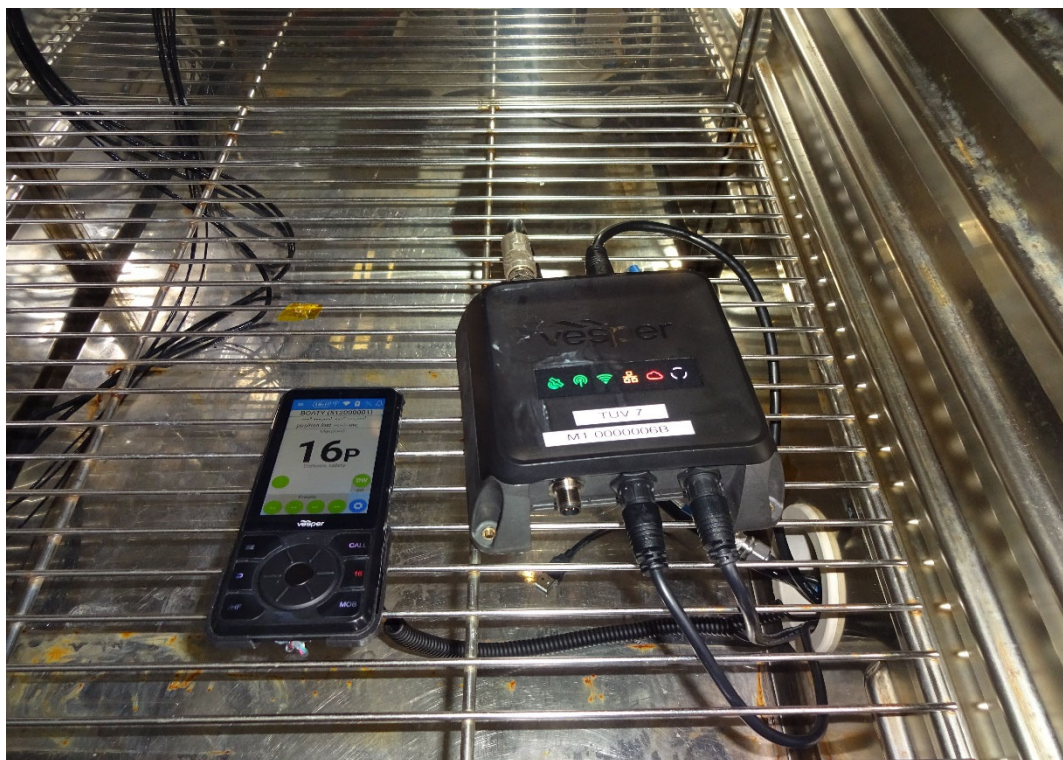
2.1.6.2 - EUT setup inside chamber

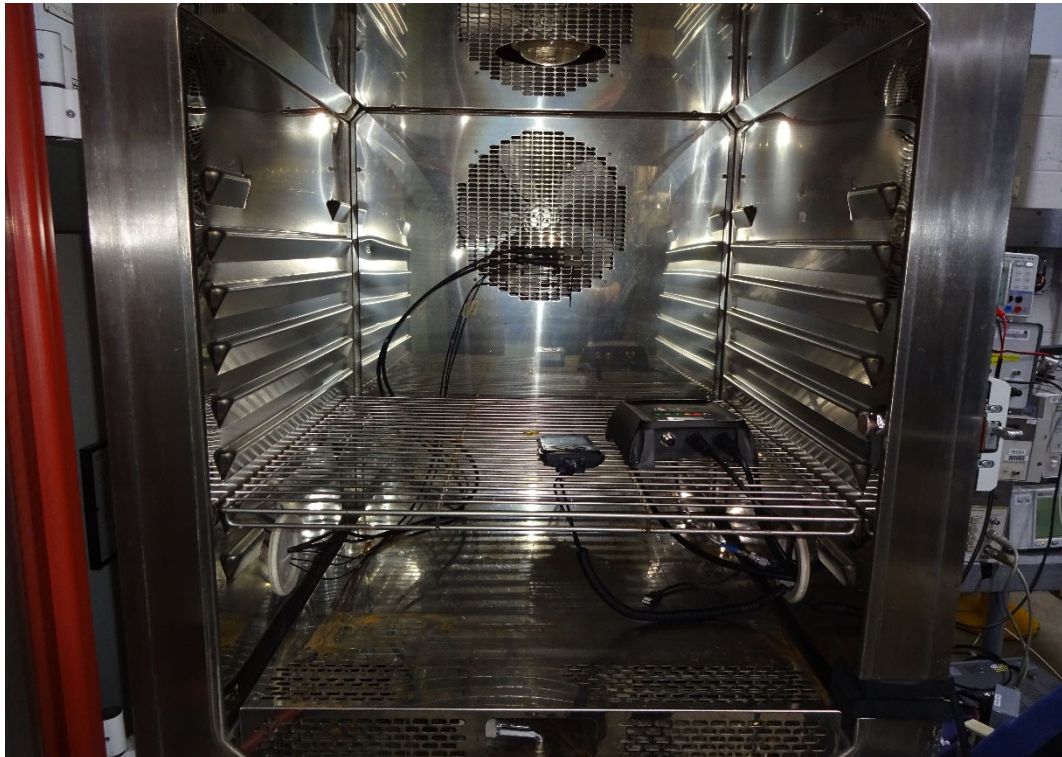
**2.1.6.3 - EUT test setup**

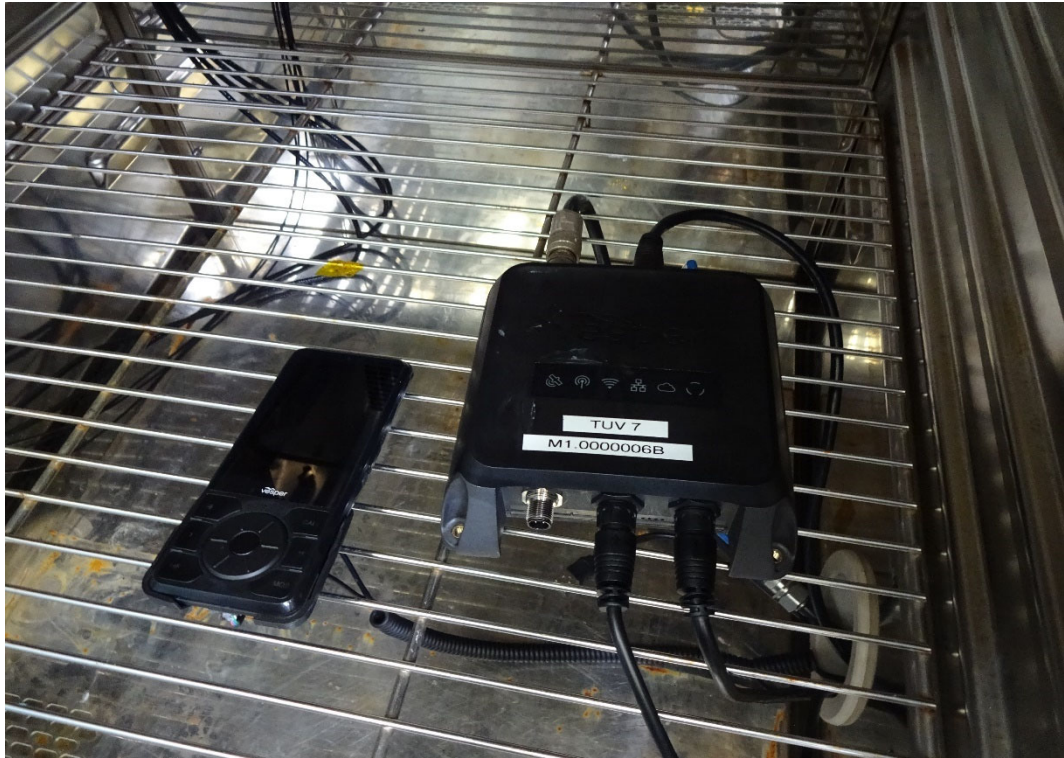
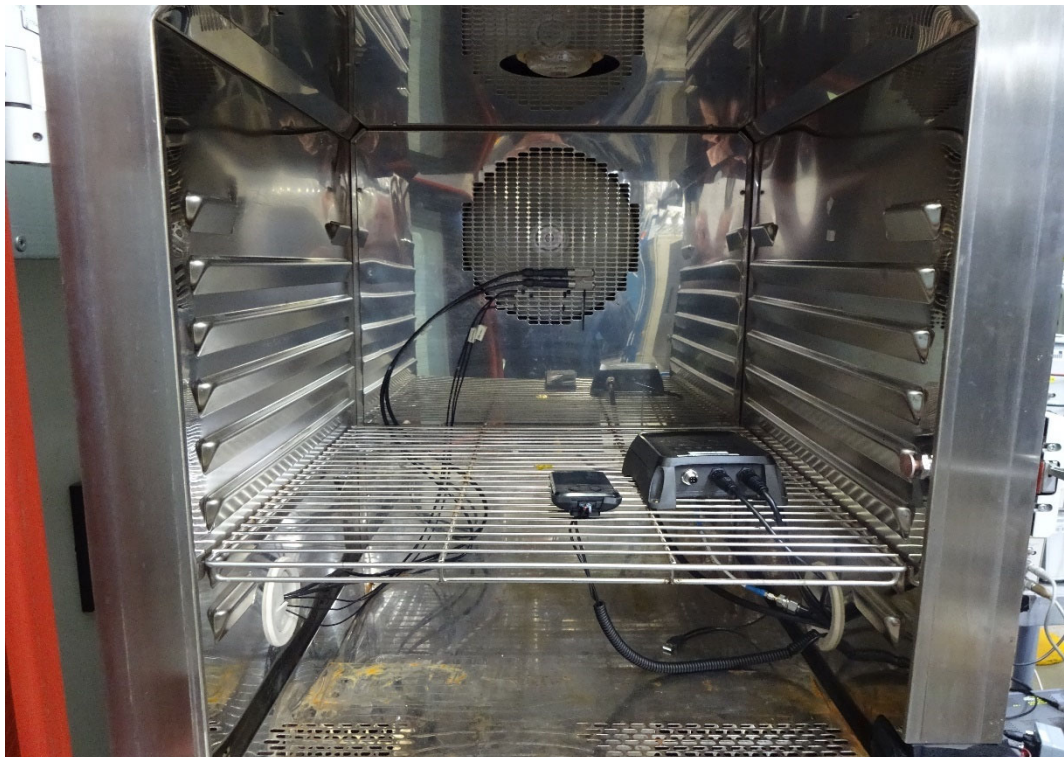
2.2.6.1 - EUT setup

2.2.6.2 - EUT setup

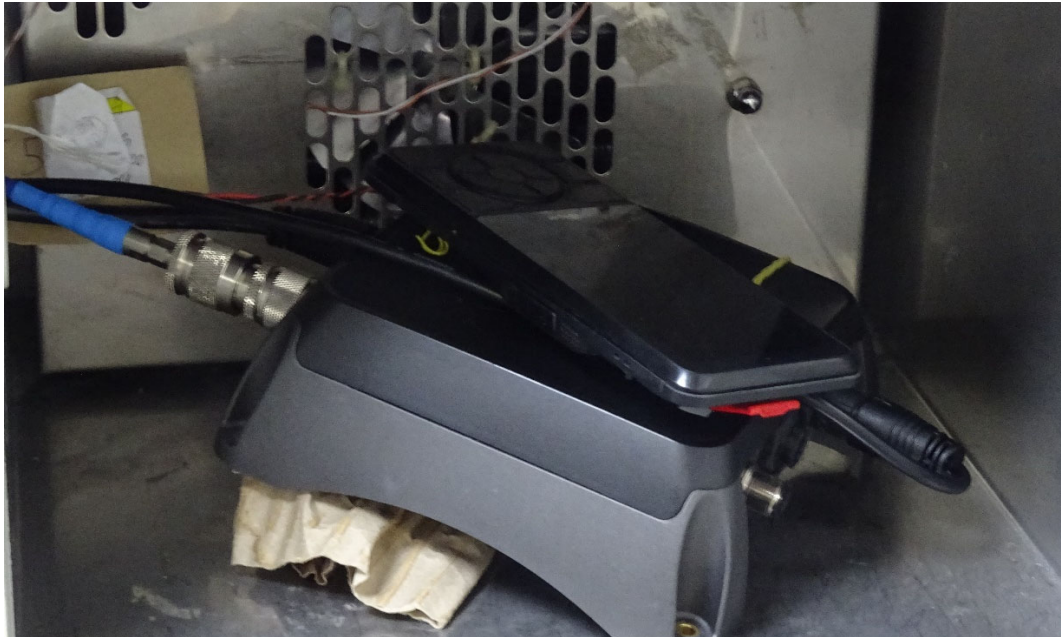
2.3.6.3 - EUT test setup (Re-test in February 2020)

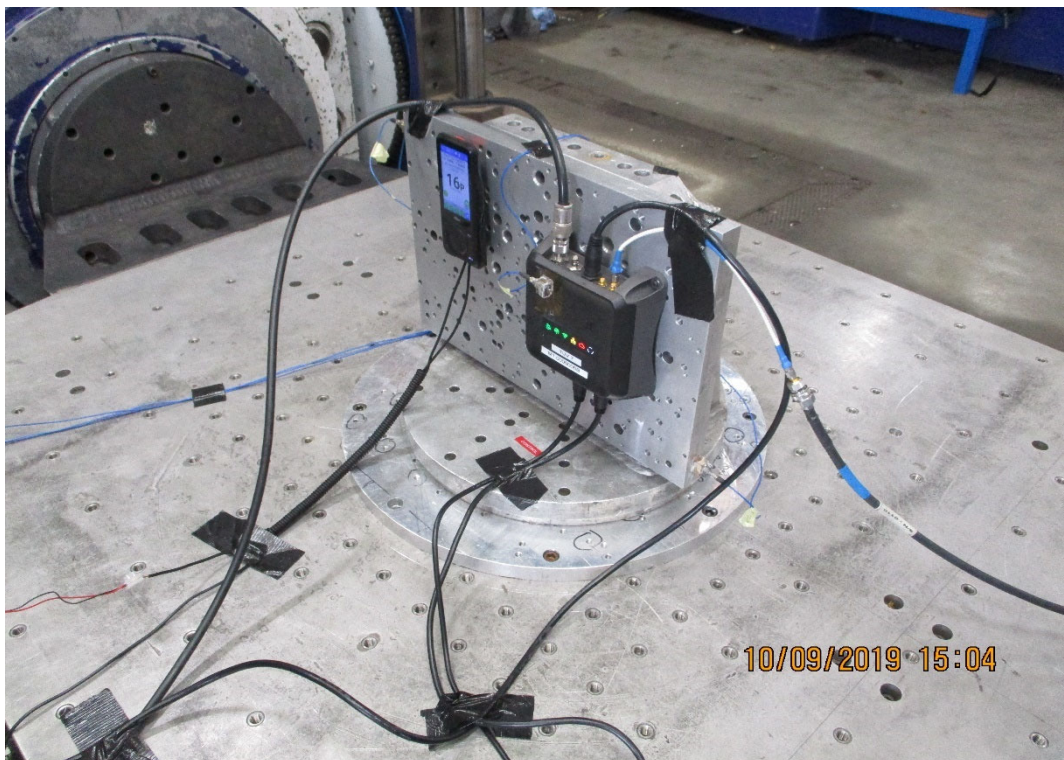
2.4.6.2 EUT Y Axis test set-up

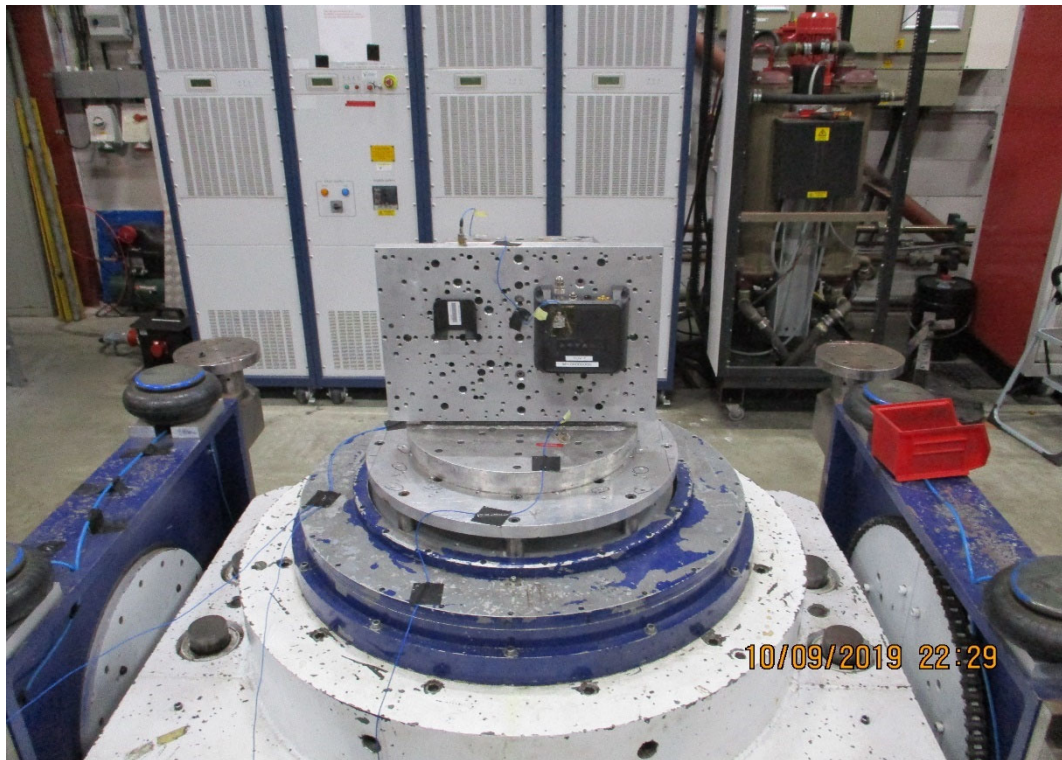
**2.4.6.3 - EUT Z Axis test set-up****2.4.7 Test Results**VHF Transceiver

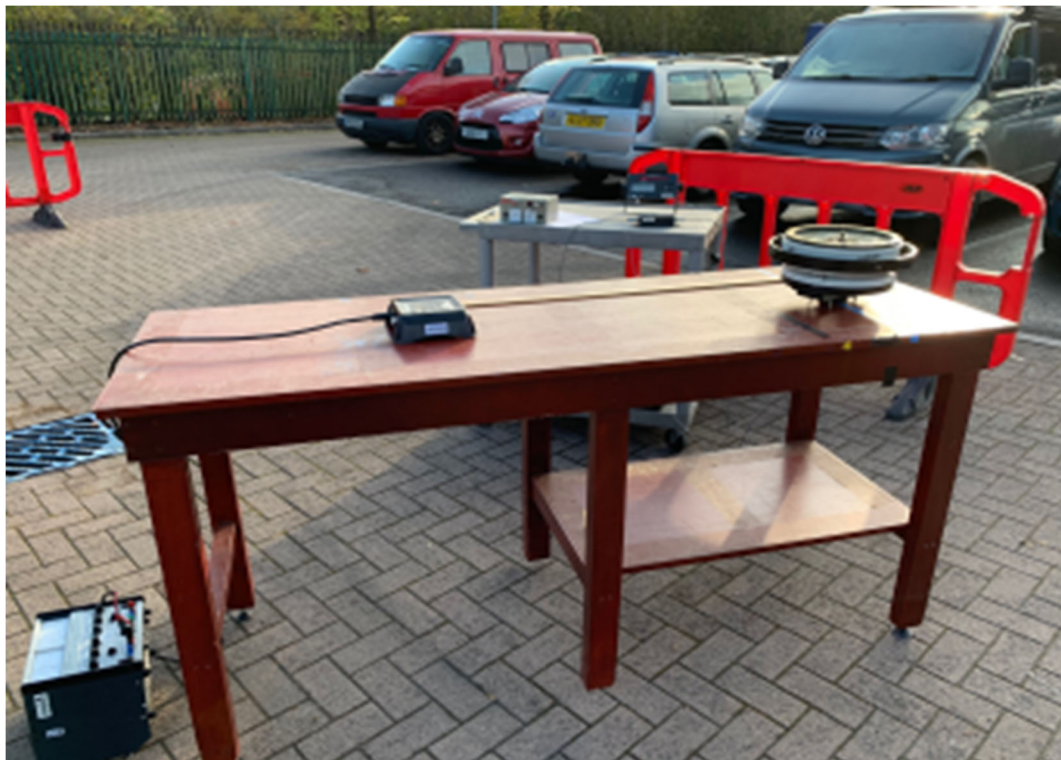
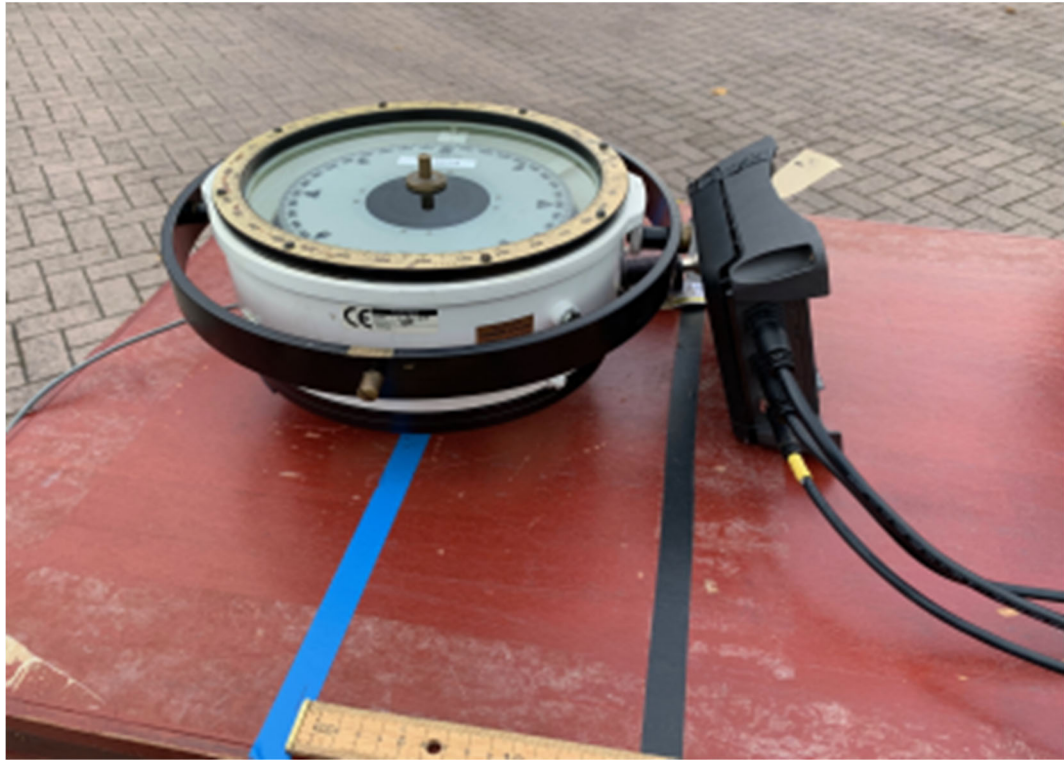
2.4.8.9 - Test Setup

**2.4.8.9 - Test Setup**
