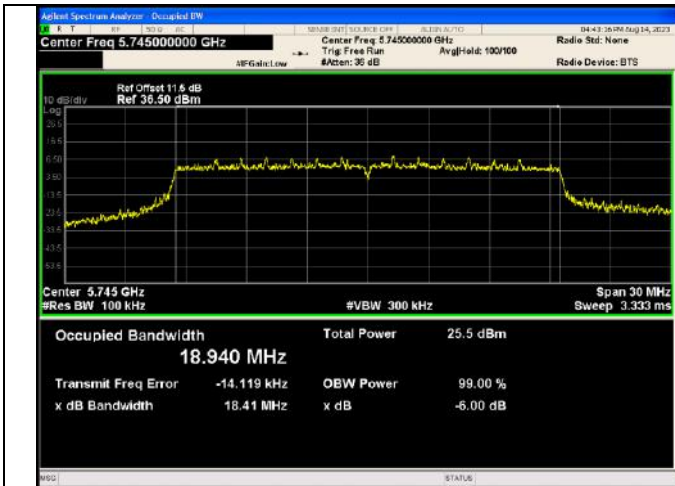
IEEE 802.11ax_Channel 149_20MHz_Antenna 0_RU&Index SU

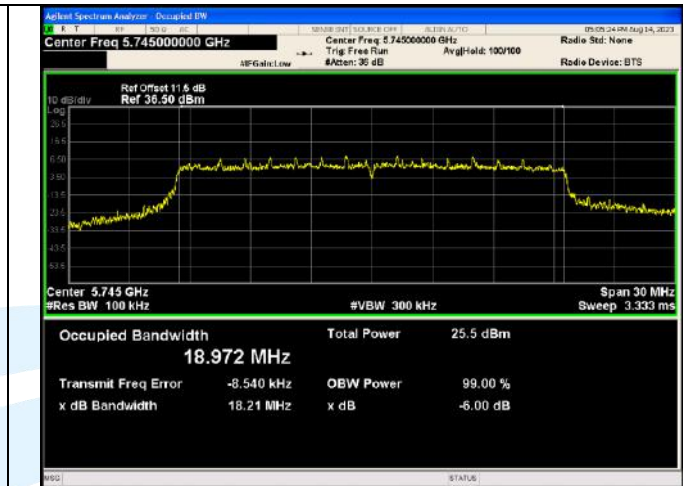
IEEE 802.11ax_Channel 149_20MHz_Antenna 1_RU&Index SU

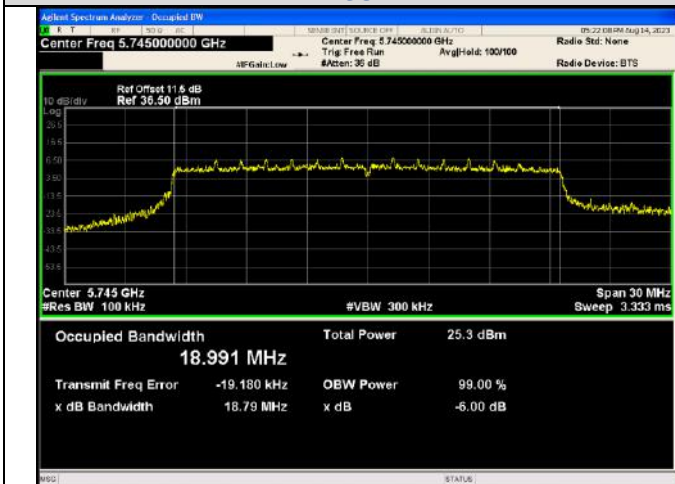
IEEE 802.11ax_Channel 149_20MHz_Antenna 2_RU&Index SU

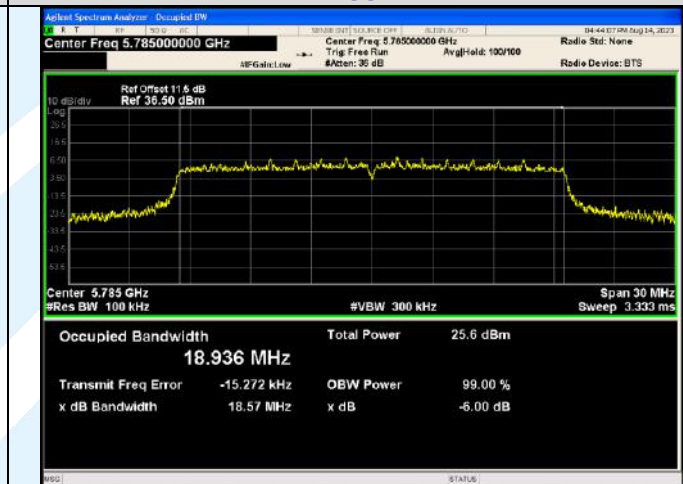
IEEE 802.11ax_Channel 157_20MHz_Antenna 0_RU&Index SU

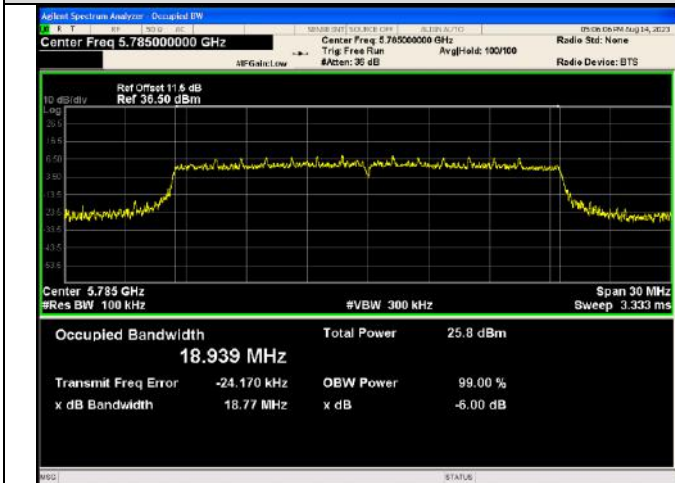
IEEE 802.11ax_Channel 157_20MHz_Antenna 1_RU&Index SU

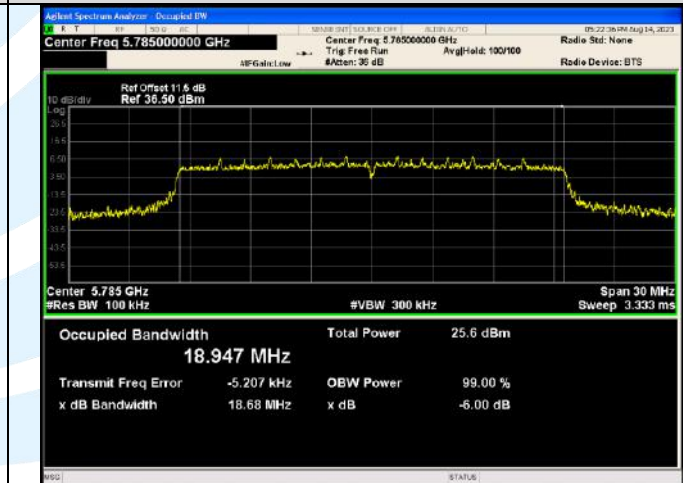
IEEE 802.11ax_Channel 157_20MHz_Antenna 2_RU&Index SU

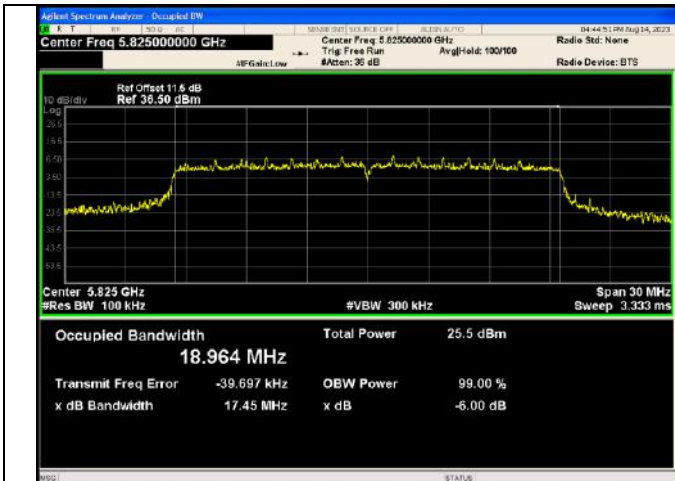
IEEE 802.11ax_Channel 165_20MHz_Antenna 0_RU&Index SU

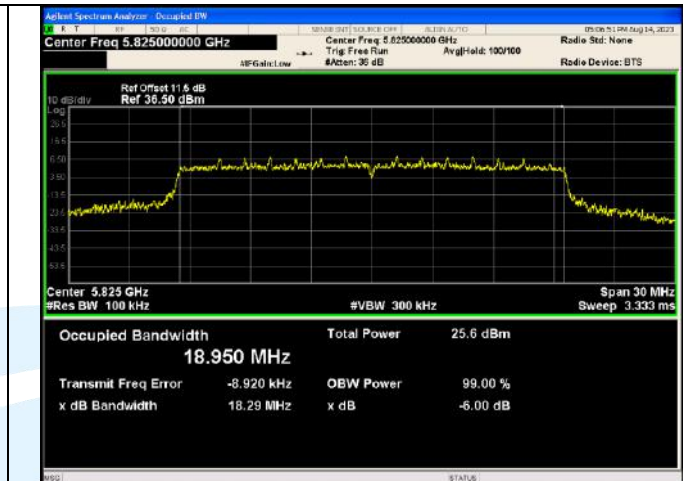
IEEE 802.11ax_Channel 165_20MHz_Antenna 1_RU&Index SU

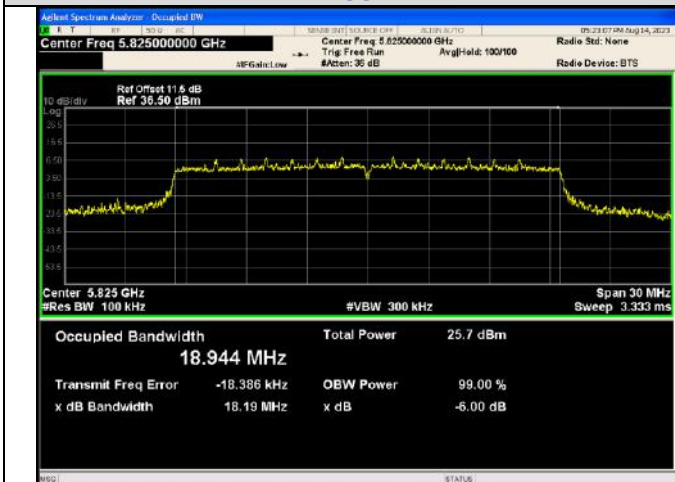
IEEE 802.11ax_Channel 165_20MHz_Antenna 2_RU&Index SU

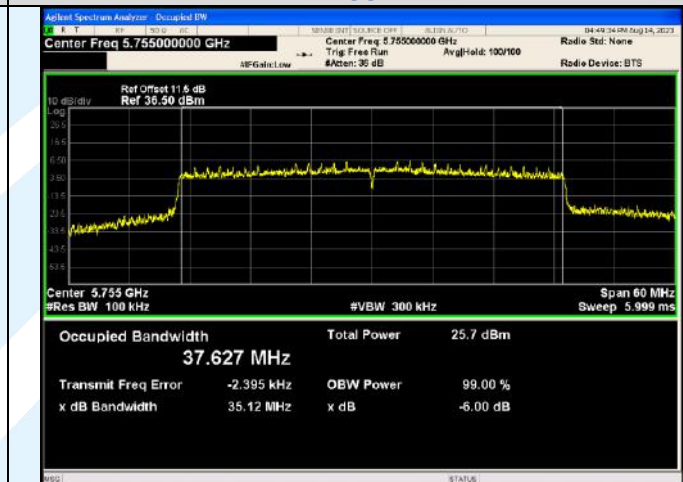
IEEE 802.11ax_Channel 151_40MHz_Antenna 0_RU&Index SU

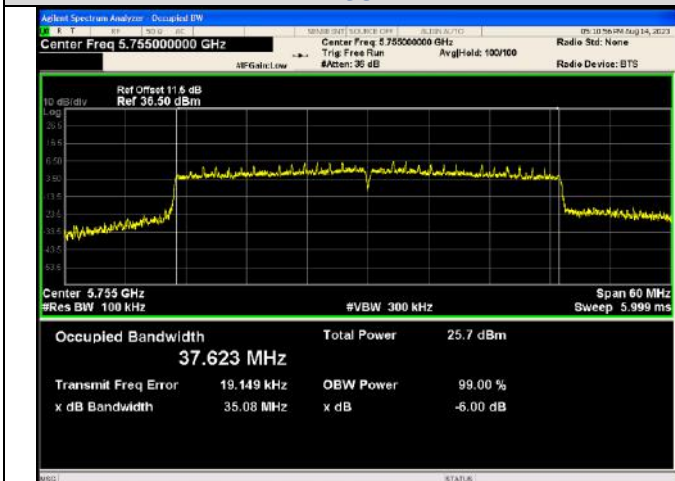
IEEE 802.11ax_Channel 151_40MHz_Antenna 1_RU&Index SU

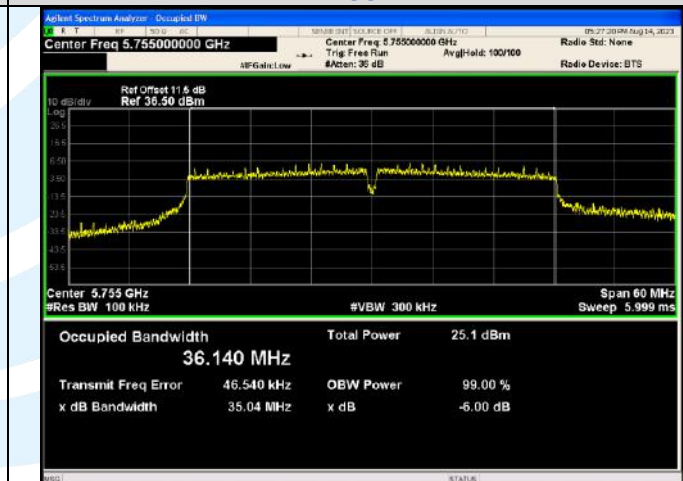
IEEE 802.11ax_Channel 151_40MHz_Antenna 2_RU&Index SU

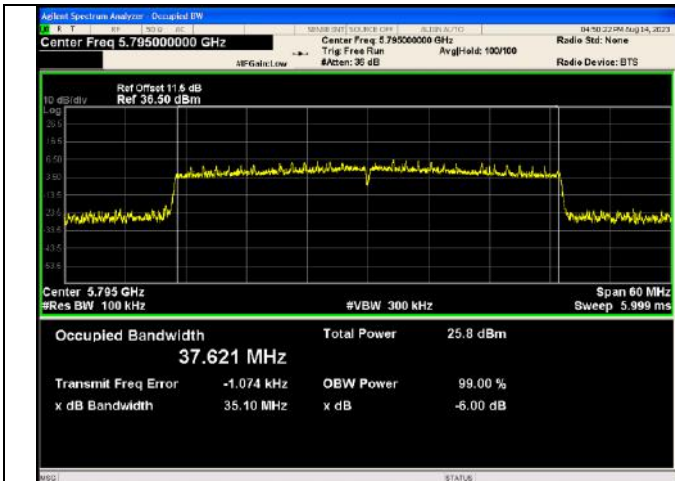
IEEE 802.11ax_Channel 159_40MHz_Antenna 0_RU&Index SU

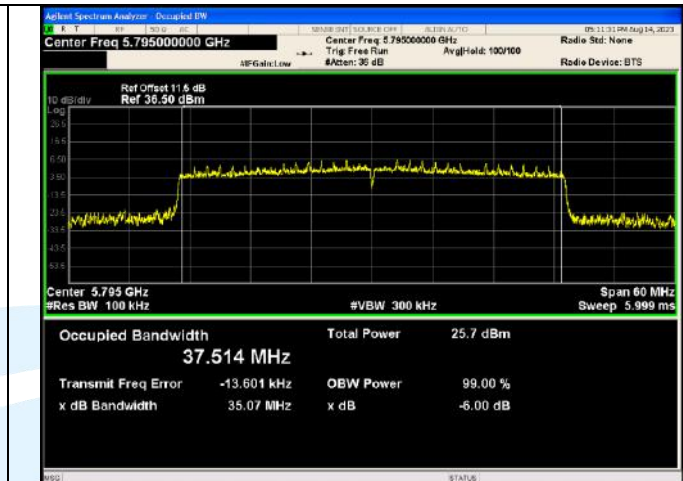
IEEE 802.11ax_Channel 159_40MHz_Antenna 1_RU&Index SU

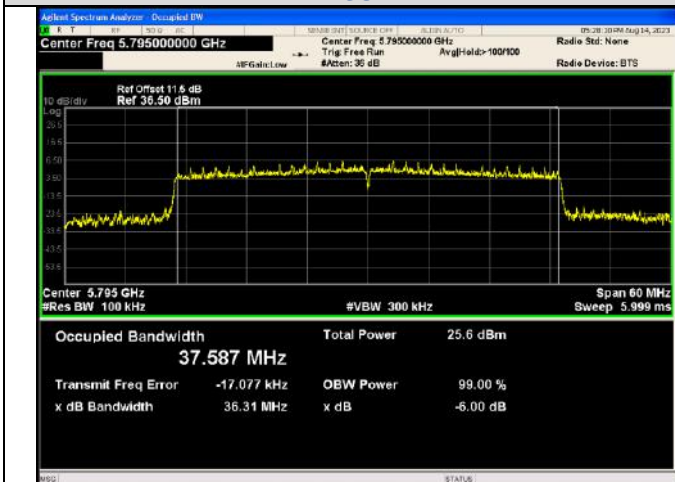
IEEE 802.11ax_Channel 159_40MHz_Antenna 2_RU&Index SU

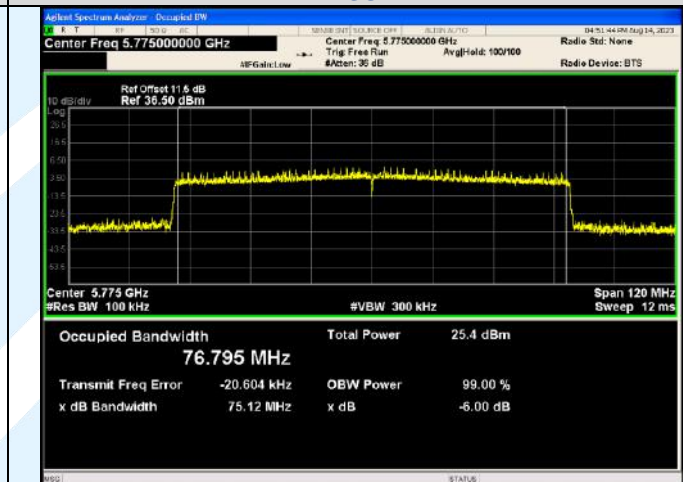
IEEE 802.11ax_Channel 155_80MHz_Antenna 0_RU&Index SU

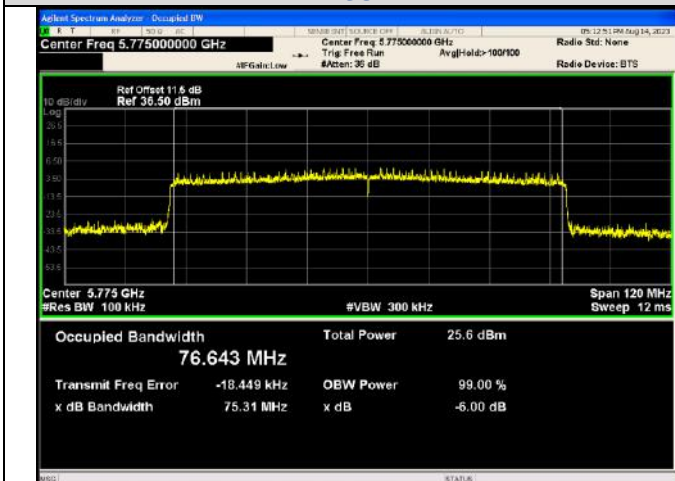
IEEE 802.11ax_Channel 155_80MHz_Antenna 1_RU&Index SU

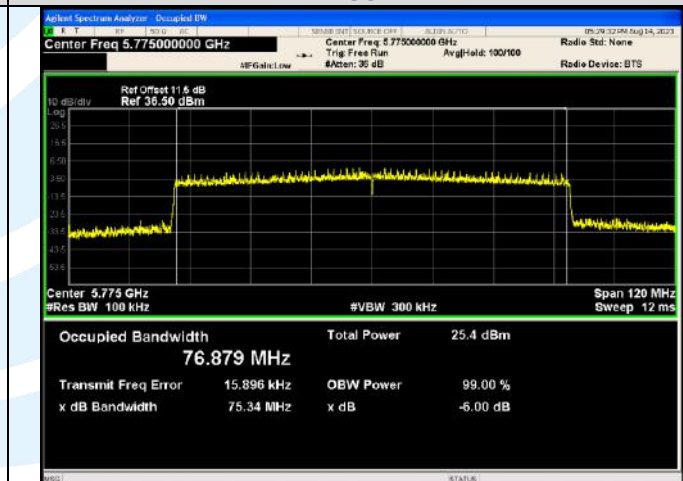
IEEE 802.11ax_Channel 155_80MHz_Antenna 2_RU&Index SU
