1. SETUP PHOTOS

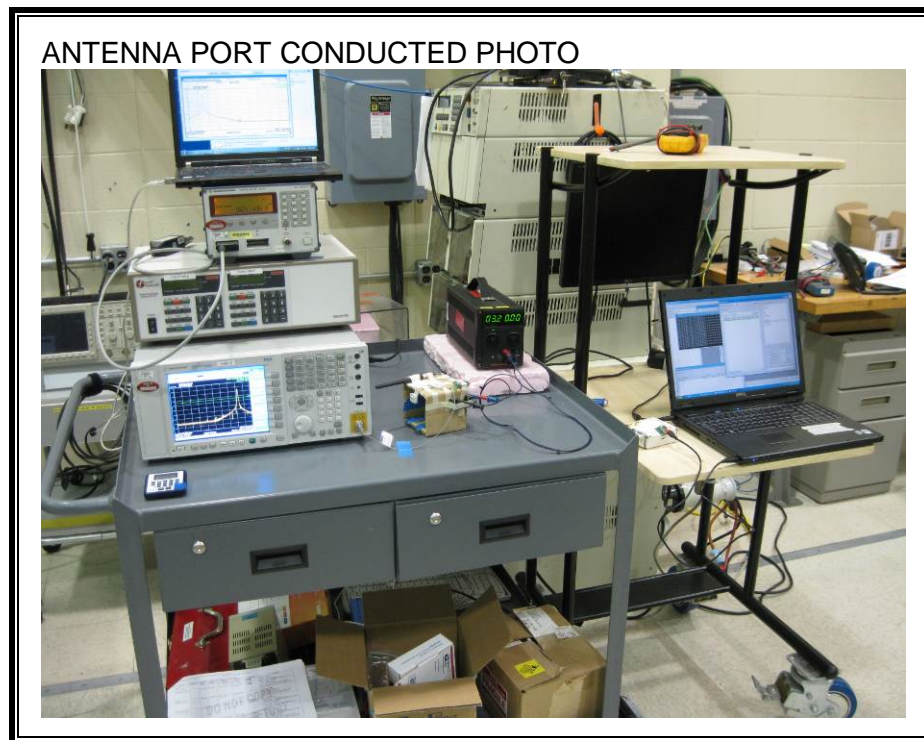
ANTENNA PORT CONDUCTED RF MEASUREMENT SETUP

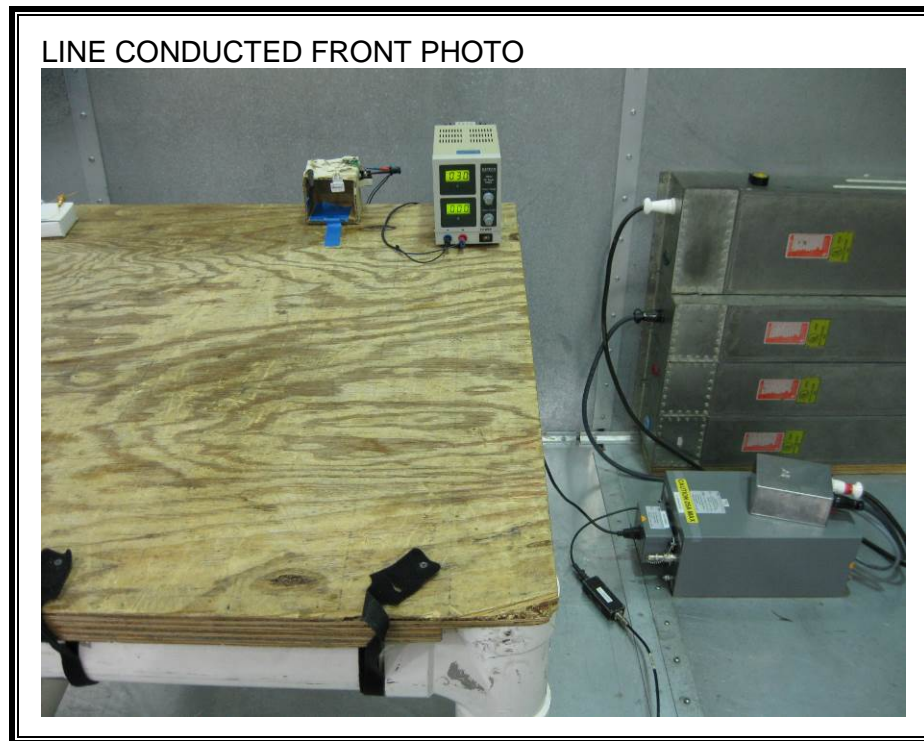
POWERLINE CONDUCTED EMISSIONS MEASUREMENT SETUP

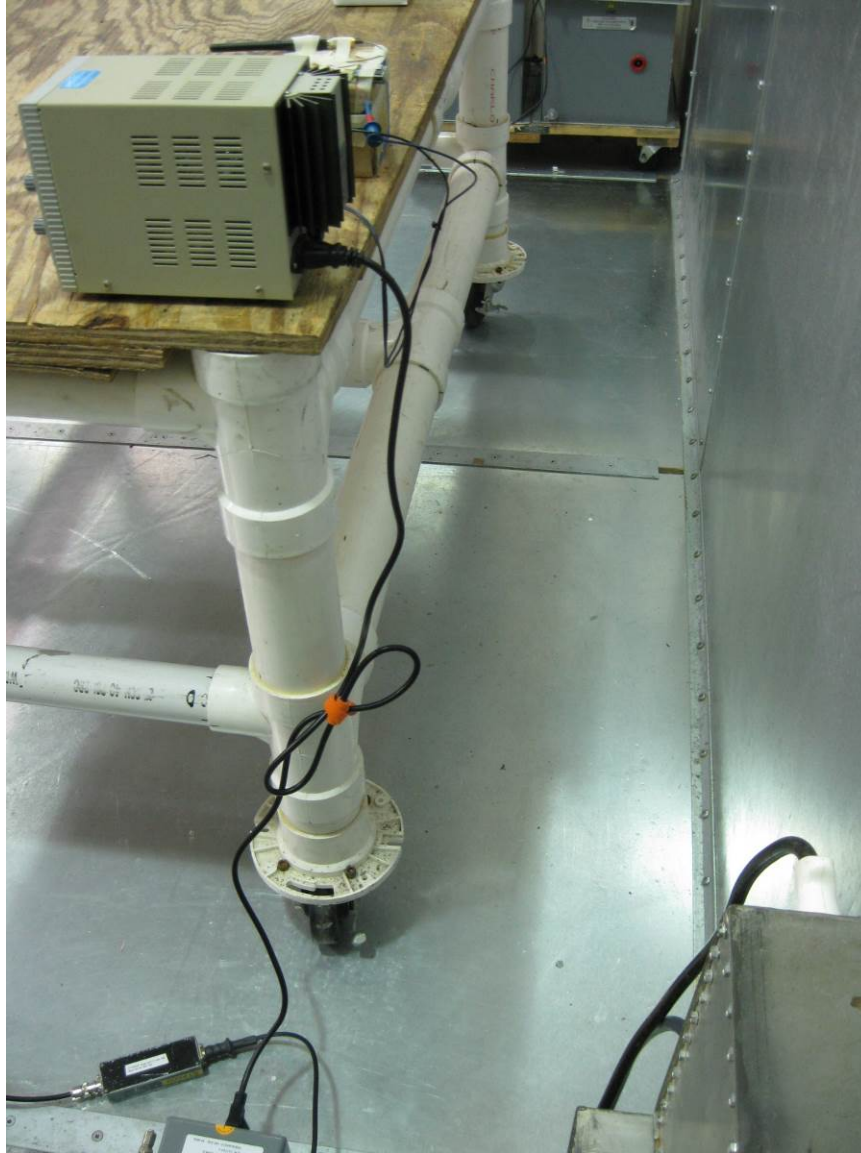
LINE CONDUCTED BACK PHOTO
