EXHIBIT 2 - TEST SETUP PHOTOGRAPHS

TEST REPORT NUMBER	DBN 1528TEL187-C
TEST REPORT DATE	17 th Aug 2015
TEST REPORT VERSION	1.0
MANUFACTURER	Cambium Networks
PRODUCT NAME	ePMP 2.4GHz Transceiver (Force 200)
PRODUCT MODEL NO.	C024900P161A
PART NO.	C024900C161A, 142000001127A, 142000001227A
REV	0B
CONDITION OF EUT WHEN RECEIVED	GOOD and in working condition
ISSUED TO	3800 Golf Road, Suite 360 Rolling Meadows, IL 60008. USA +1 888-863-5250
ISSUED BY	TARANG Lab Wipro Technologies, SJP2, Survey#70,77,78/8A, Dodda Kanelli, Sarjapur road, Bangalore. Karnataka. India - 560 035 Tel: +91-80-30292929 Fax: +91-80-30298200 Email: tarang.planet@wipro.com Web: www.wipro.com

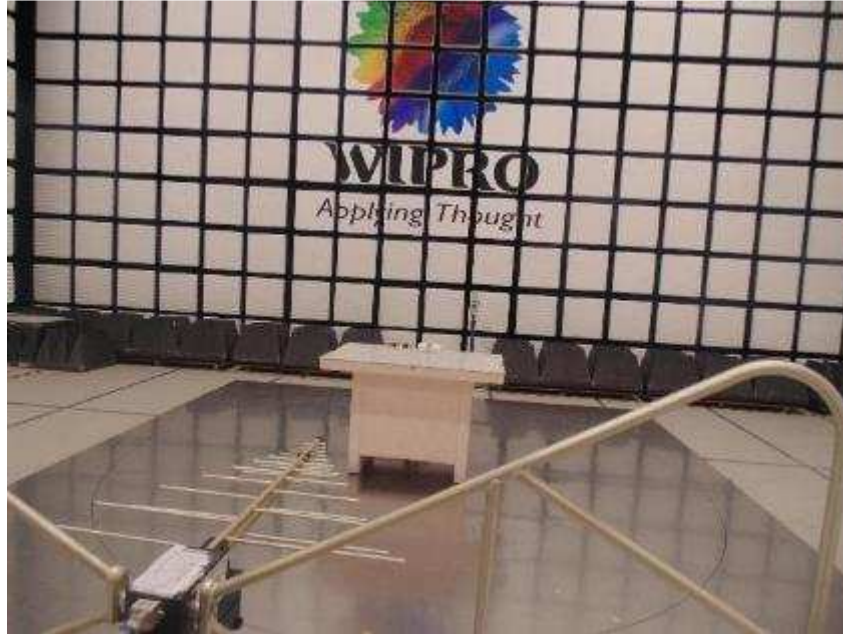
Figure 7: Test setup for Radiated Emission test from 30MHz to 1GHz - Horizontal Polarization

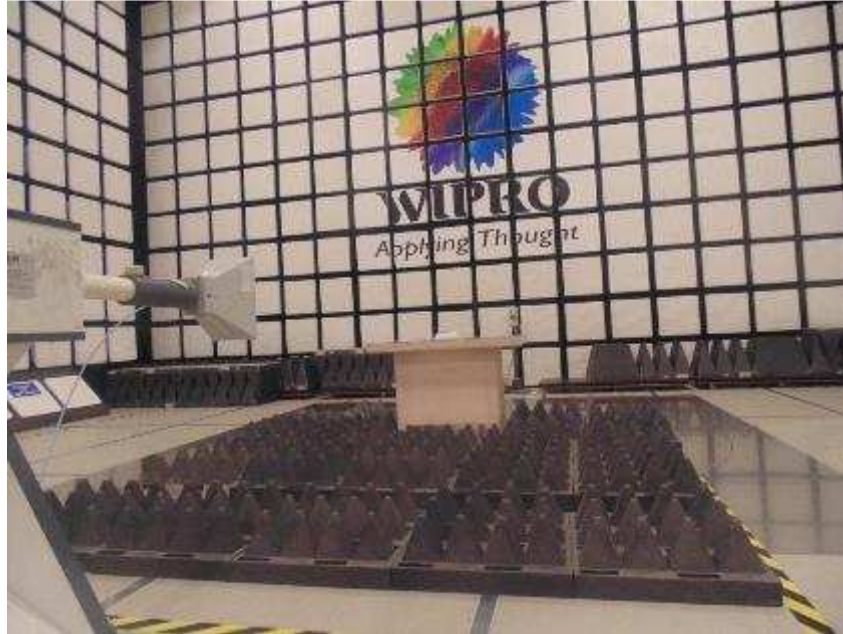
Figure 9: Test setup for Radiated Emission Test from 1 GHz to 18 GHz – Horizontal Polarization

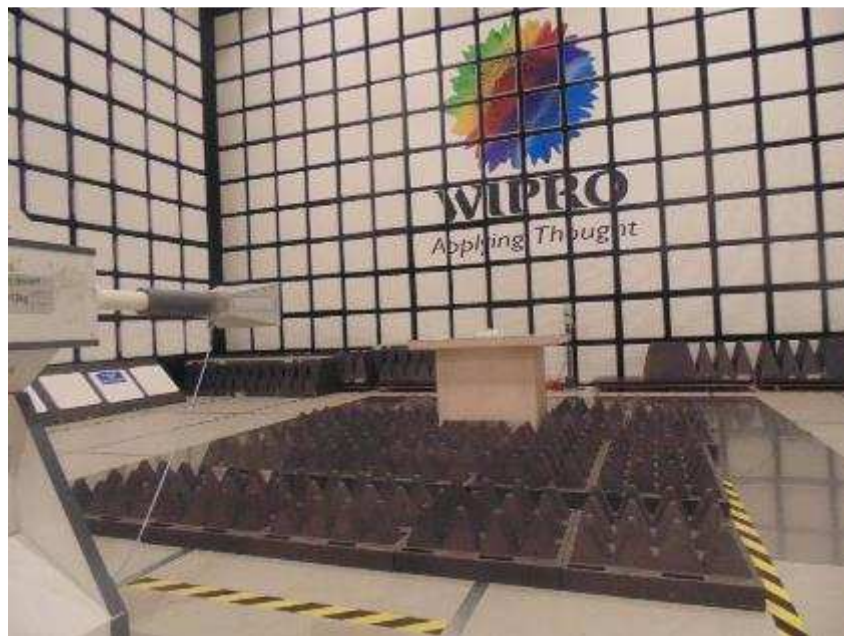
Figure 10: Test setup for Radiated Emission Test from 1 GHz to 18 GHz – Vertical Polarization

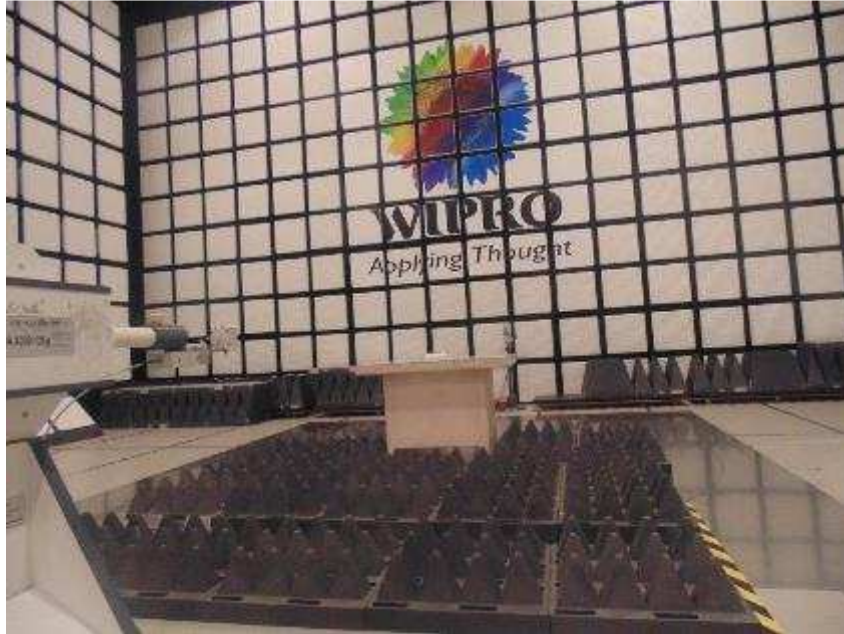
Figure 11: Test setup for Radiated Emission Test from 18 GHz to 26.5 GHz – Horizontal Polarization

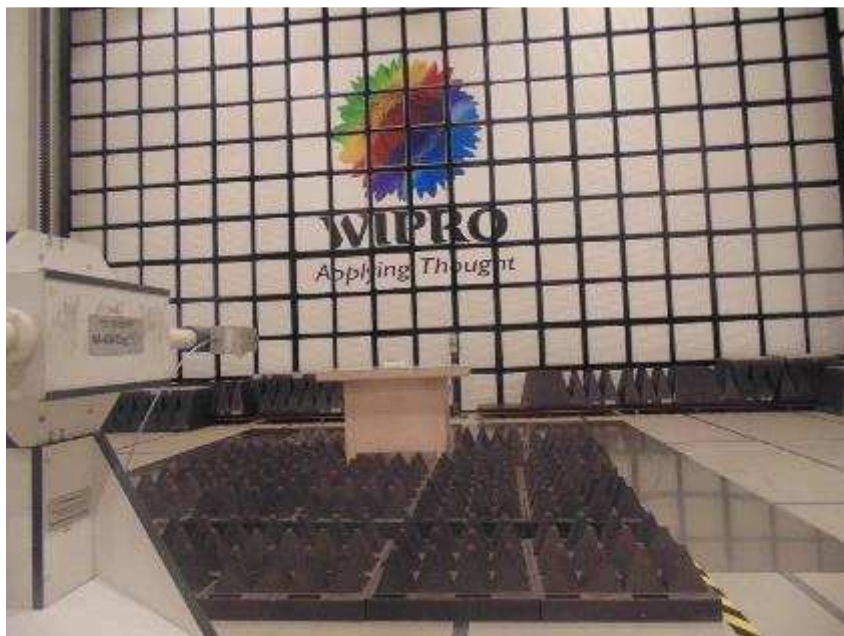
Figure 12: Test setup for Radiated Emission Test from 18 GHz to 26.5 GHz – Vertical Polarization

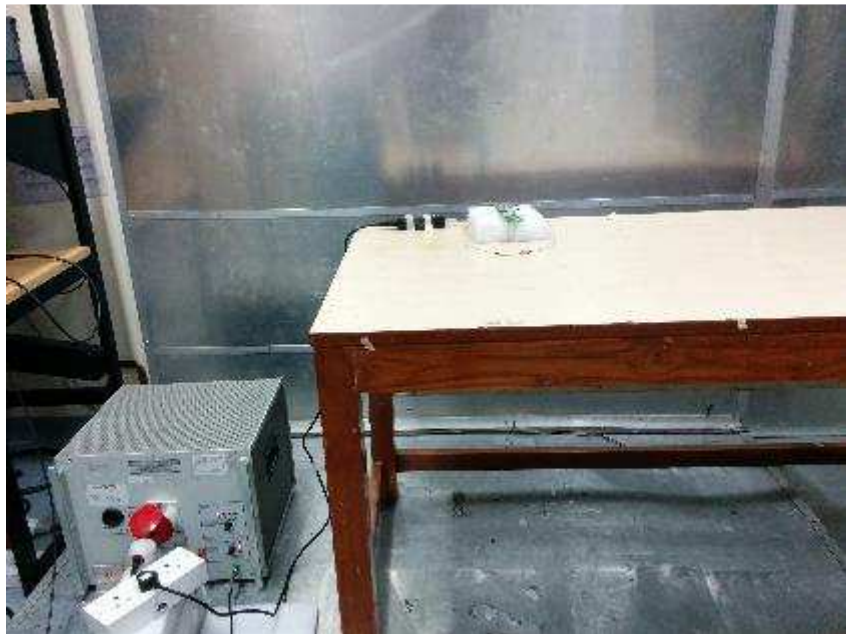
Figure 14: Conducted Emission Test set up photograph – 150 kHz to 30 MHz

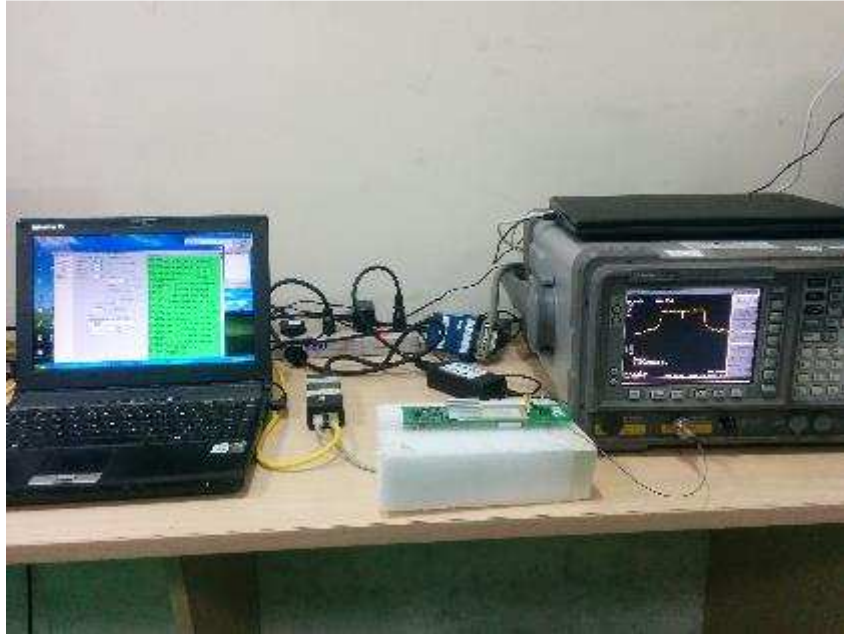
Figure 15: Conducted RF Test set up photograph

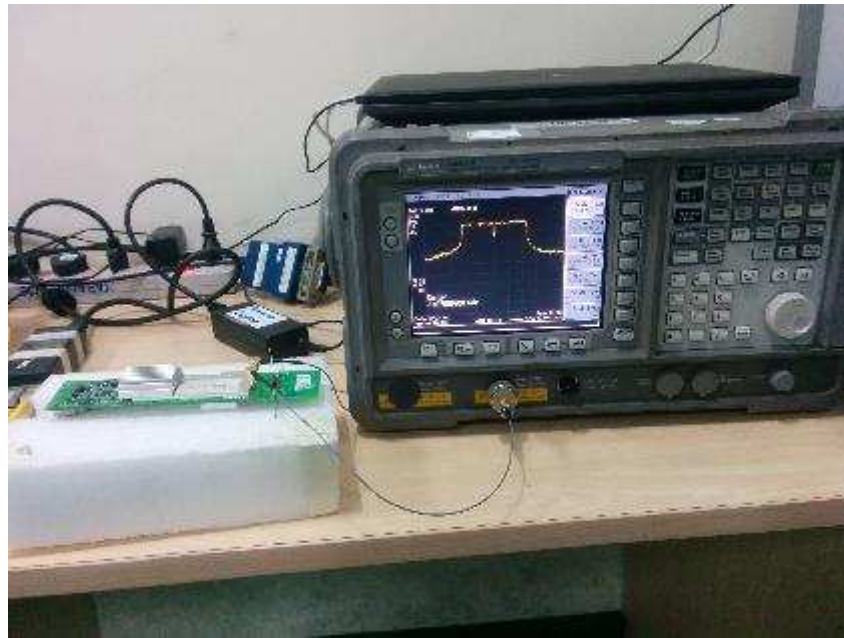
Figure 16 Conducted RF Test set up photograph
