**Appendix E: Reference level measurement
Test Result**

Appendix F: Band edge measurements Test Result

Appendix G: Conducted Spurious Emission Test Result

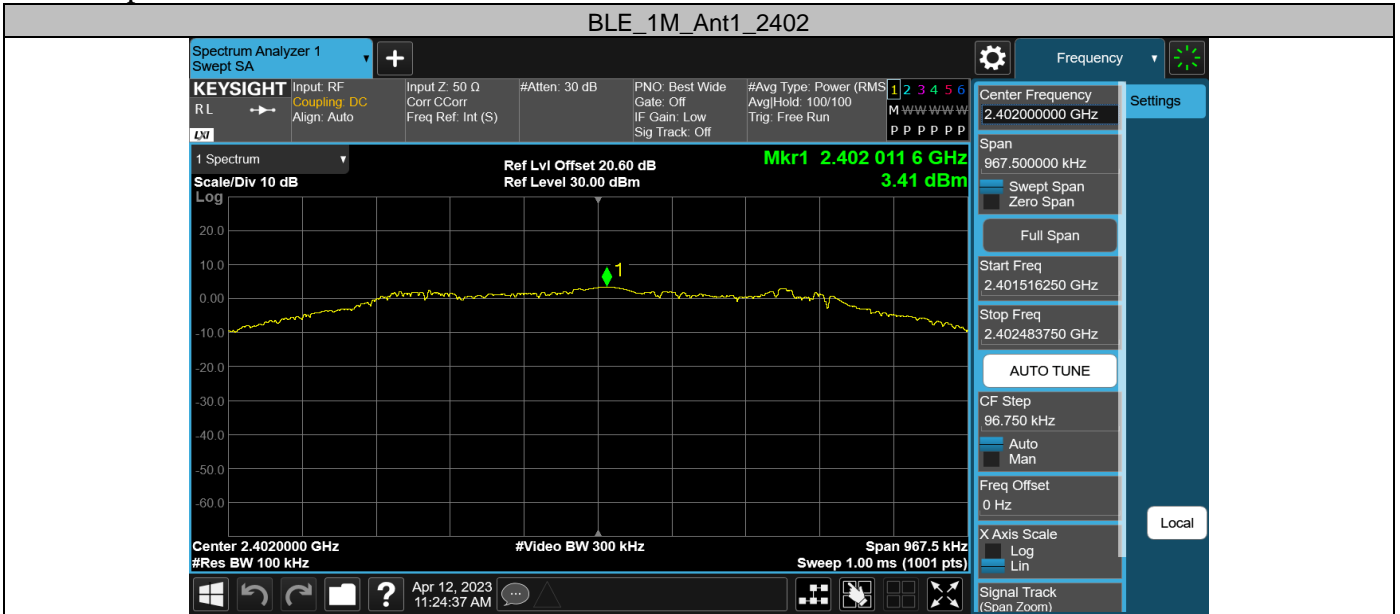
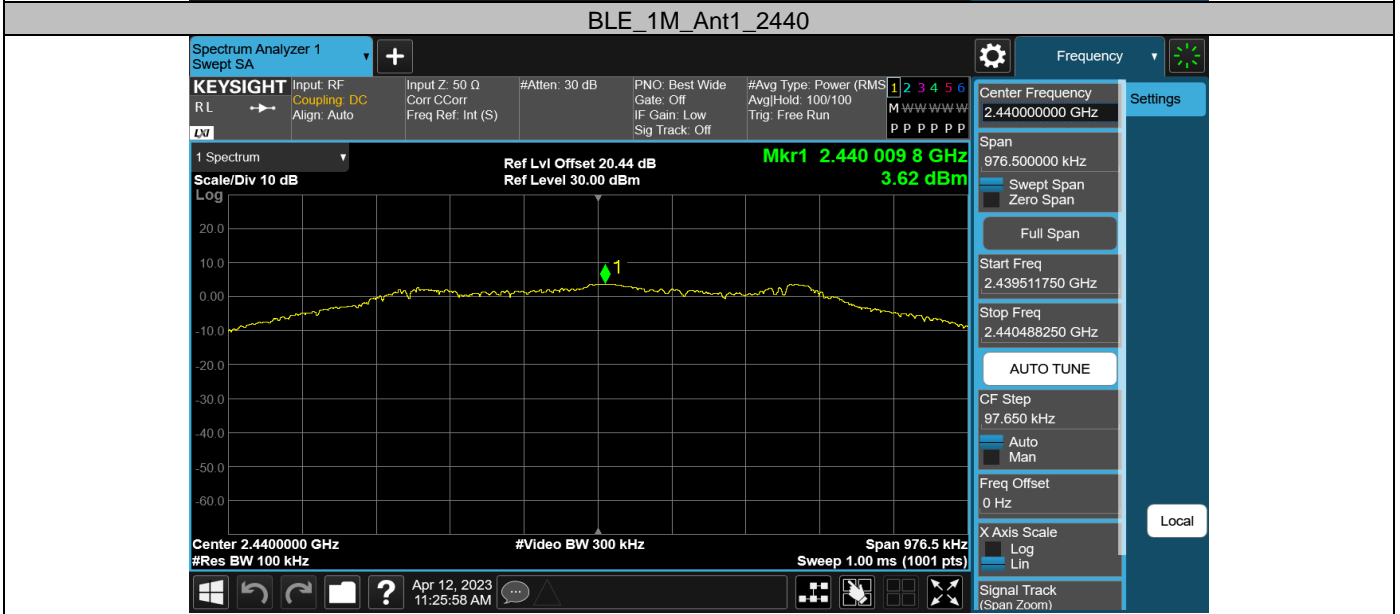
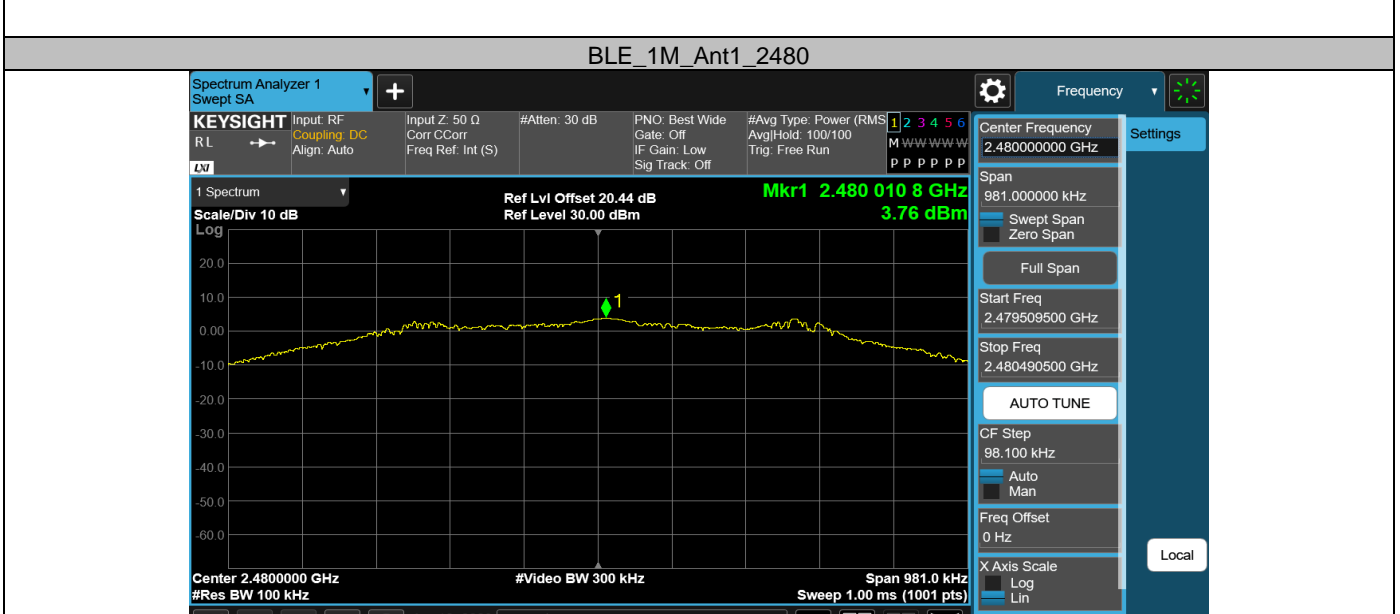
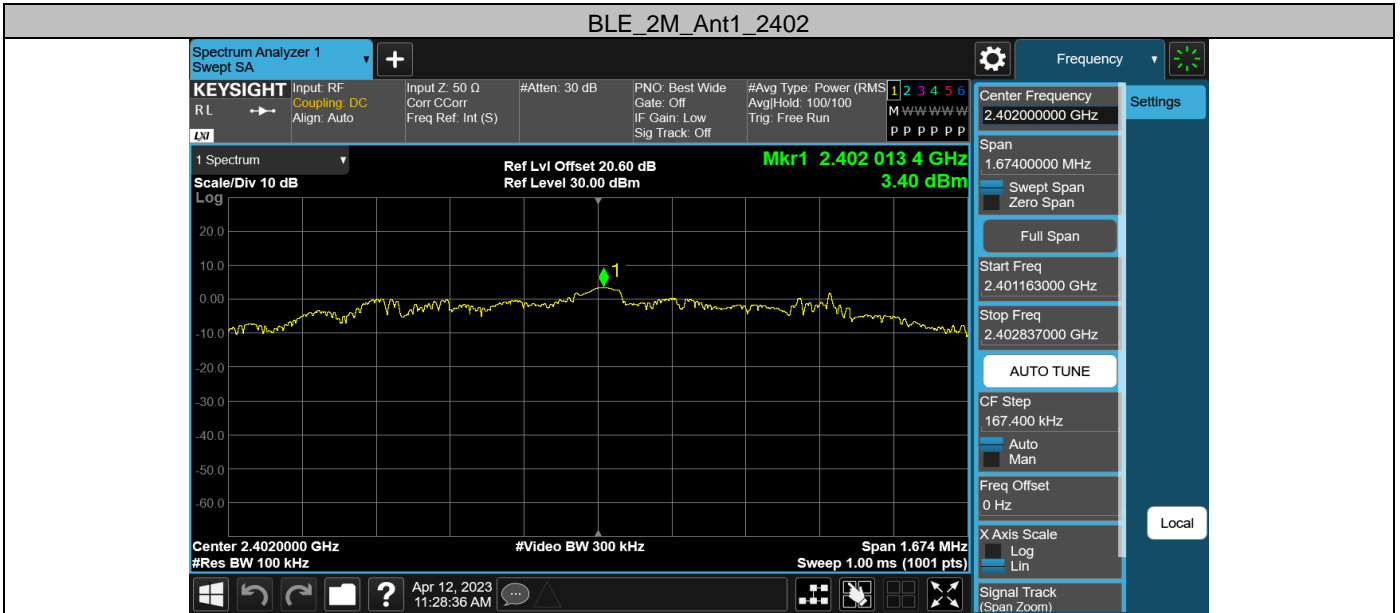
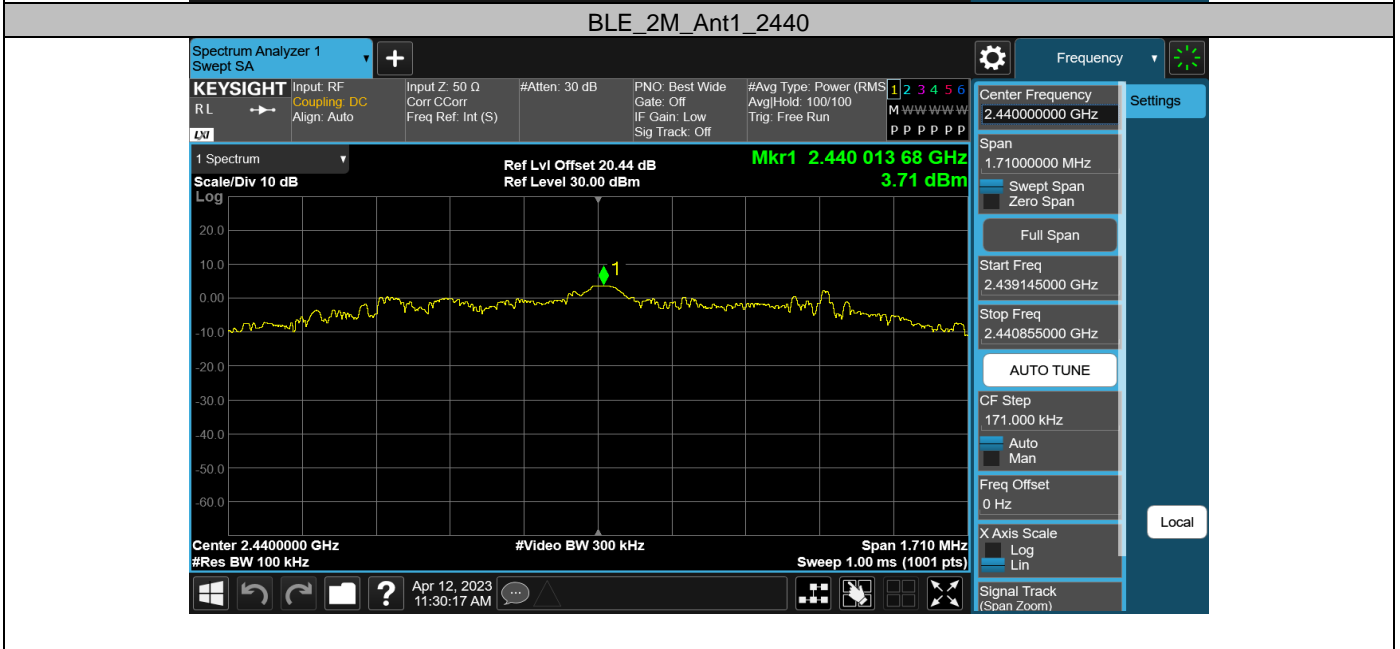
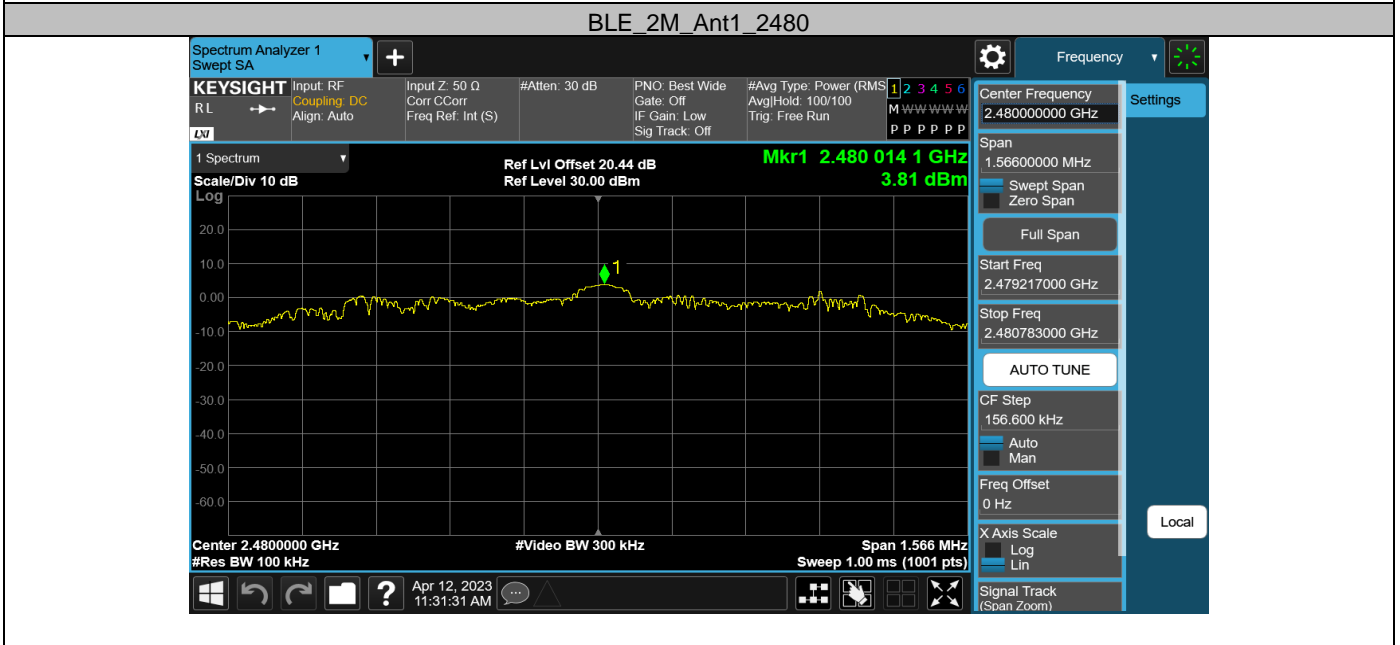
Test Graphs

Test Mode	Antenna	Freq(MHz)	Max.Point[MHz]	Result[dBm]
BLE_1M	Ant1	2402	2402.01	3.41
		2440	2440.01	3.62
		2480	2480.01	3.77
BLE_2M	Ant1	2402	2402.01	3.40
		2440	2440.01	3.71
		2480	2480.01	3.81

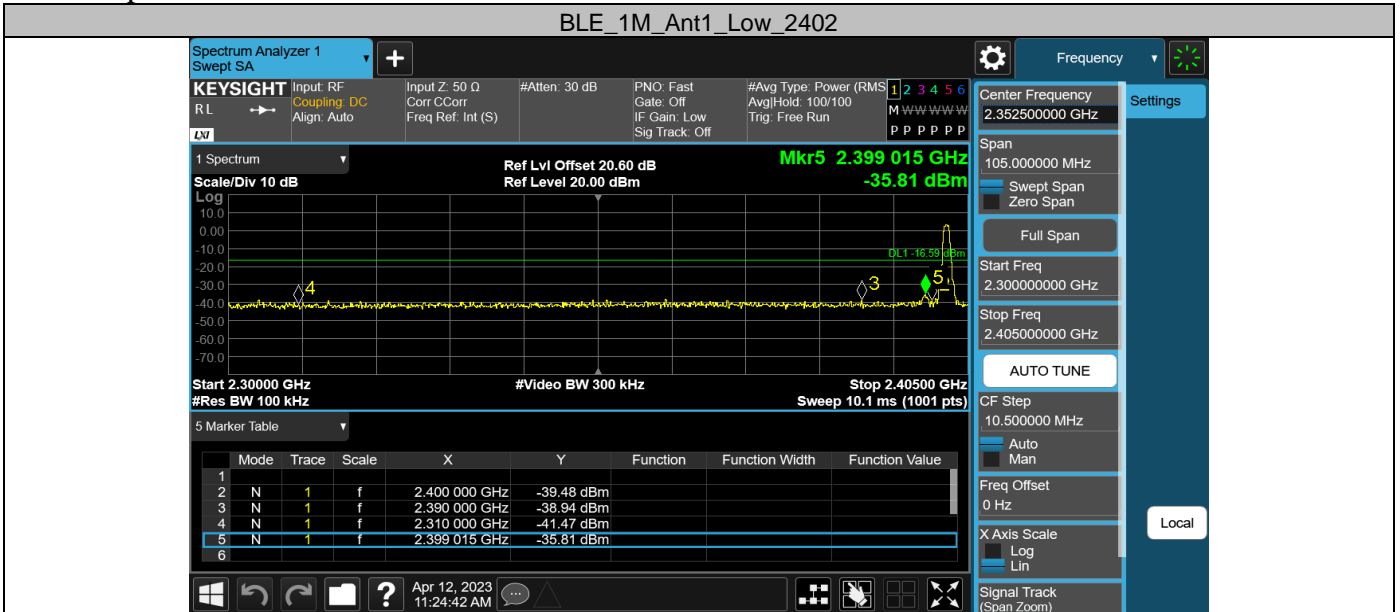
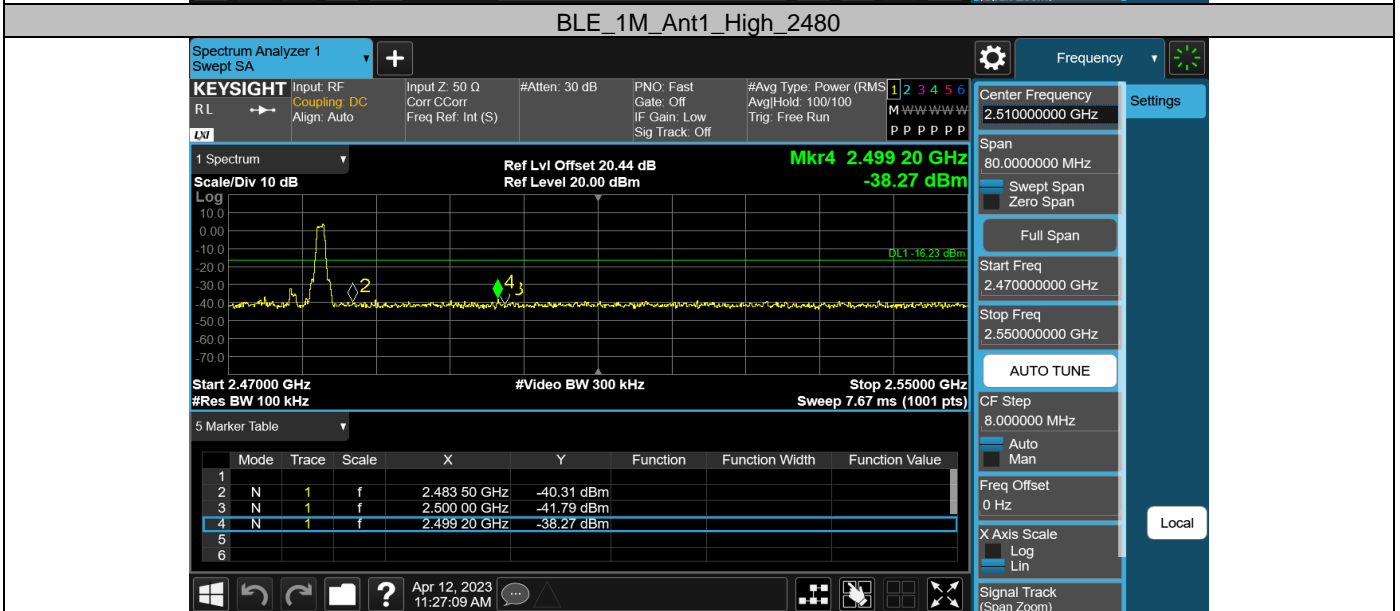
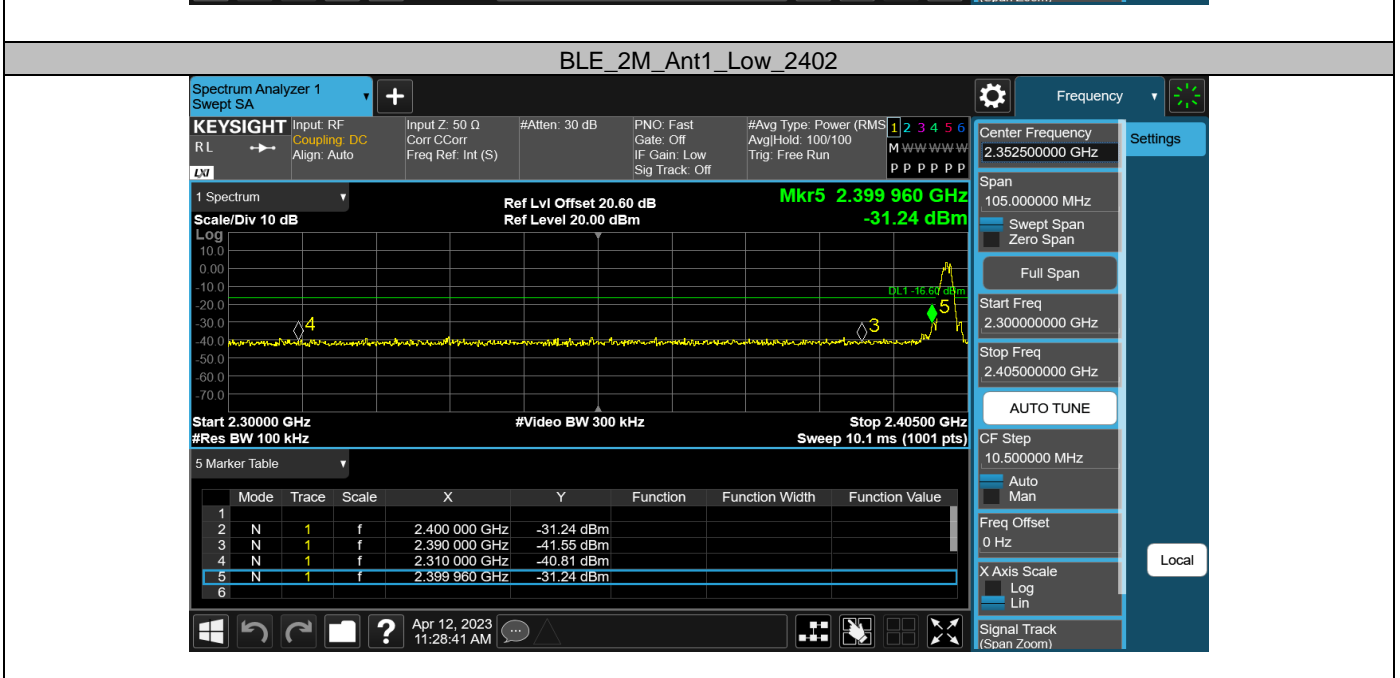
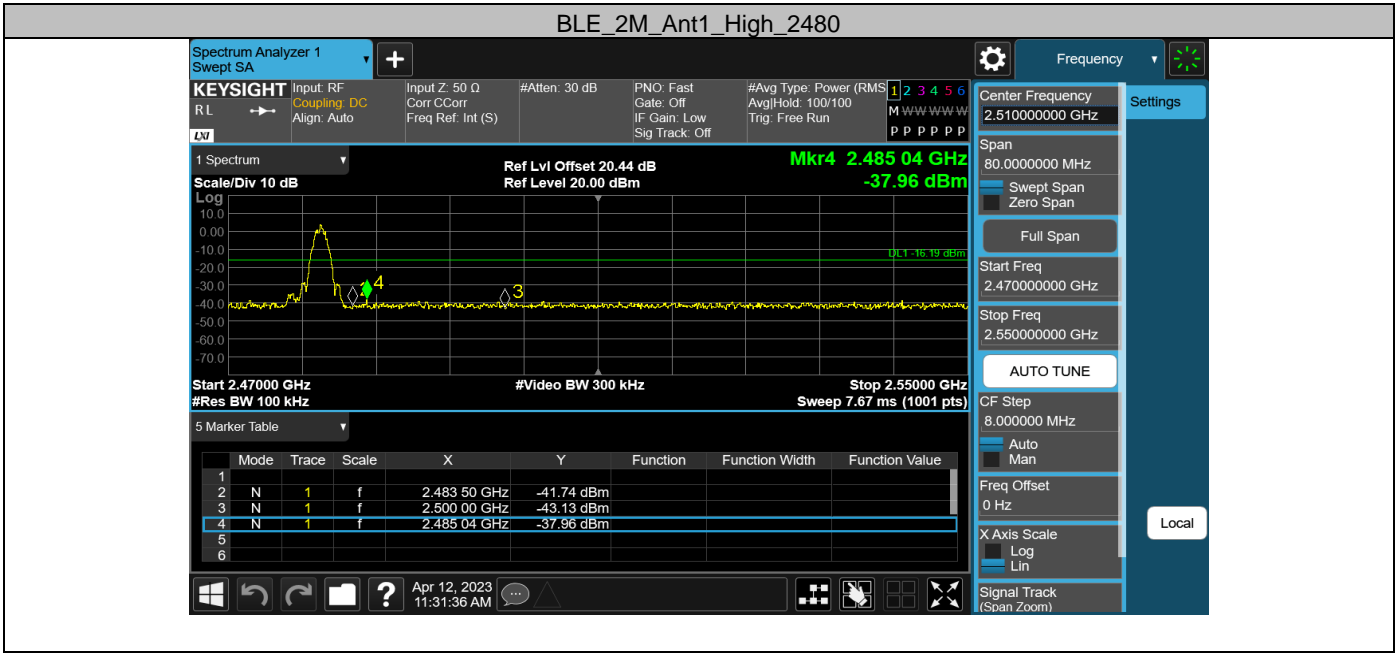
Test Graphs

Test Mode	Antenna	Ch Name	Frequency [MHz]	Ref Level [dBm]	Result [dBm]	Limit [dBm]	Verdict
BLE_1M	Ant1	Low	2402	3.41	-35.81	≤-16.59	PASS
		High	2480	3.77	-38.28	≤-16.23	PASS
BLE_2M	Ant1	Low	2402	3.40	-31.24	≤-16.6	PASS
		High	2480	3.81	-37.96	≤-16.19	PASS

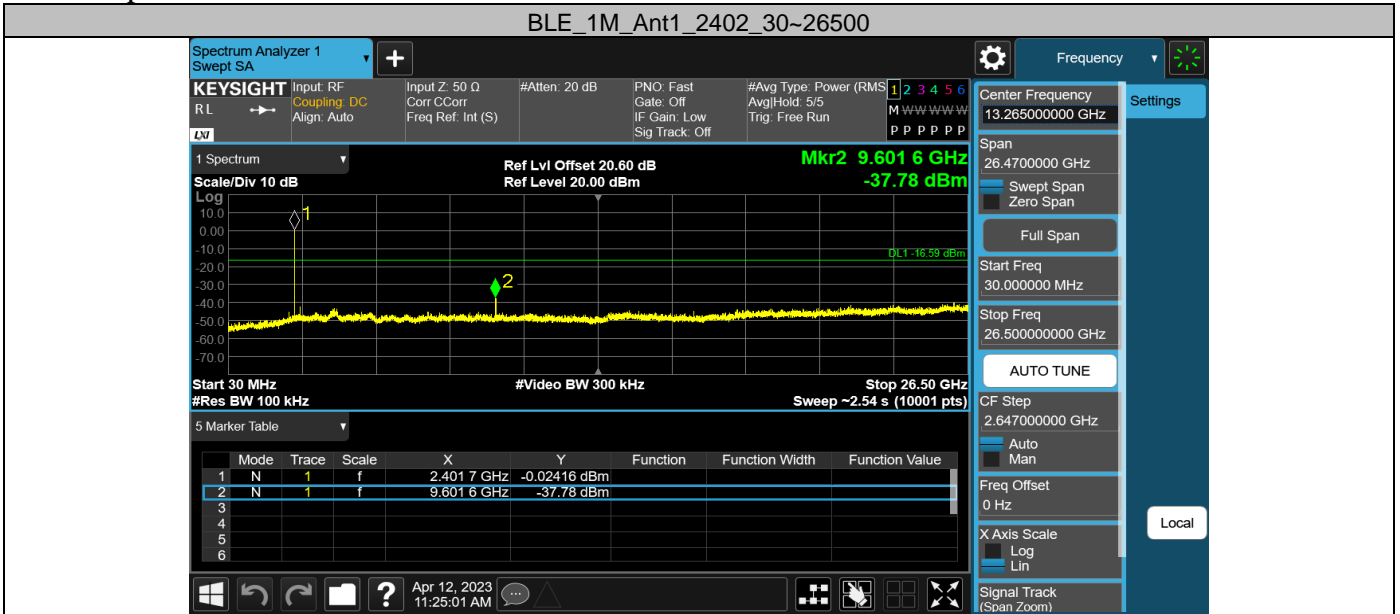
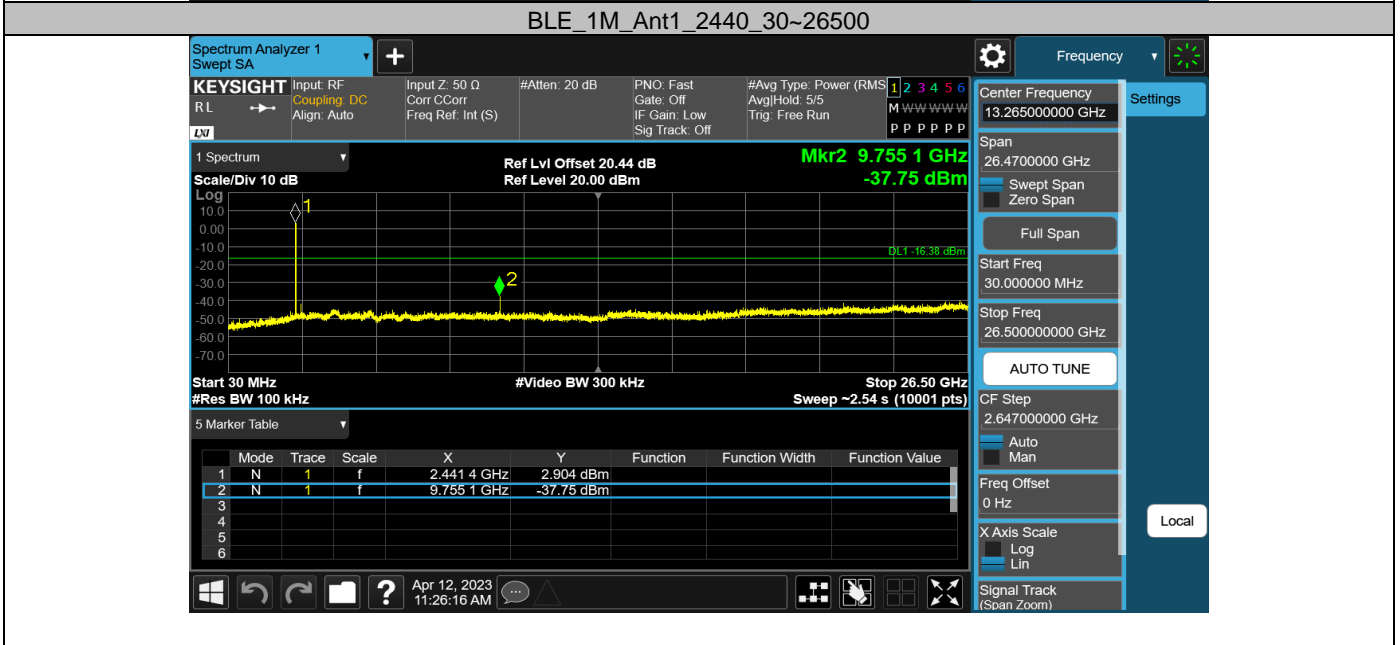
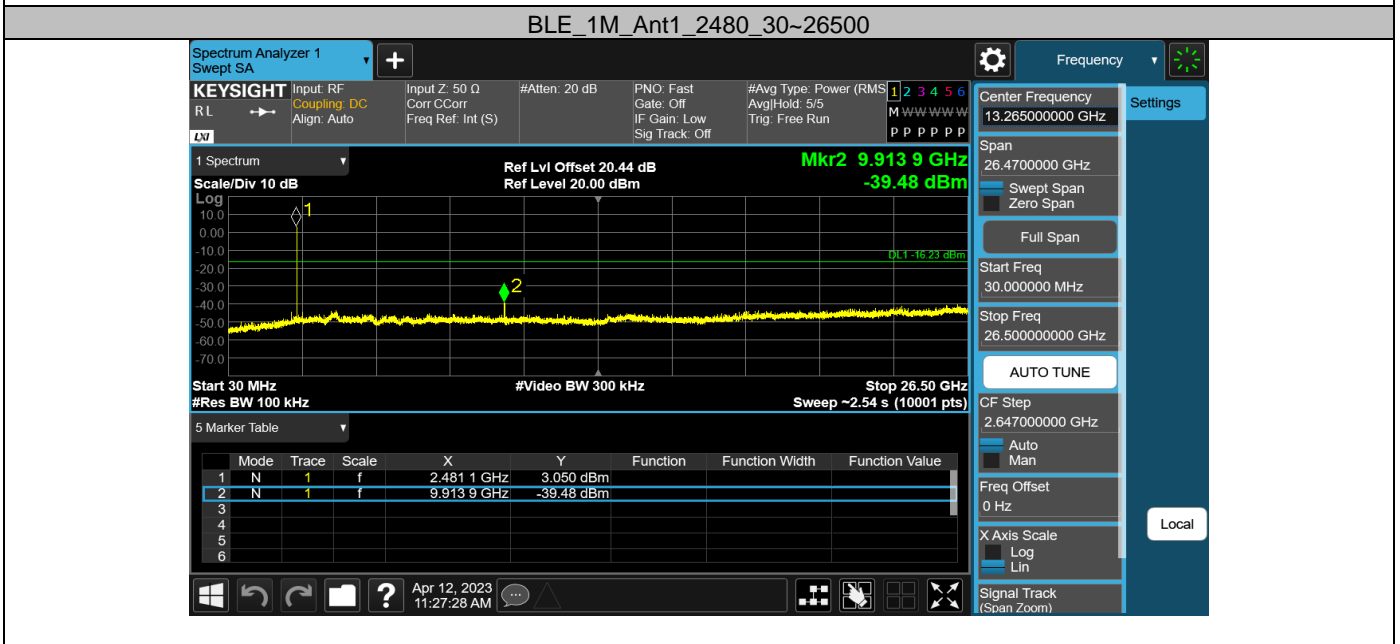
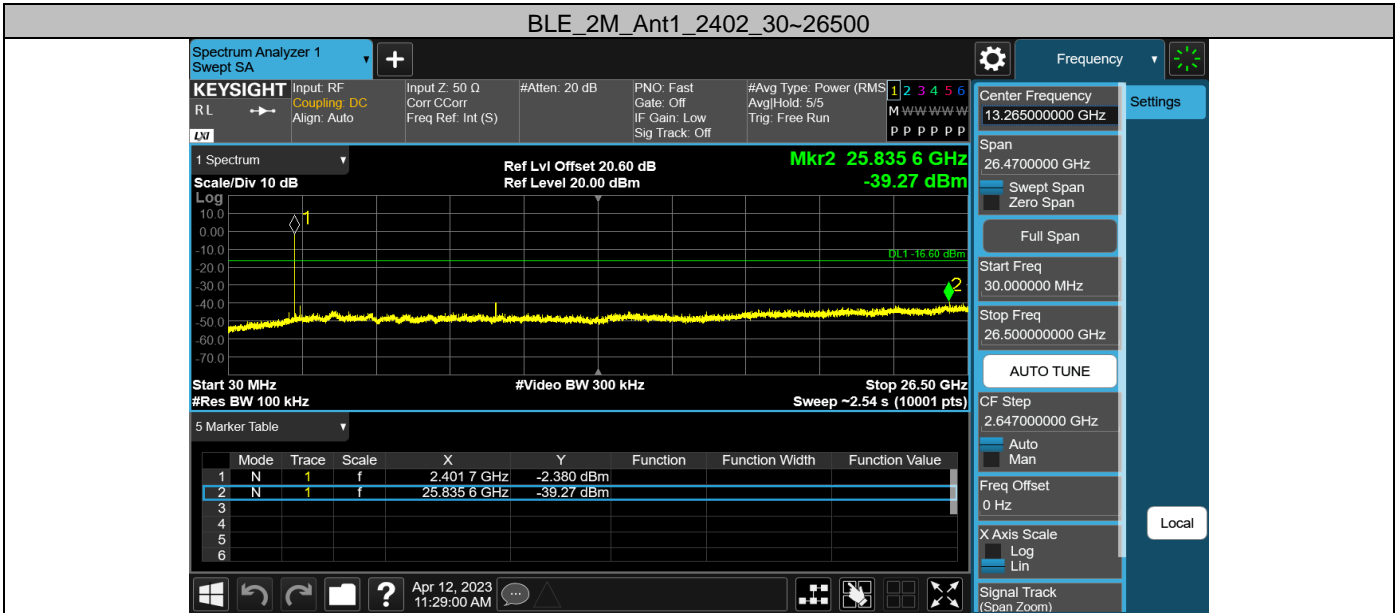
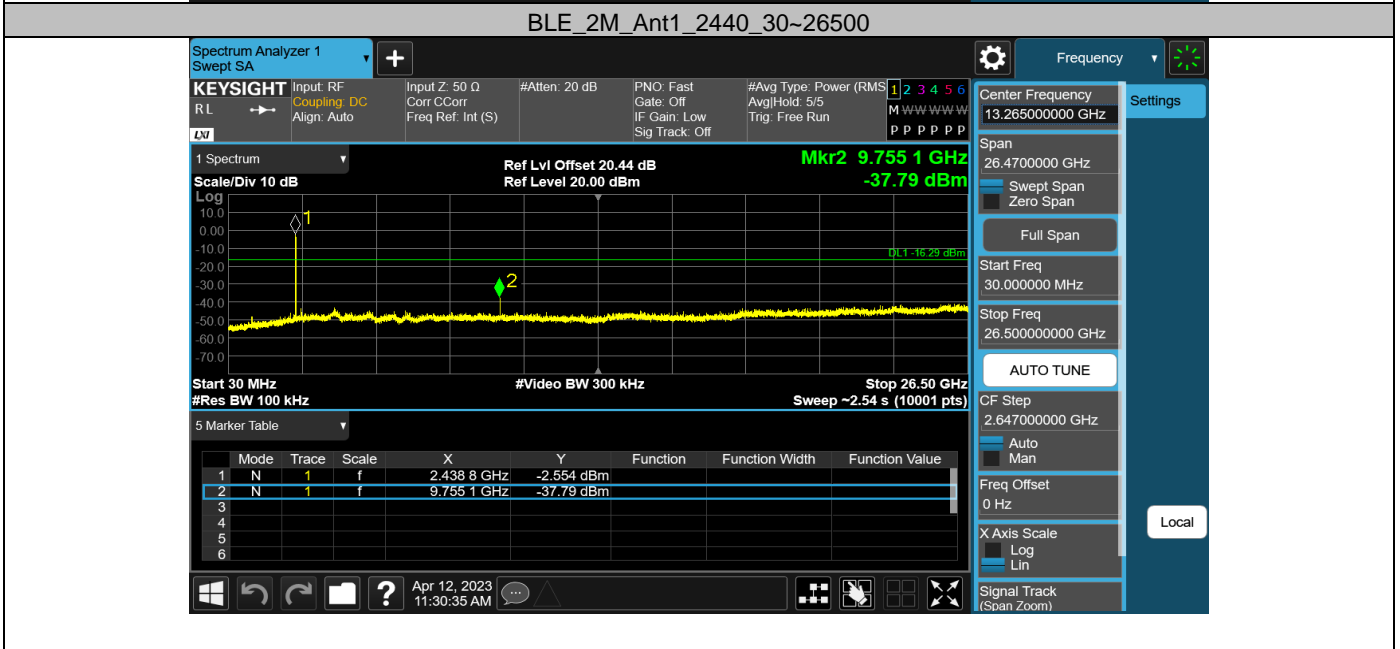
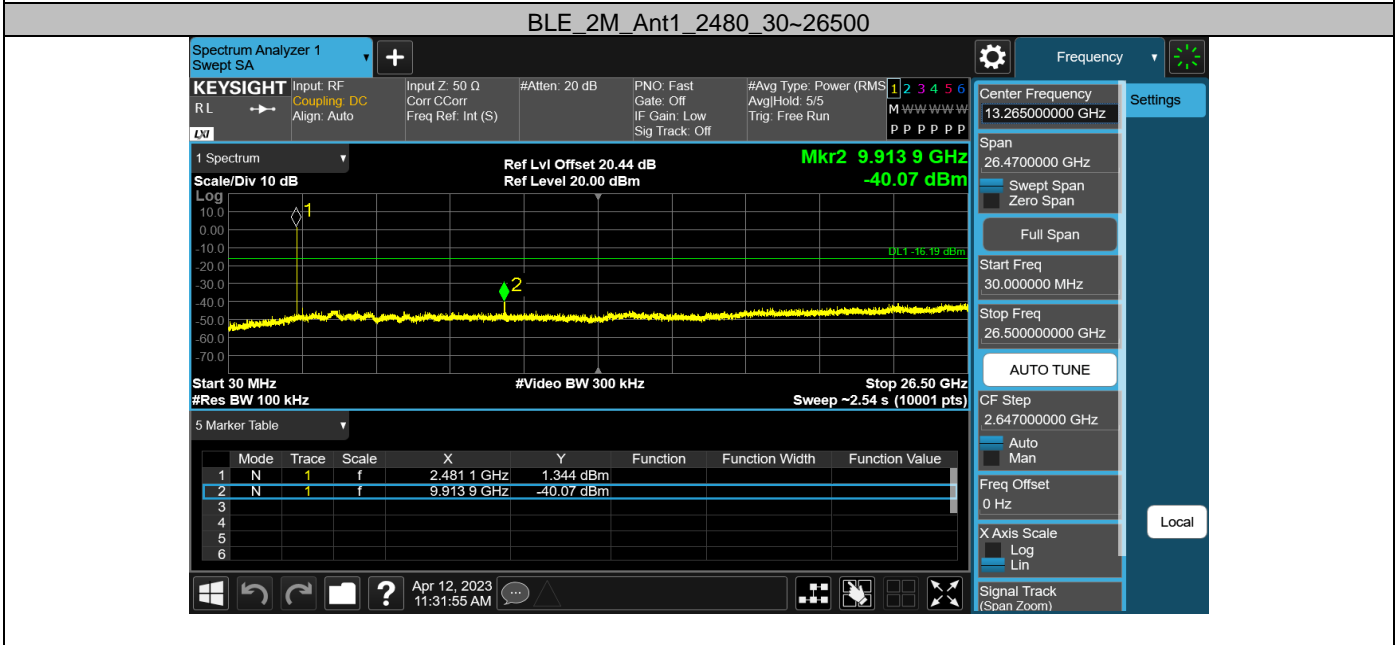
Test Graphs

Test Mode	Antenna	Frequency[MHz]	Freq Range [MHz]	Ref Level [dBm]	Result [dBm]	Limit[dBm]	Verdict
BLE_1M	Ant1	2402	30~26500	3.41	-37.78	≤-16.59	PASS
		2440	30~26500	3.62	-37.75	≤-16.38	PASS
		2480	30~26500	3.77	-39.48	≤-16.23	PASS
BLE_2M	Ant1	2402	30~26500	3.40	-39.27	≤-16.6	PASS
		2440	30~26500	3.71	-37.79	≤-16.29	PASS
		2480	30~26500	3.81	-40.07	≤-16.19	PASS

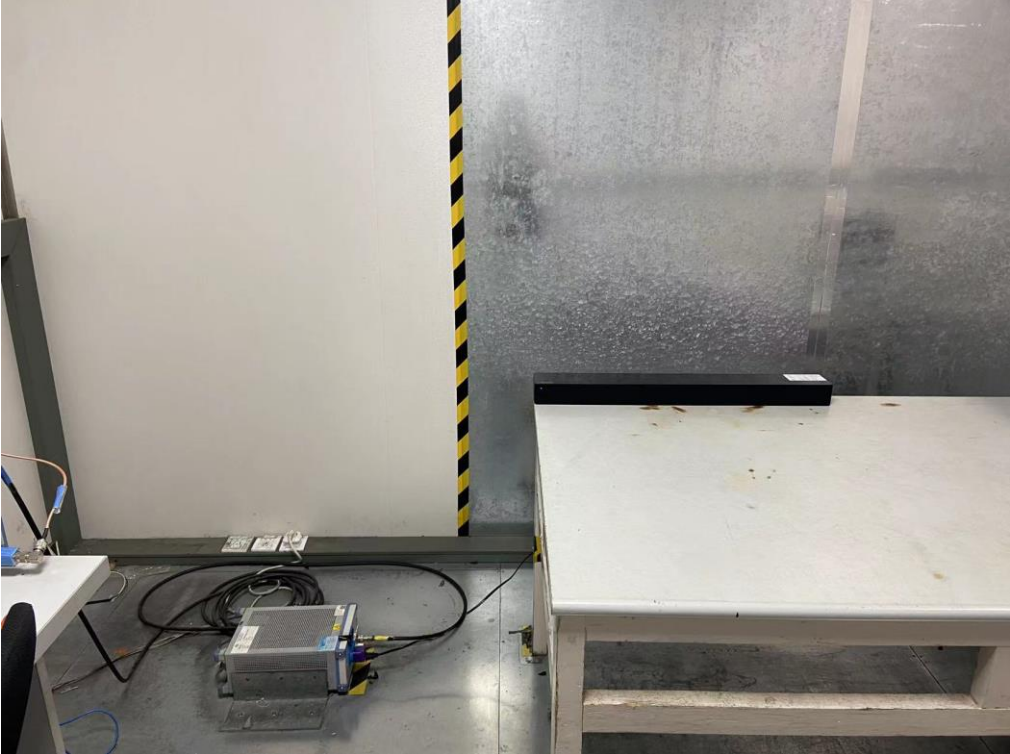
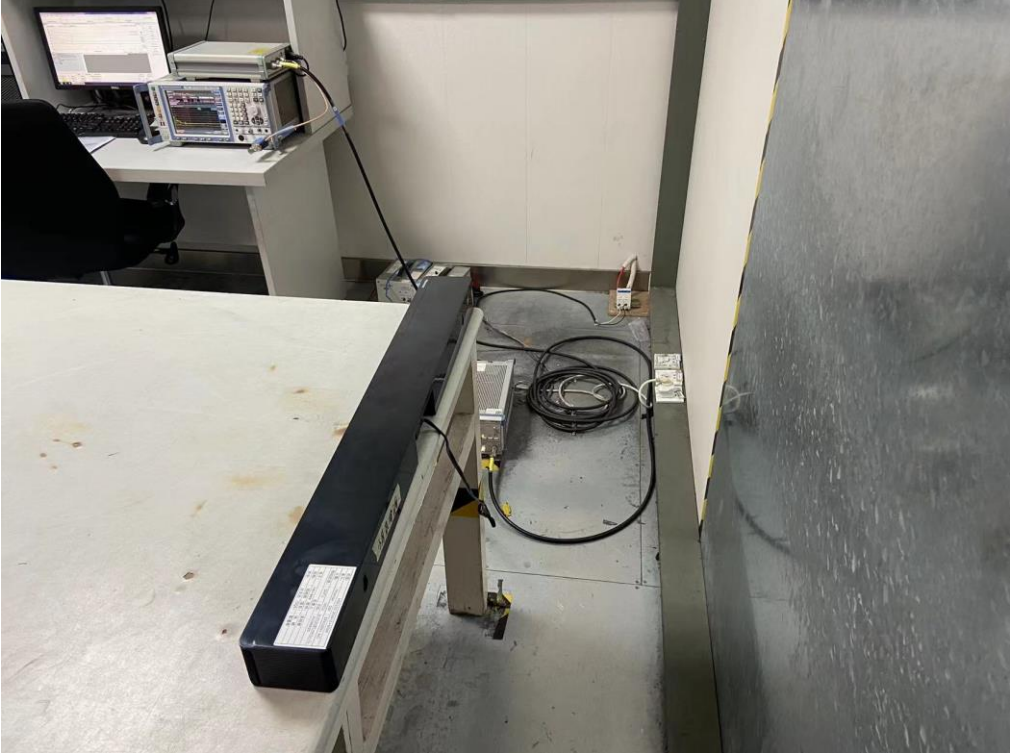
Conducted Test

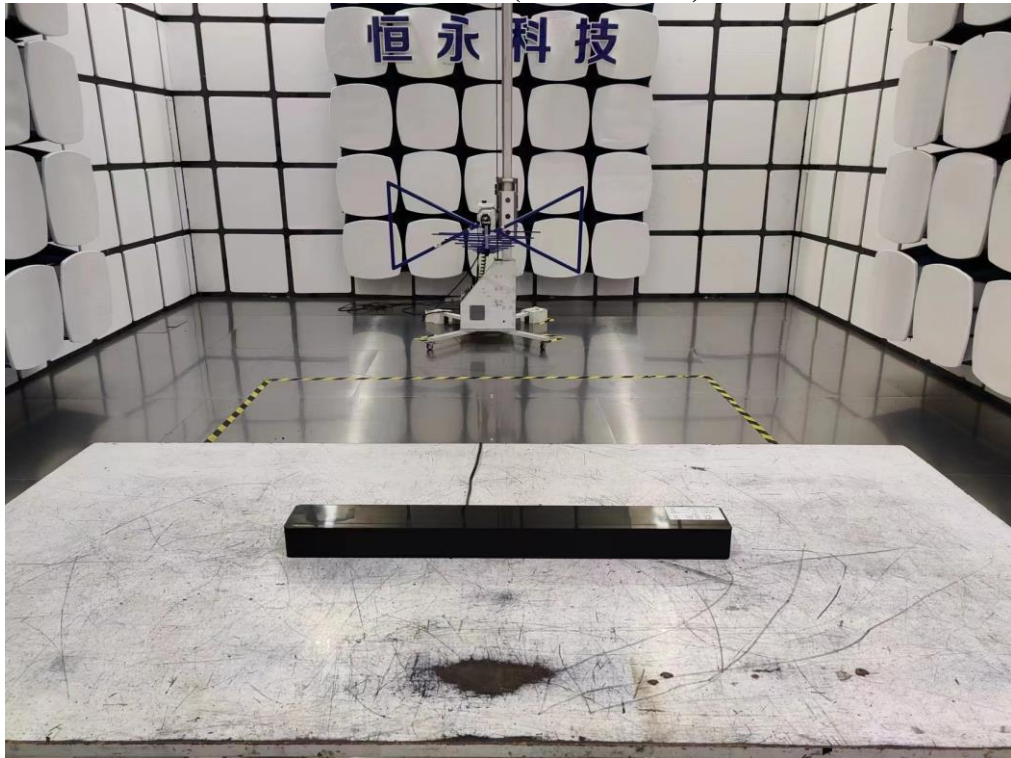
Radiated Test (Below 1GHz)

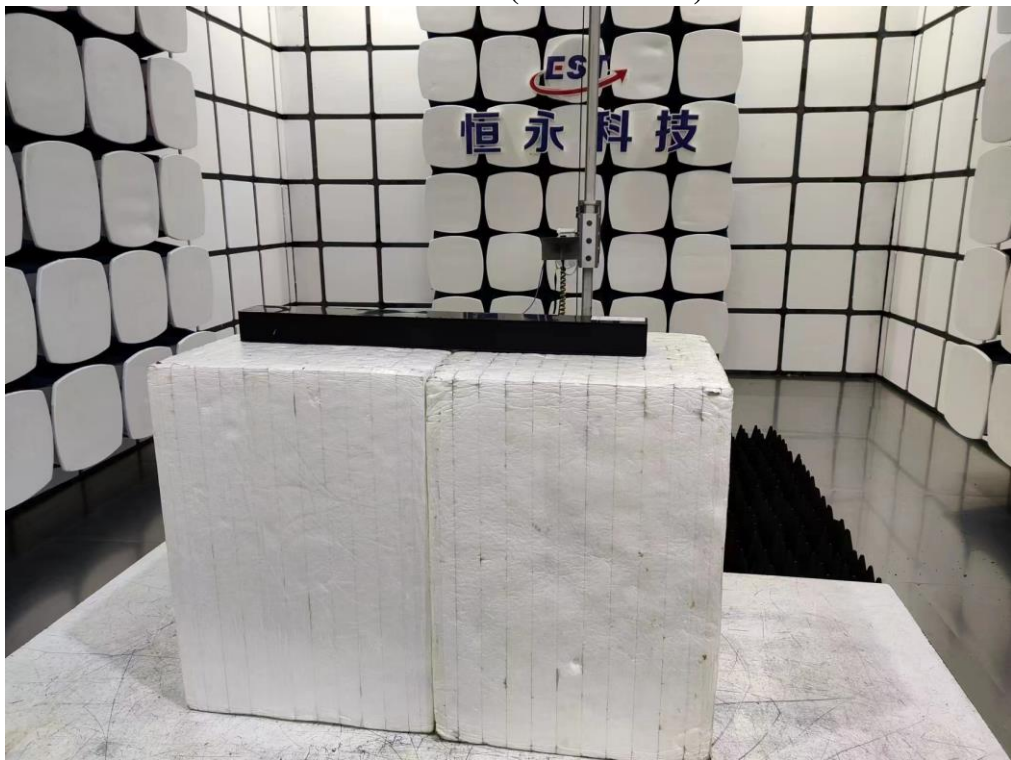
Radiated Test (Above 1GHz)
