Prüfbericht - Nr.: 15045012 001
Test Report No.:

7. Photographs of the Test Setup

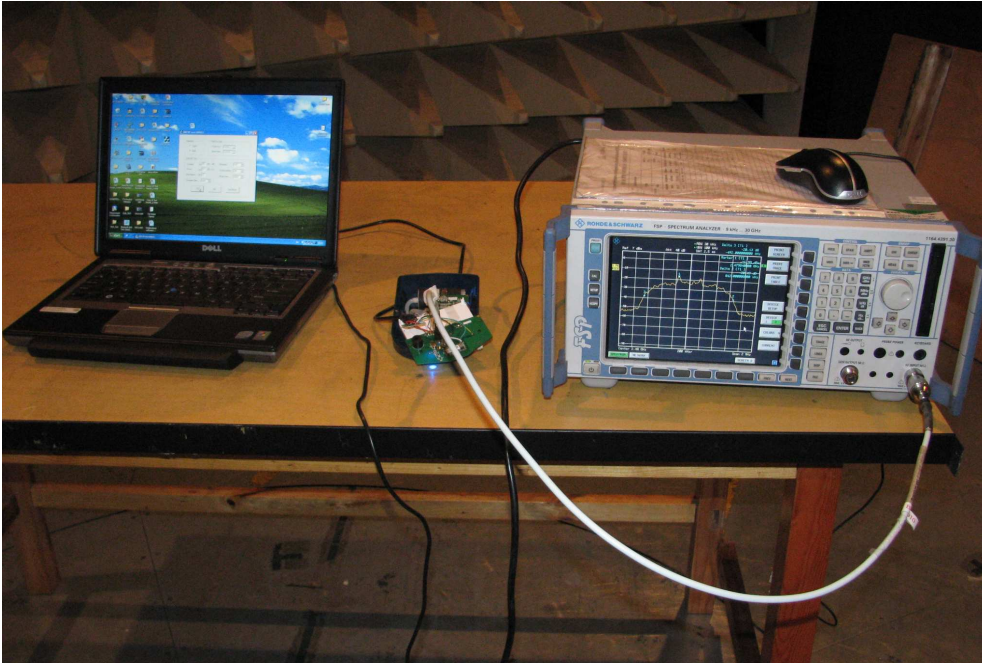
Photograph 1: Set-up for Conducted Emissions at Antenna Port

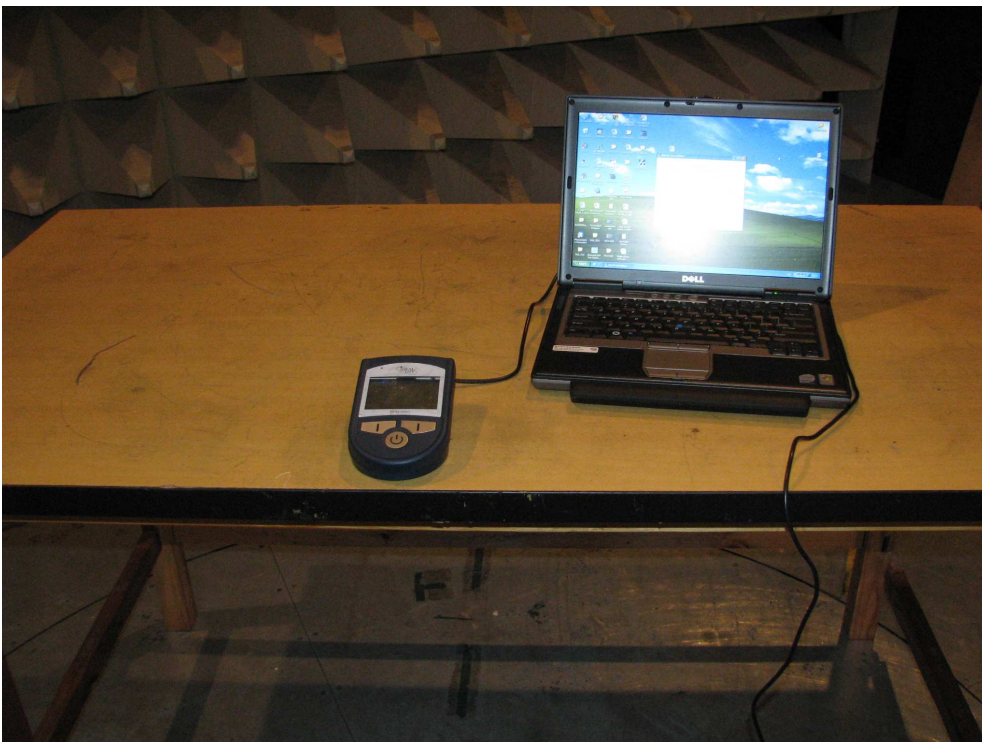
Photograph 2: Maximum emission orientation of the sample on the table

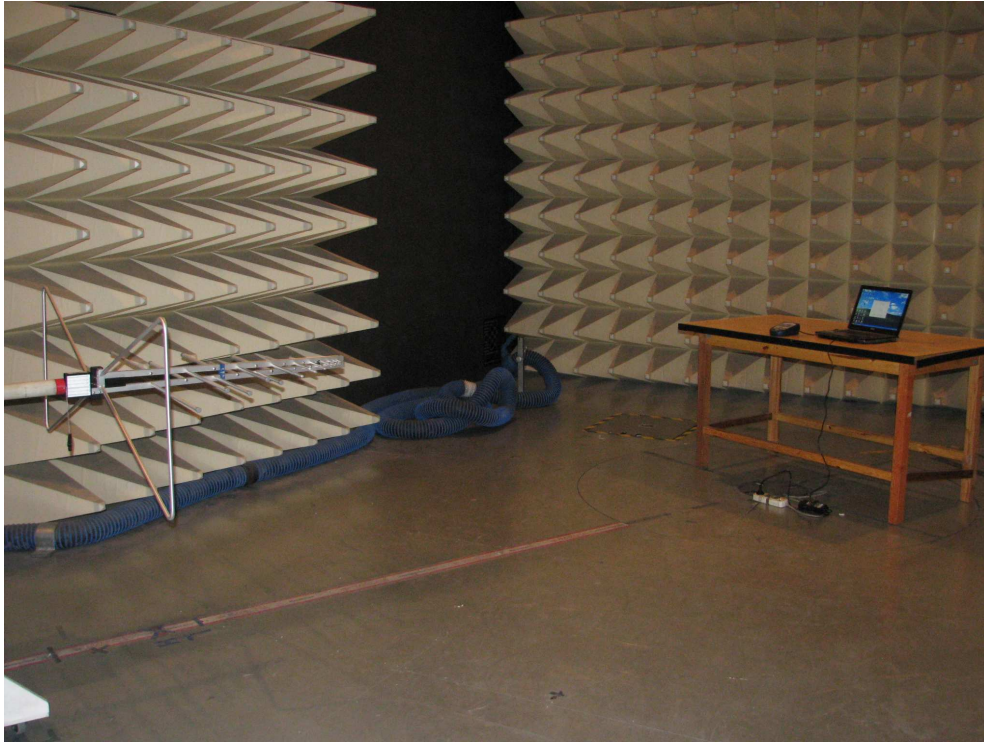
Photograph 3: Set-up for Set-up for Radiated Emission, 30MHz-1000MHz

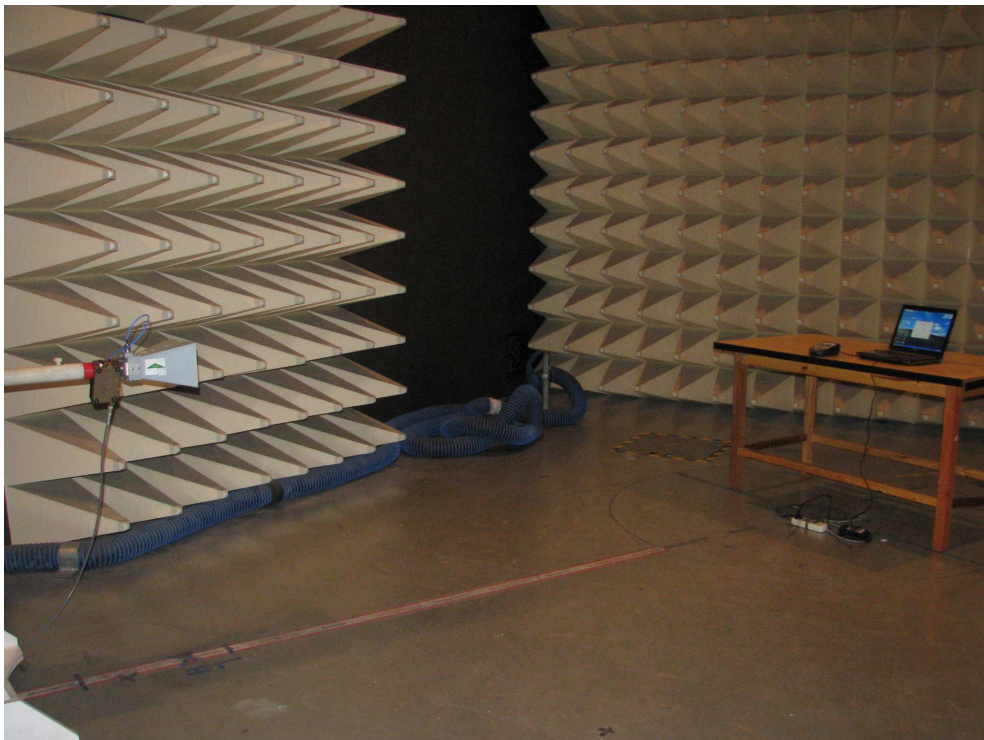
Photograph 4: Set-up for Radiated Emission, 1G-18GHz
