# **MICROWAVE PATH SURVEY REPORT**

## **RADIO FREQUENCY INTERFERENCE (RFI) MEASUREMENT REPORT**

**Transmit and Receive Earth Station**

**October 16, 2014**

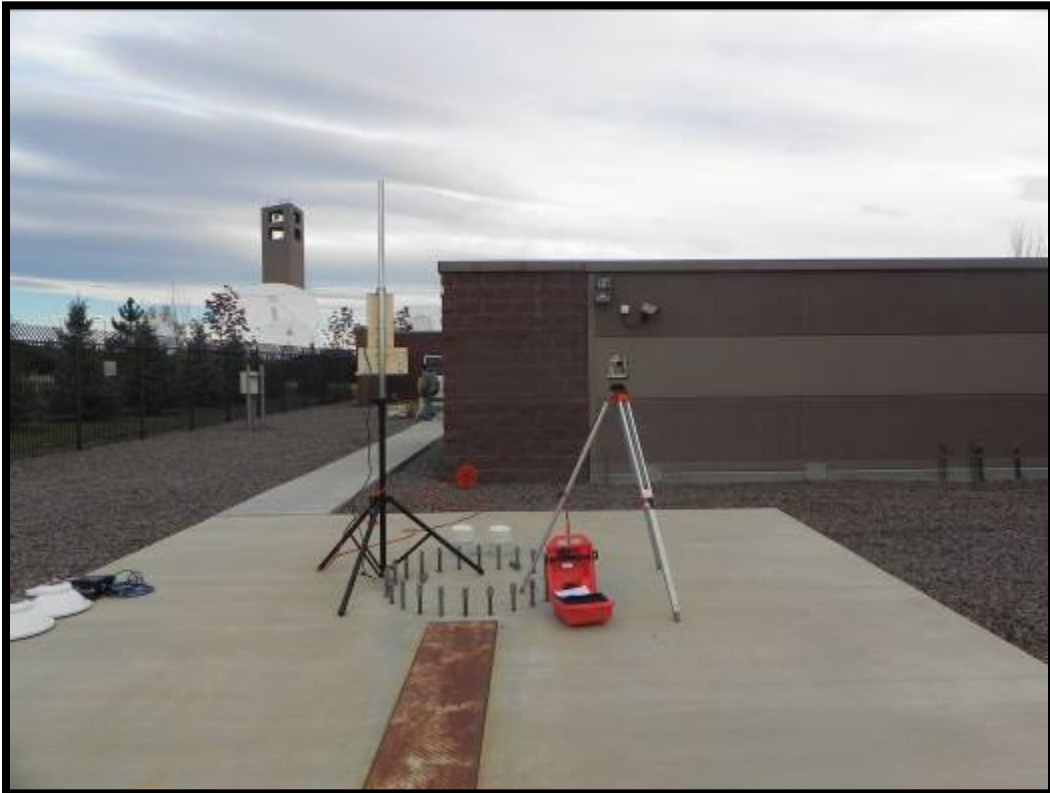
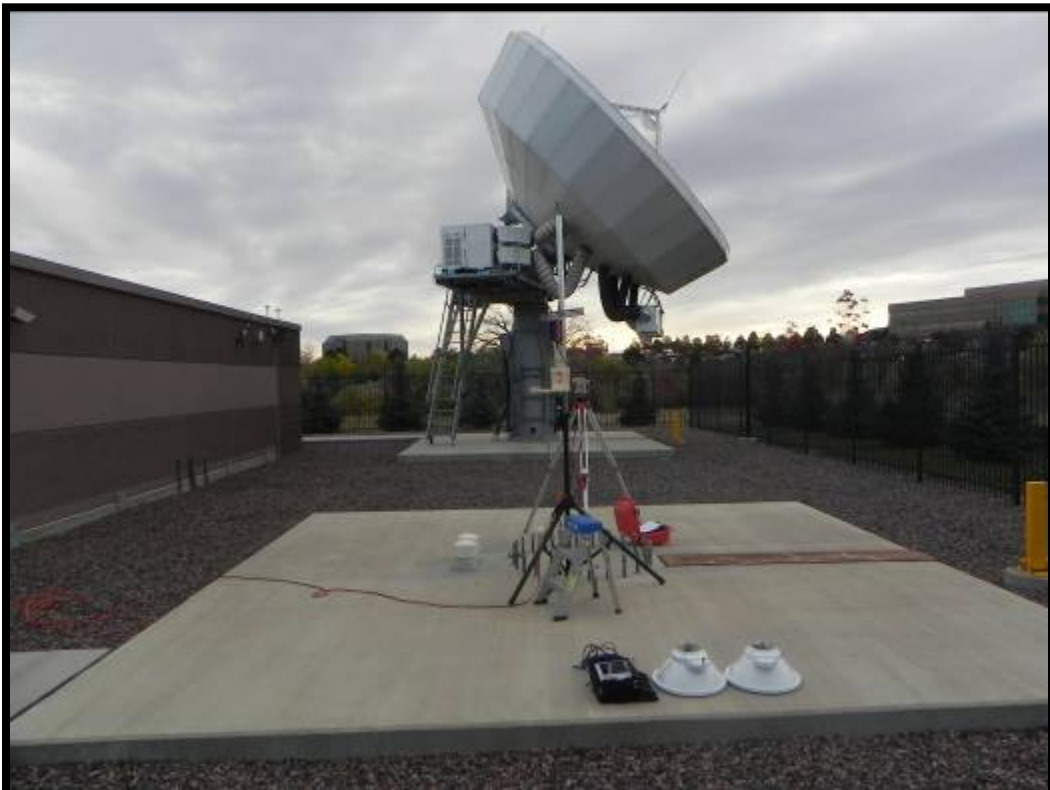
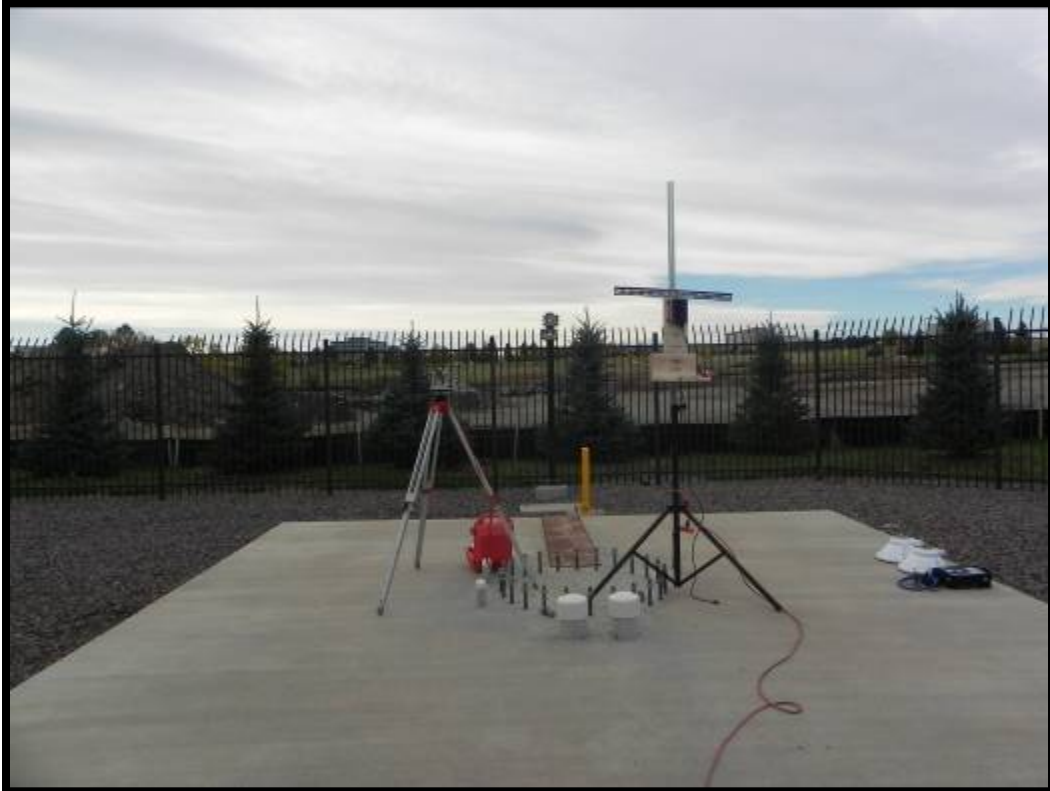
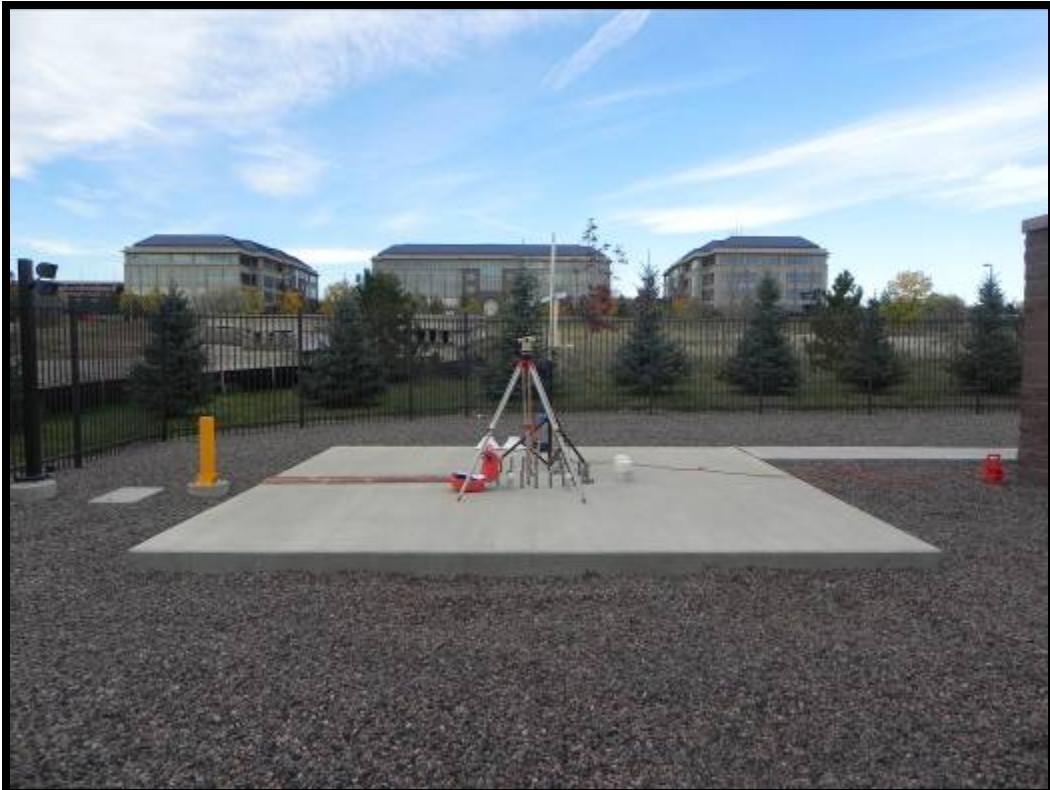
Figure 3.1-1 Earth Station Site Photographs

- Table 3.1-1 presents a site data sheet including all pertinent site information.
- Figures 3.1-1 and 3.1-2 are the photographs depicting the existing earth station site and satellite arc.
- Figures 3.1-3 through 3.1-10 are the RF spectrum photographs depicting the interference environment at the test site.

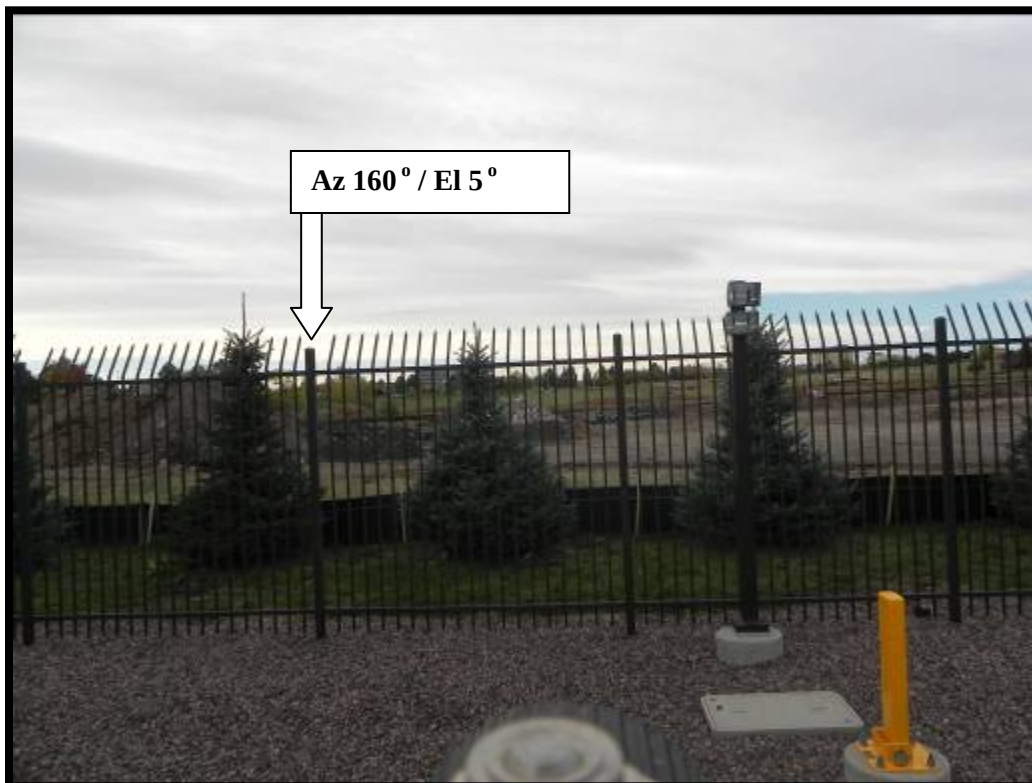
Figure 3.1-2 Horizon Photographs of Earth Station Site

There is no potential satellite arc blockage at this site. Final arc clearance will depend on antenna placement.

The satellite arc has no potential blockage from 55W through 115W.
