RE: E120247 (SES-MOD-20180613-01480) Frequency Coordination Report Pleading

## SUPPLEMENTAL SHOWING PART 101.103(D)

File Number: J1820011 3.70 GHz

KPIX-TV 1, CA

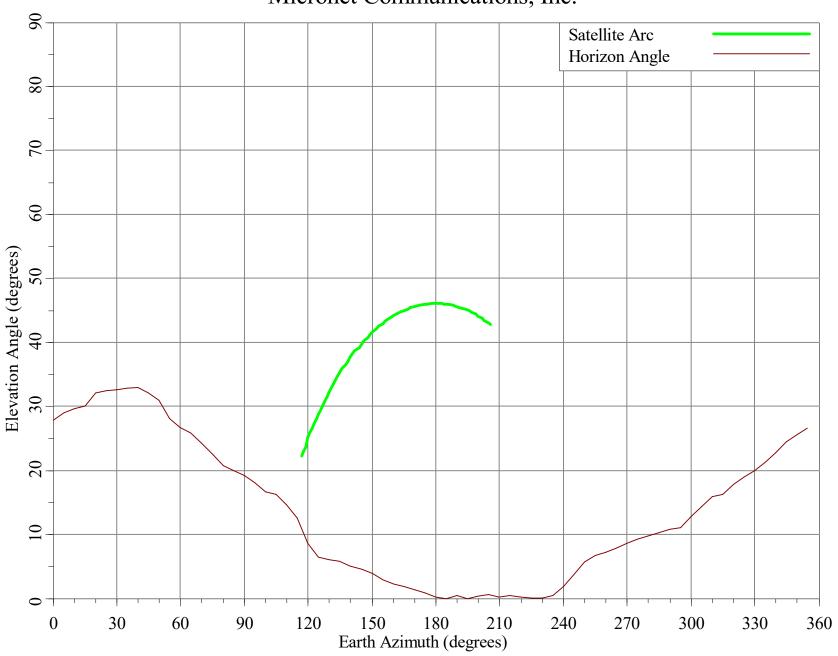
Horizon Angle & Satellite Arc for KPIX-TV 1, CA Micronet Communications, Inc.

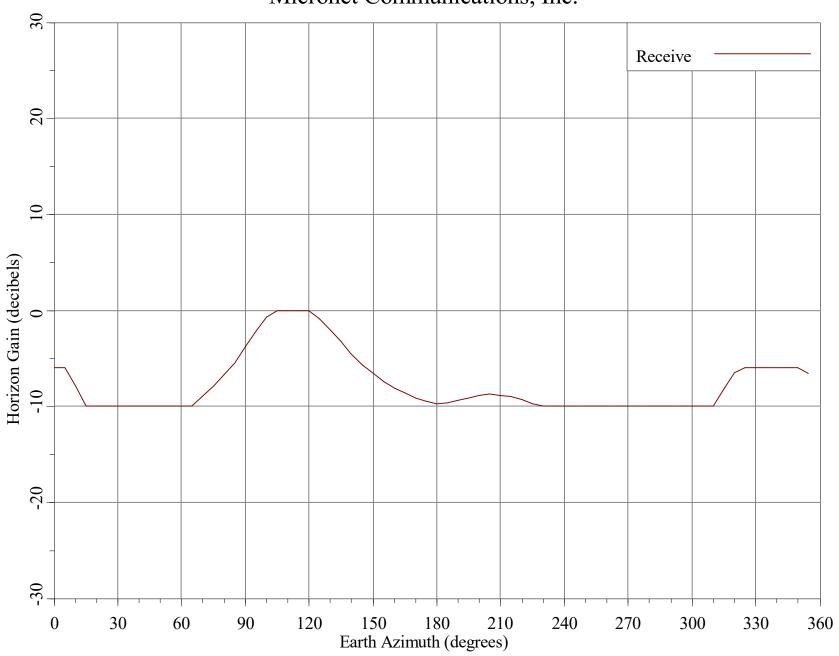
Horizon Gain for KPIX-TV 1, CA Micronet Communications, Inc.

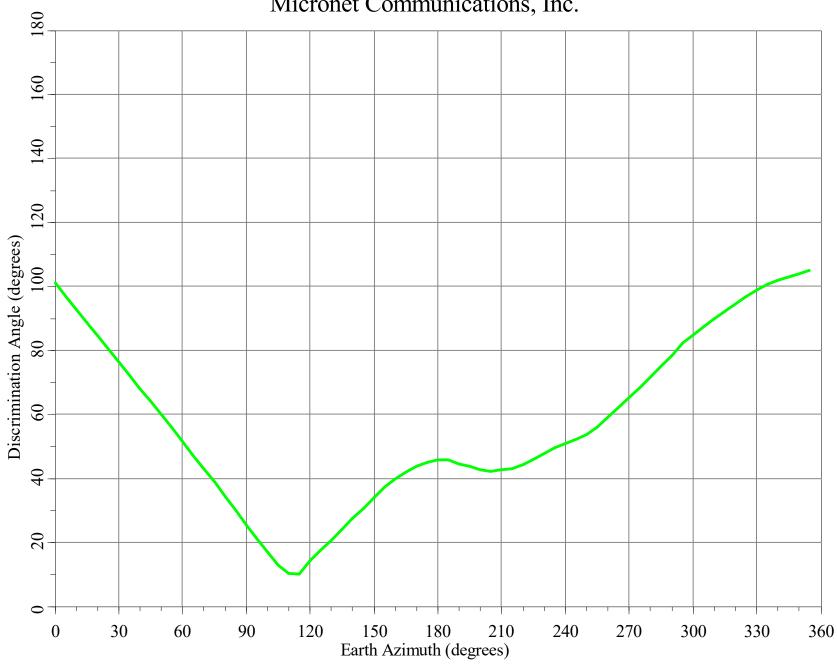
Minimum Discrimination Angles for KPIX-TV 1, CA Micronet Communications, Inc.

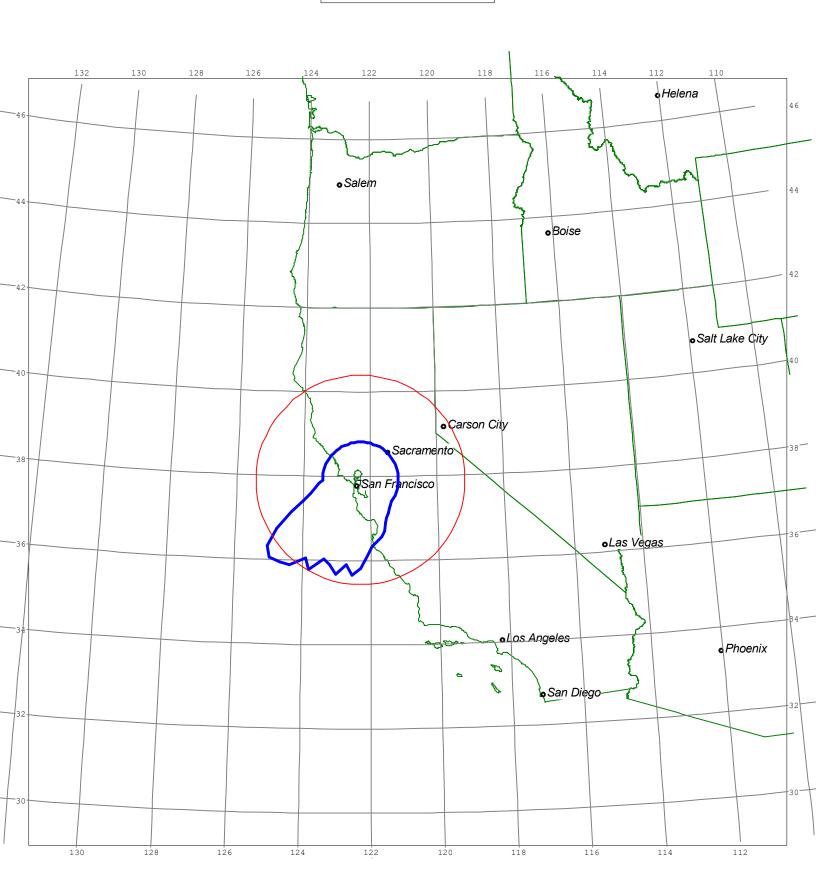
## Final Contour & Rain Scatter for KPIX-TV 1, CA - Receive

Final Contour Rain Scatter
