# **MICROWAVE PATH SURVEY REPORT**

## **RADIO FREQUENCY INTERFERENCE (RFI) MEASUREMENT REPORT**

ViaSat

**Transmit and Receive Earth Station**  
17-21 GHz and 27-31 GHz

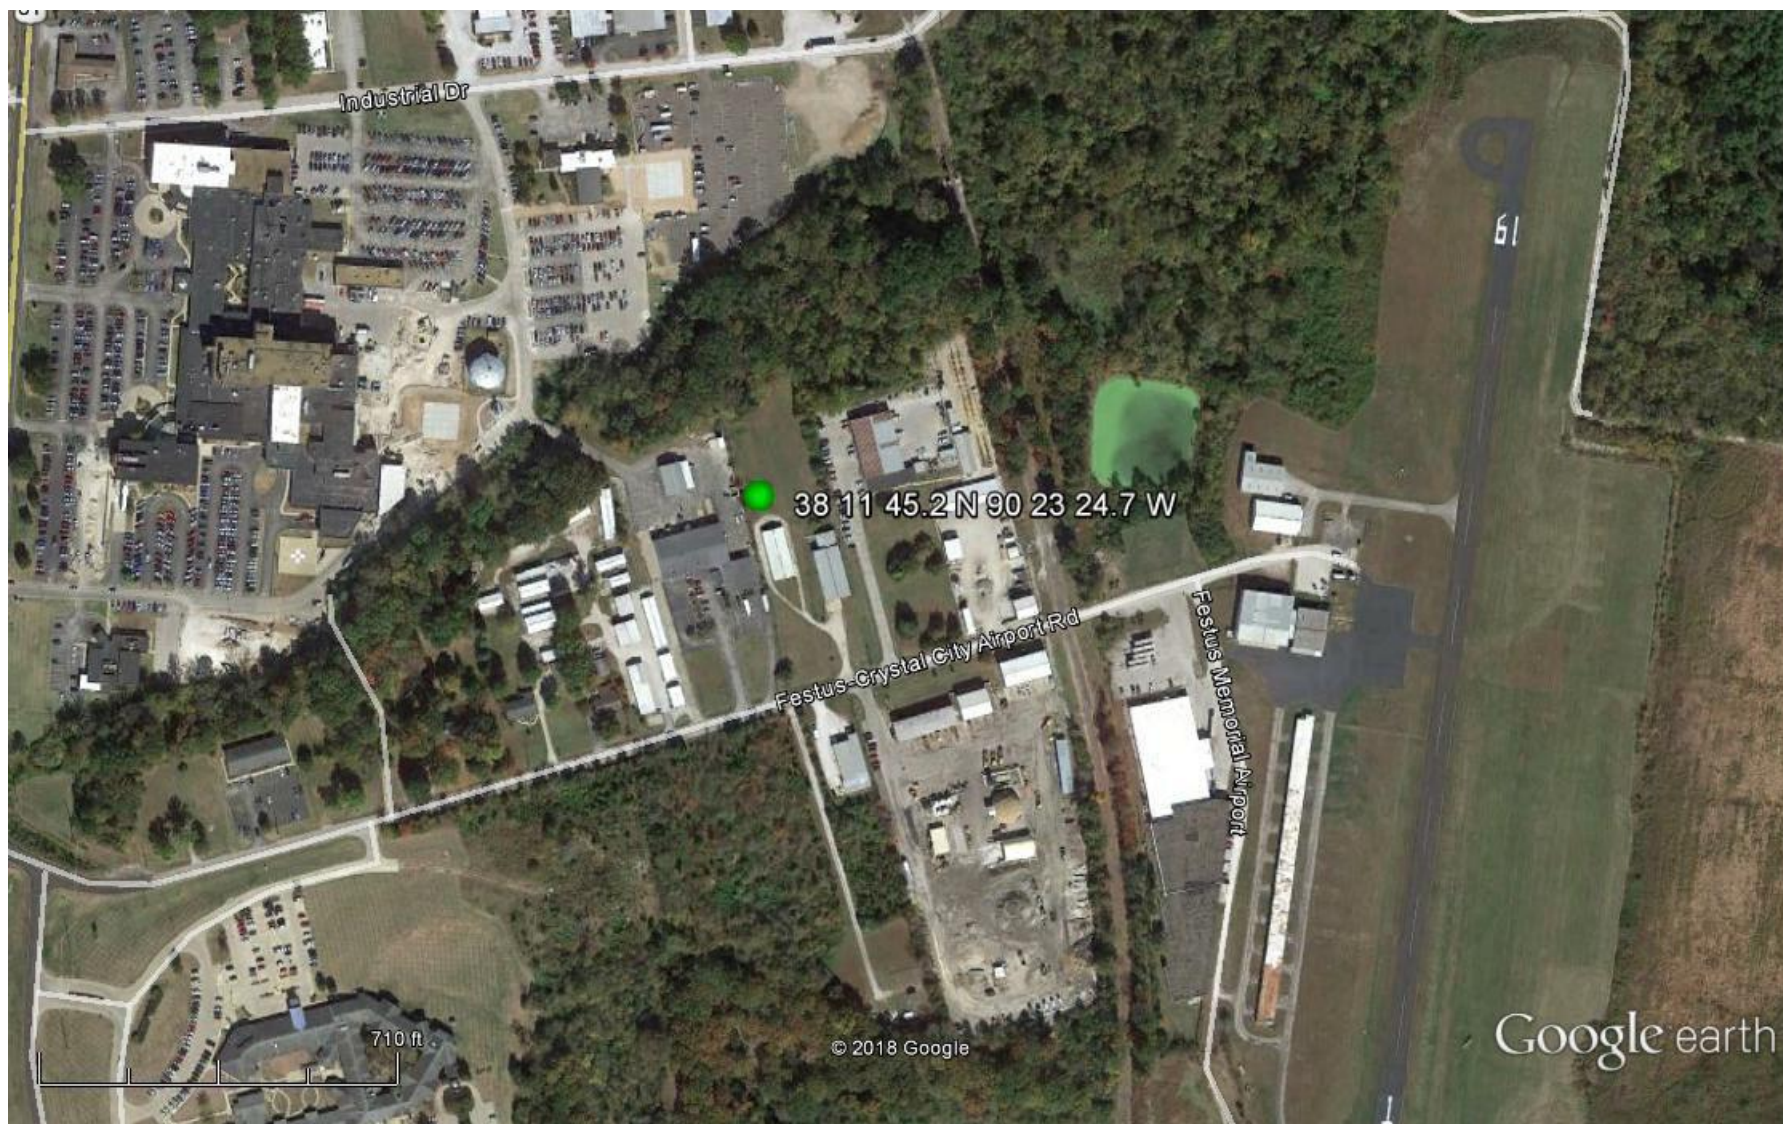
Figure 1.2-2 – Aerial Photograph

The measured site is identified on a portion of a topographic map shown in Figure 1.2-1. An aerial photo of the site location is shown in Figure 1.2-2. A photo of the measurement using a GPS is shown in Figure 1.2-3.

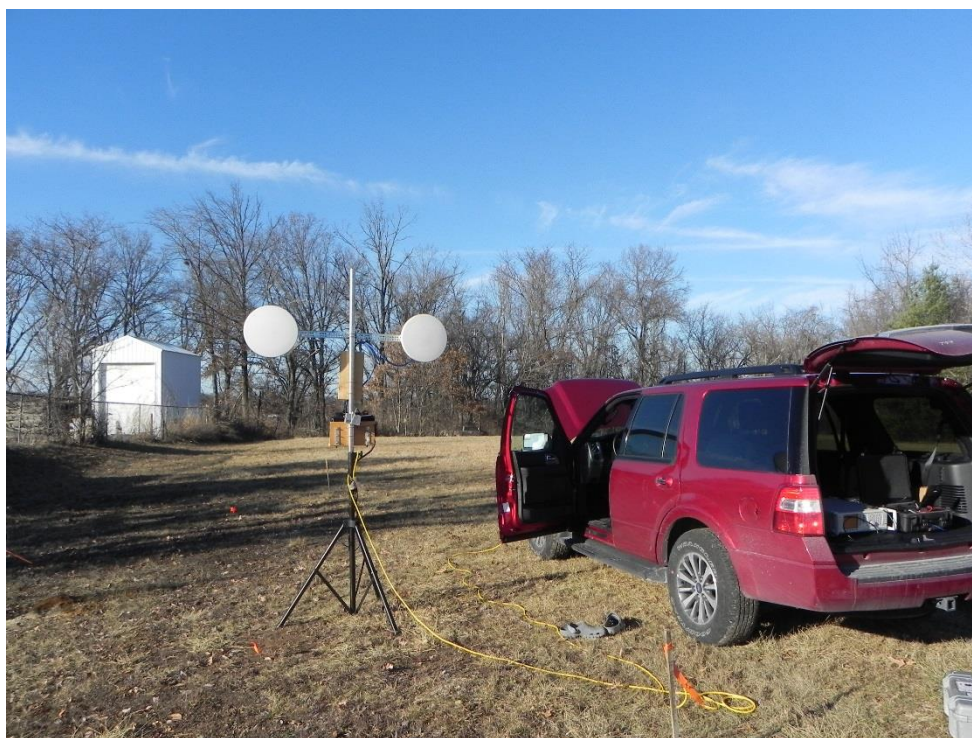
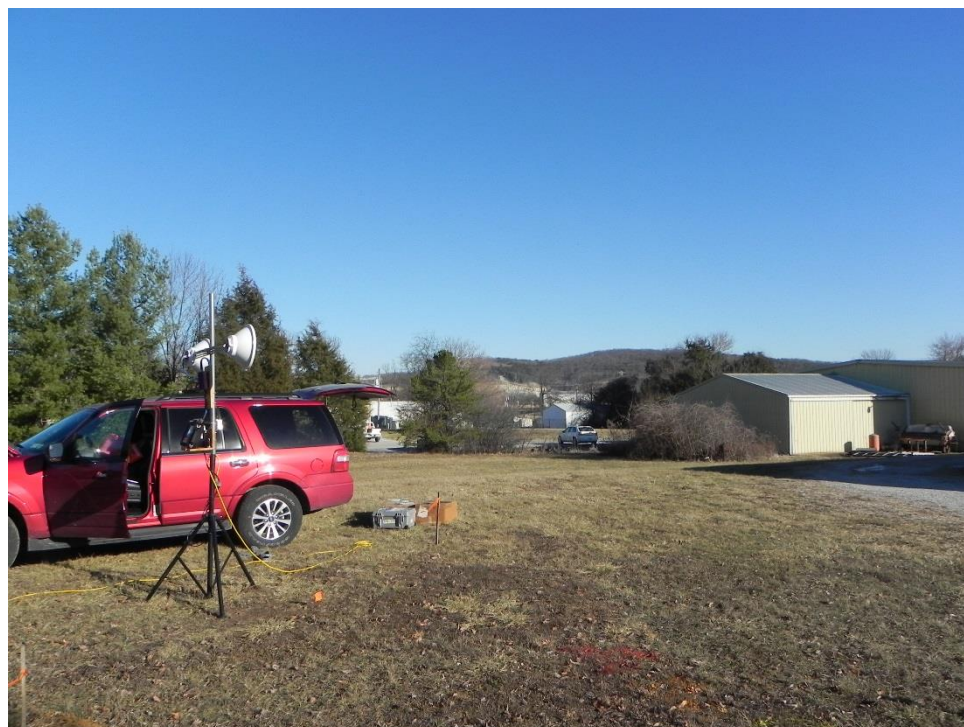
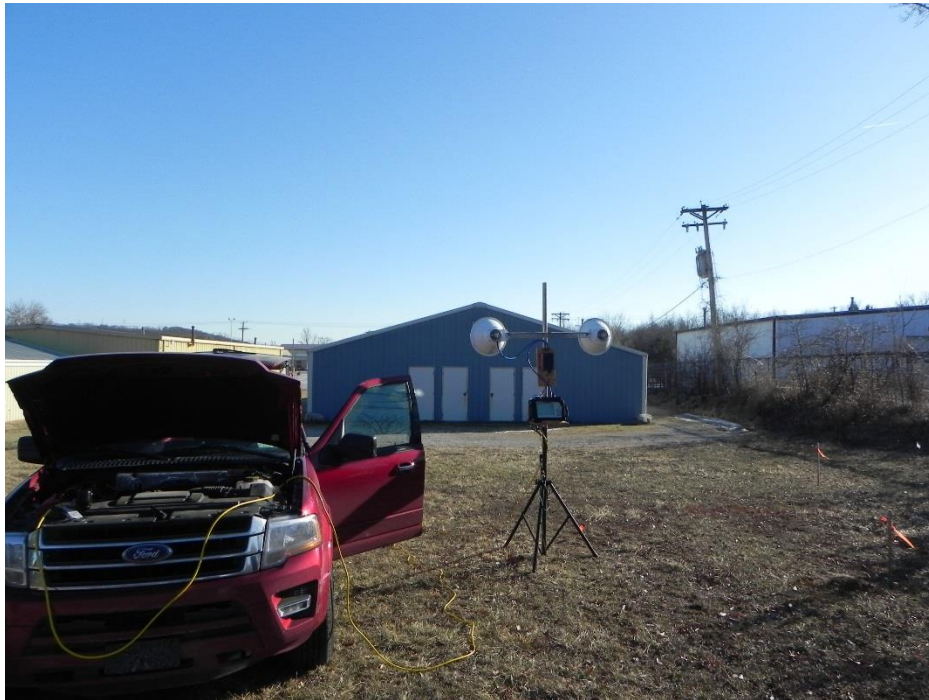
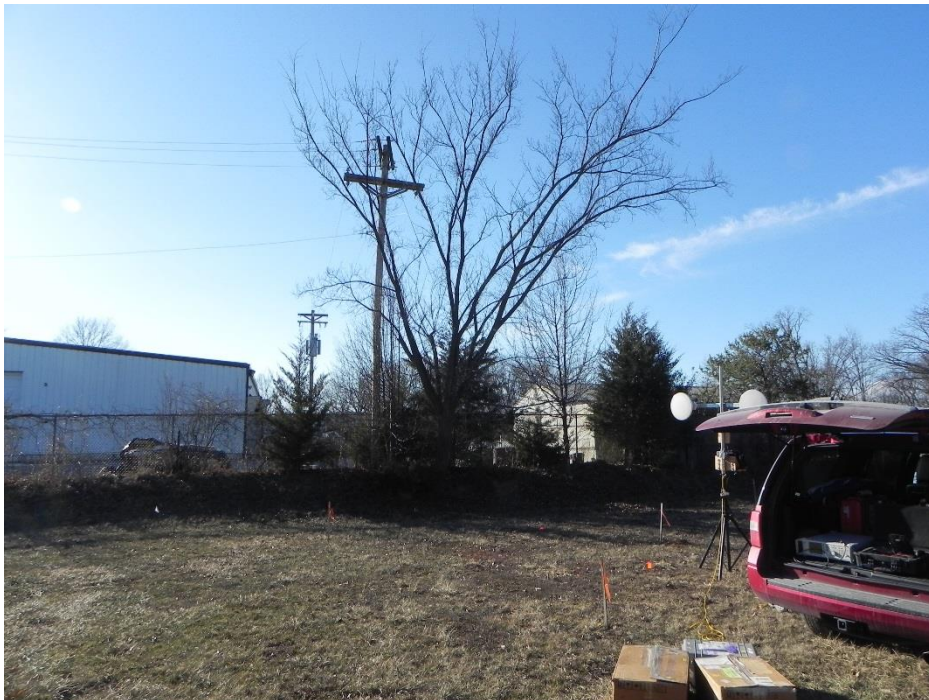
Figure 3.1-1 Earth Station Site Photographs

- Table 3.1-1 presents a site data sheet including all pertinent site information.
- Figures 3.1-1 and 3.1-2 are the photographs depicting the existing earth station site and satellite arc.
- Figures 3.1-3 through 3.1-10 are the RF spectrum photographs depicting the interference environment at the test site.

There is no potential satellite arc blockage at this site. Final arc clearance will depend on antenna placement.

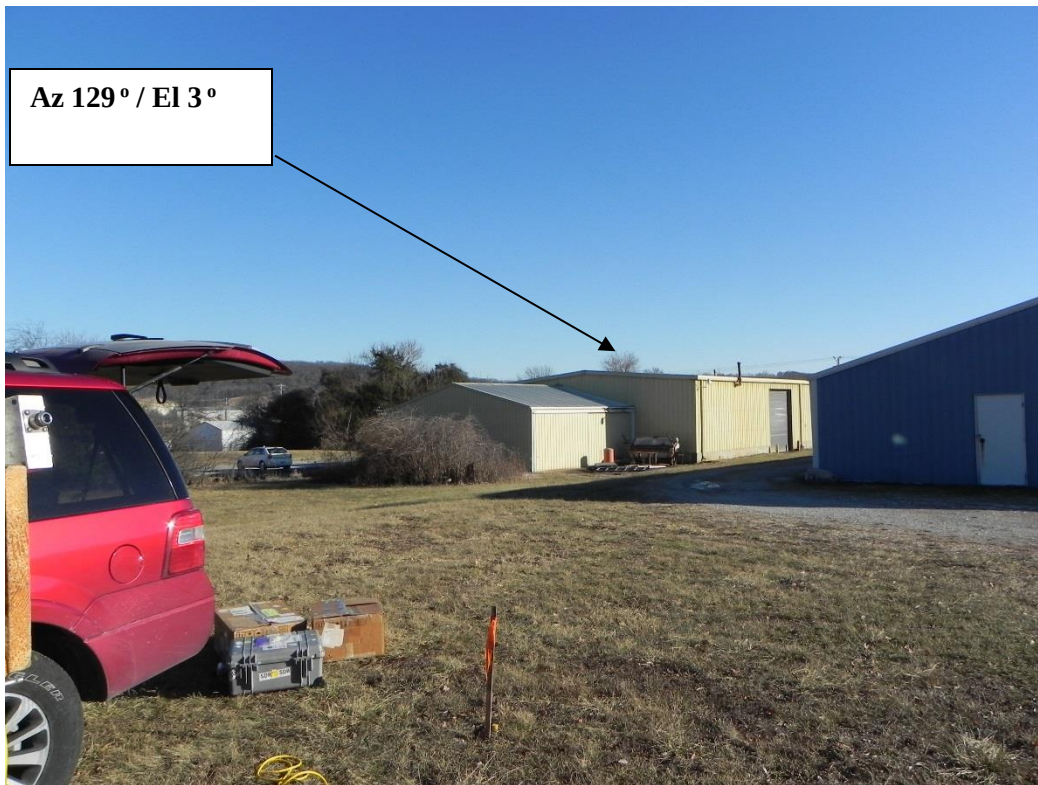
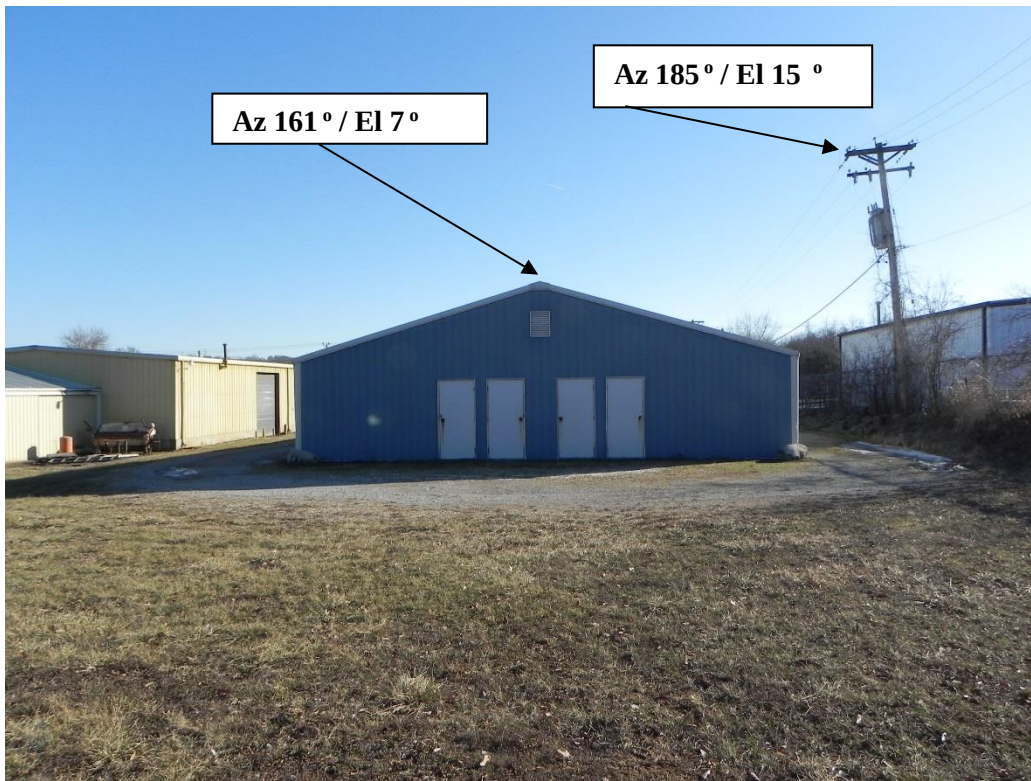
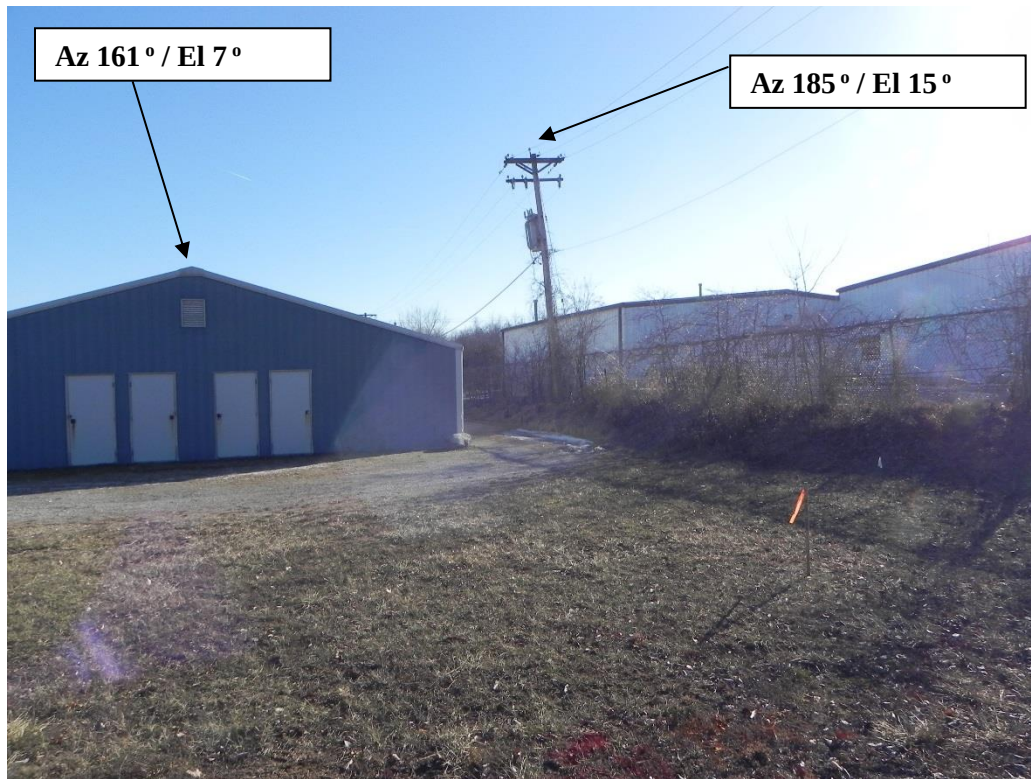
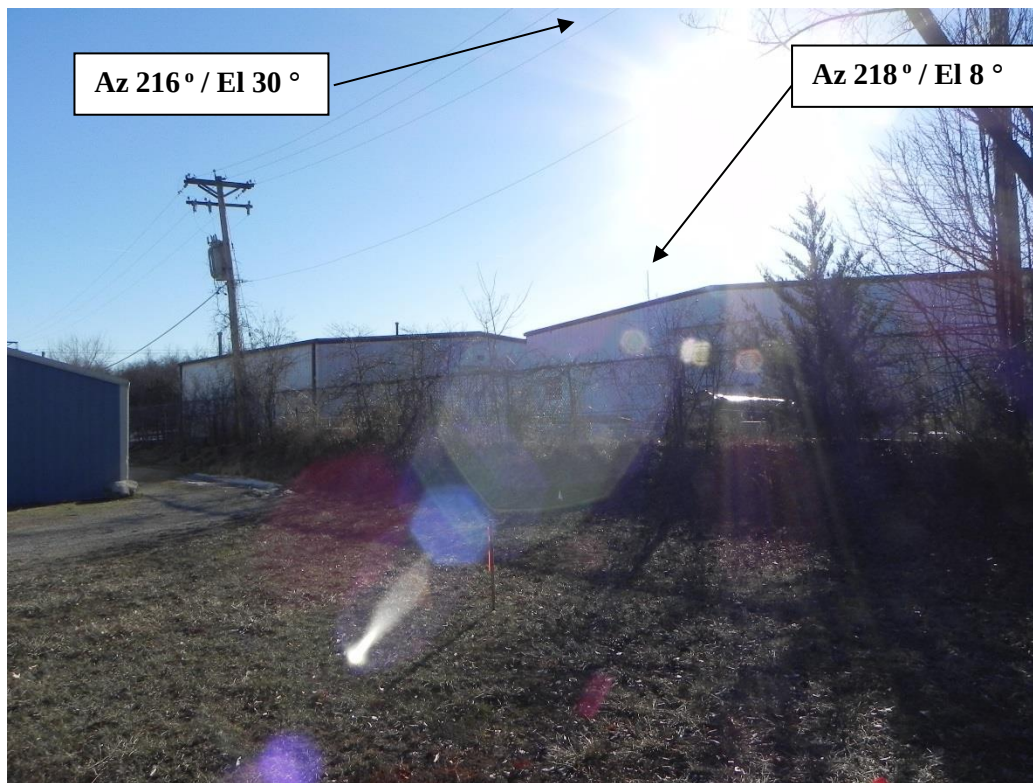
Figure 3.1-2 Horizon Photographs of Earth Station Site

| 8. GEOSTATIONARY ARC VISIBILITY: | Satellite arc has no permanent blockage at this time. |

The satellite arc has no potential blockage from 55W through 115W.
